**REPORT INTO THE GAS EXPLOSION INCIDENT
AT 16 BUCKSTONE GROVE, EDINBURGH
ON 30 NOVEMBER 2005**

APRIL 2006

Gas & Pipelines Unit (Scotland)
Specialised Industries Division
Hazardous Installations Directorate
Lord Cullen House
Aberdeen

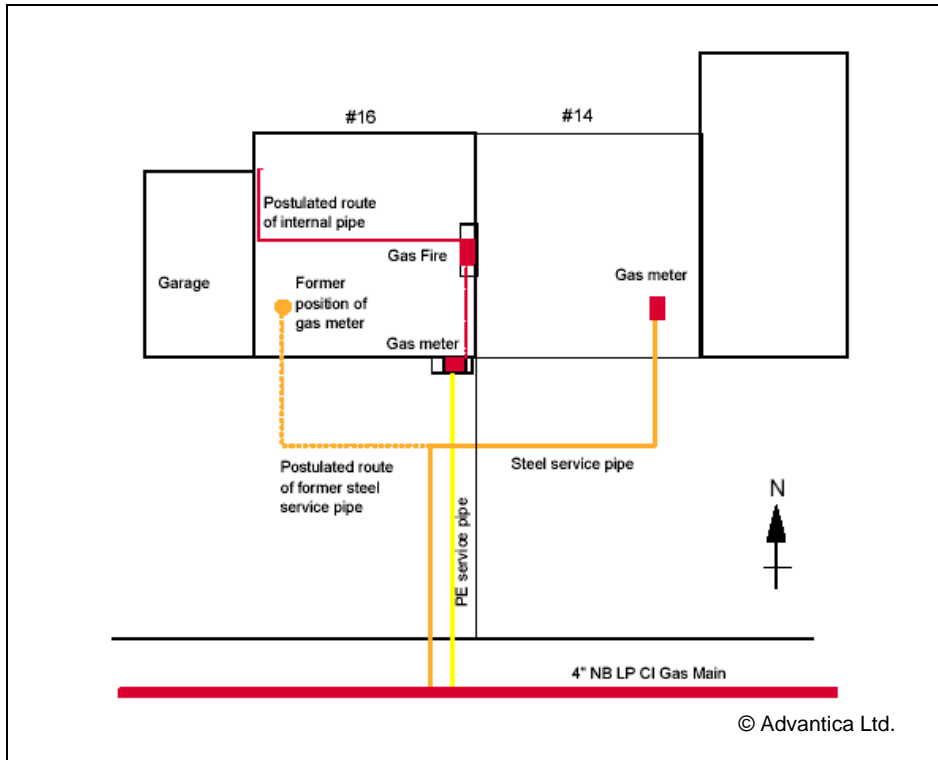
Figure 2 - Gas services to No's 14 & 16 Buckstone Grove

Leading from the 4" main there was a 25mm polyethylene (PE) service pipe supplying 16 Buckstone Grove. This ran underground, beneath the front lawn up to the front elevation of the property where it surfaced to terminate at an emergency control valve (ECV) within an externally mounted meter box. A semi-rigid steel connector ran from the ECV to a U6 type gas meter.

Prior to the installation of the PE service described above, No 14 and No 16 had originally shared a steel service that also connected to the 4" cast iron main. The steel service branched to supply the two properties, at a point in the front garden of No 16. The branch to No 14 is still operational, but the branch to No 16 was cut and capped at both ends when the PE service was installed. Within the property, it terminated at a capped meter control valve in the under stairs cupboard in the hallway.

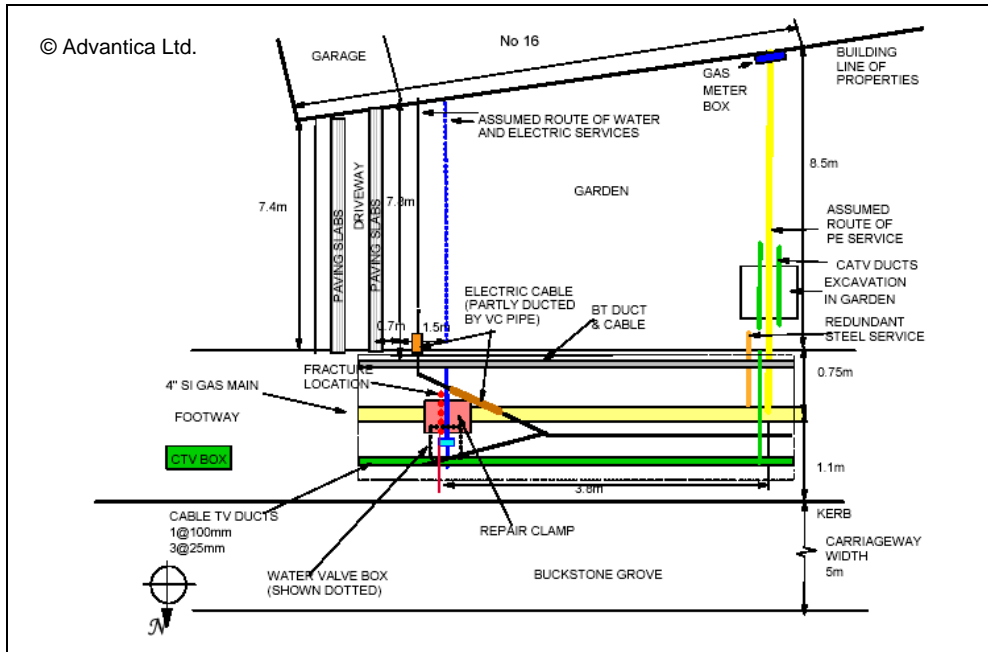
Figure 4 - Plan of utility services outside No 16 Buckstone Grove

The electricity supply to Buckstone Grove ran close to and parallel to the gas main under the footway. The supply branch to No 16 ran from the street supply, at a point near the fractured gas main, to the front of no 16 where it entered the property underground, close to the front door. The cable passed under the outer wall of the property via a 4" unsealed clay pipe. The supply terminated at a consumer unit located in the hall of the property.

The water main to Buckstone Grove also ran close to the gas main under the footway, being above the gas main and located closer to the roadway. The water service to No. 16 passed over the top of the gas main at the point where the gas main failed. Located on the water service was an isolation valve that was contained in a sectional concrete chamber (toby) built over the gas main. The water service entered the property underground at a point close to the electricity supply, in the area of the front door.

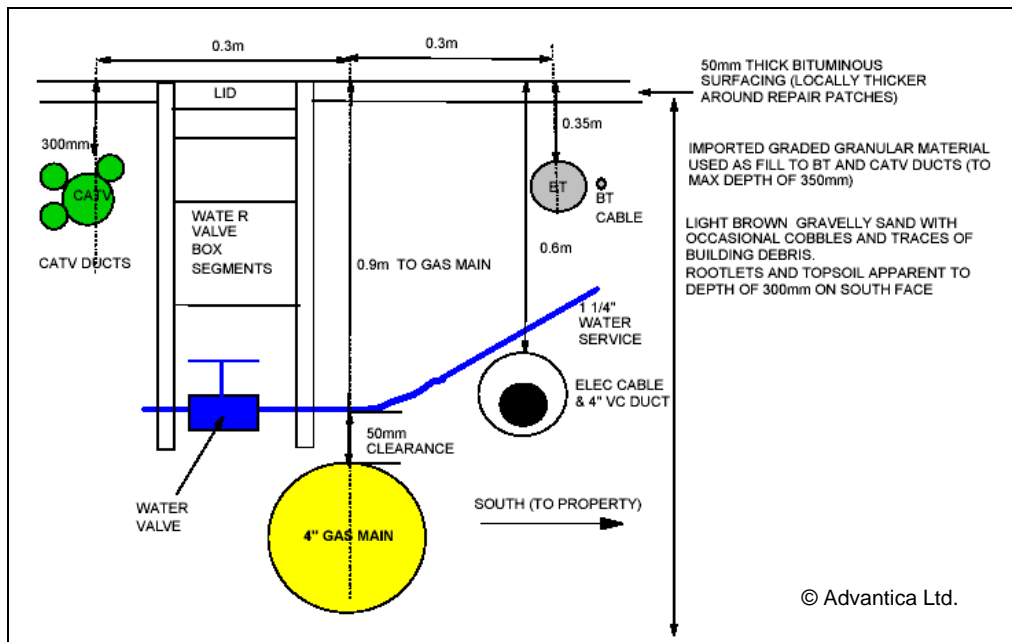
Figure 5 - Section through footway showing utilities at point of pipe failure

A water toby was located above the gas pipe (see Fig 5), although it cannot be established if it was in direct contact with the pipe. The structure of the toby is shown in figure 6. If not in direct contact it was very close to the pipe and in a position to act as a pivot point or as a means of applying a surface load to the pipe.

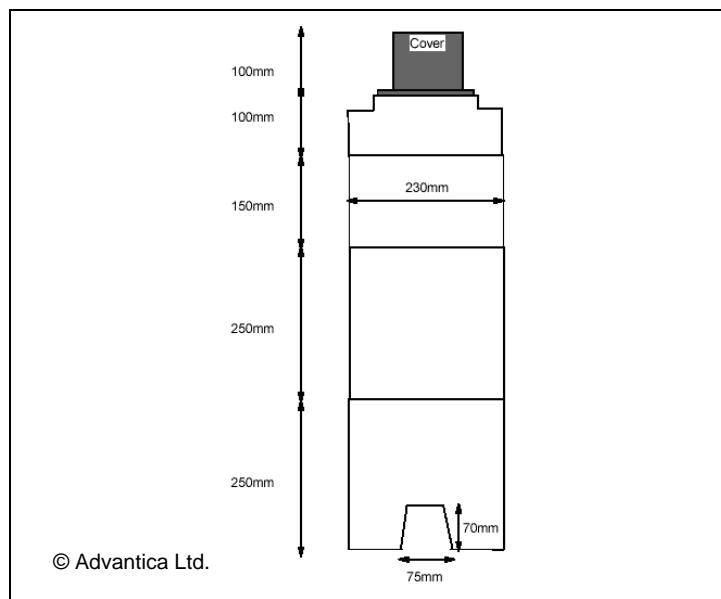
Figure 6 - Diagram to show structure of water toby.

The water toby is likely to have contributed to the pipe failure by acting as a pivot point promoting sagging flexure, leading to fissure corrosion along the bottom of the pipe. It is also possible that the toby could have played a part in transmitting force from heavy vehicles driving on the footway, to the pipe. However it is considered that the most likely scenario is that the fracture of the weakened main resulted from ground instability, as a result of the nature of the local ground, allied with the pivot point created by the toby.

4. The water toby is likely to have contributed to the pipe failure by acting as a pivot point promoting sagging flexure, leading to fissure corrosion along the bottom of the pipe. It is also possible that the toby could have played a part in transmitting force from heavy vehicles driving on the footway, to the pipe. However it is considered that the most likely scenario is that the fracture of the weakened main resulted from ground instability, as a result of the nature of the local ground, allied with the pivot point created by the toby.

- 2) A review of the issues associated with the installation and close proximity of sub-surface structures to iron gas mains is to be undertaken between SGN and the other utility companies concerned. The key objective is to determine the likely significance and extent of the issue and to identify any reasonably practicable measures which can be implemented to help reduce the likelihood of similar incidents.
