Texas City Incident

Human Factor Aspects

Jo-Anne Michael

HM Inspector of Health and Safety

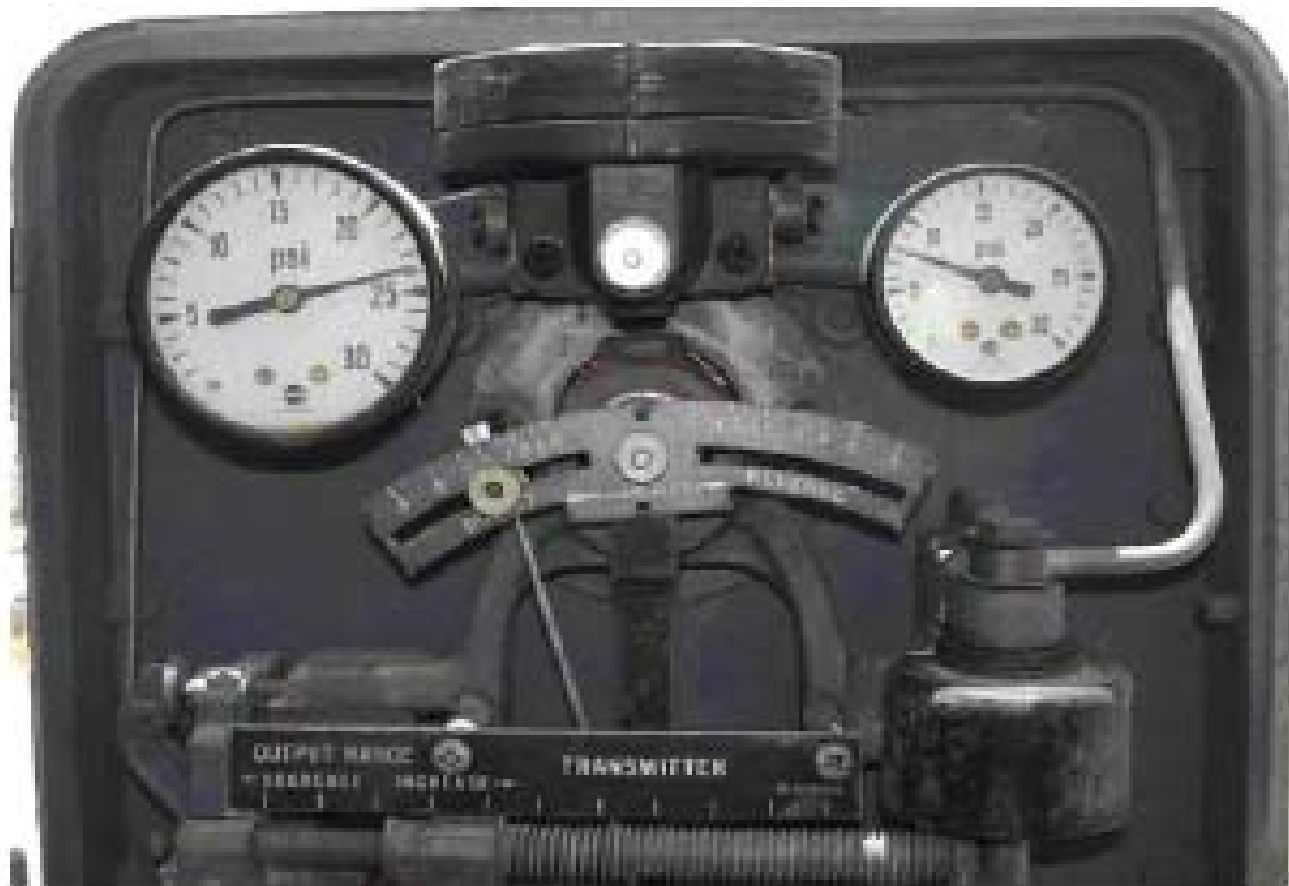
- The sight glass on the tower was dirty and unreadable.
- The redundant high level alarm on the splitter tower failed to sound.
- The level indicator that was available was miscalibrated and gave the operators false readings that suggested the liquid level in the tower was declining.
- There was no other indication of level available to the operators.

Figure S- 3. LT-5100 cabinet showing calibration set for 0.8 specific gravity

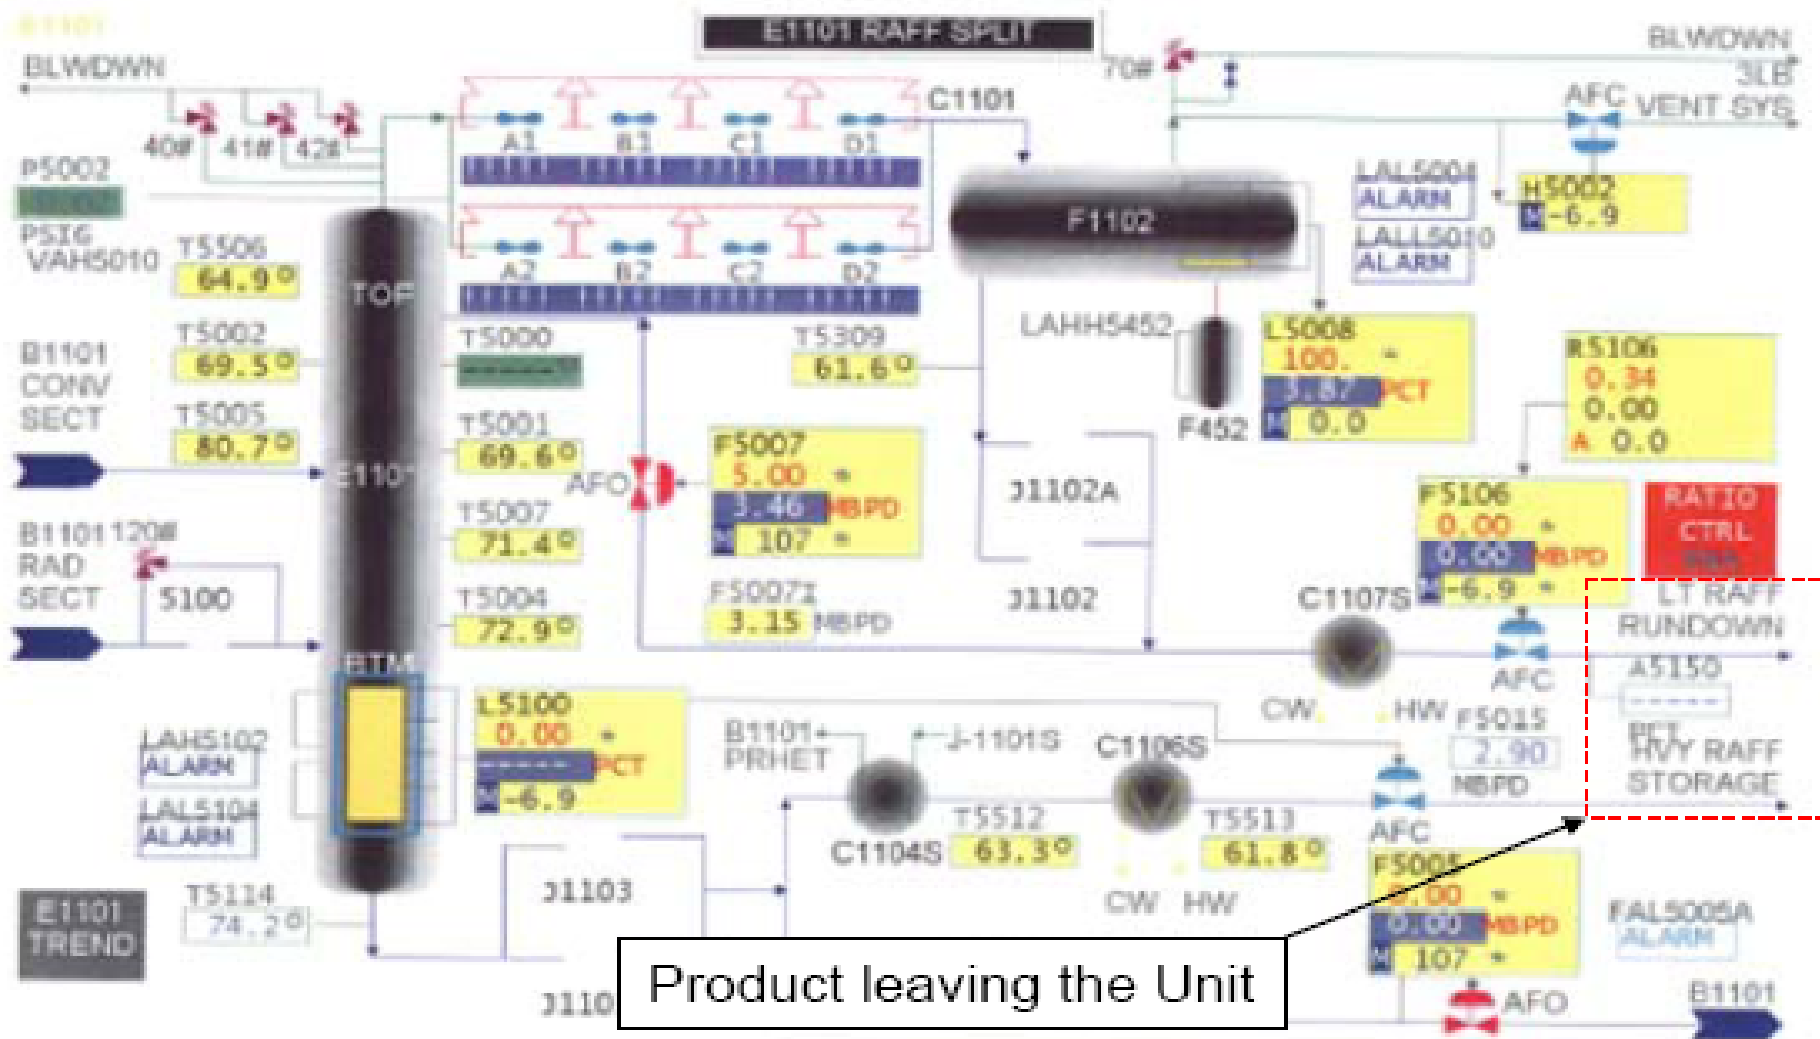
- The display lacked an adequate indication of the liquid level in the tower (and did not calculate the material balance of the system).
- Two different screens used to display liquid in and out of the unit.
- Displayed portions of the unit in discrete detailed sections— no screen providing a complete overview of the process.

Product leaving the Unit
