## Supporting images to report about the HSE investigation into the collapse of a tower crane in Canada Square, London on 21 May 2000

Figure 1 Typical luffing jib tower cranes on DS1/2 sites after the incident

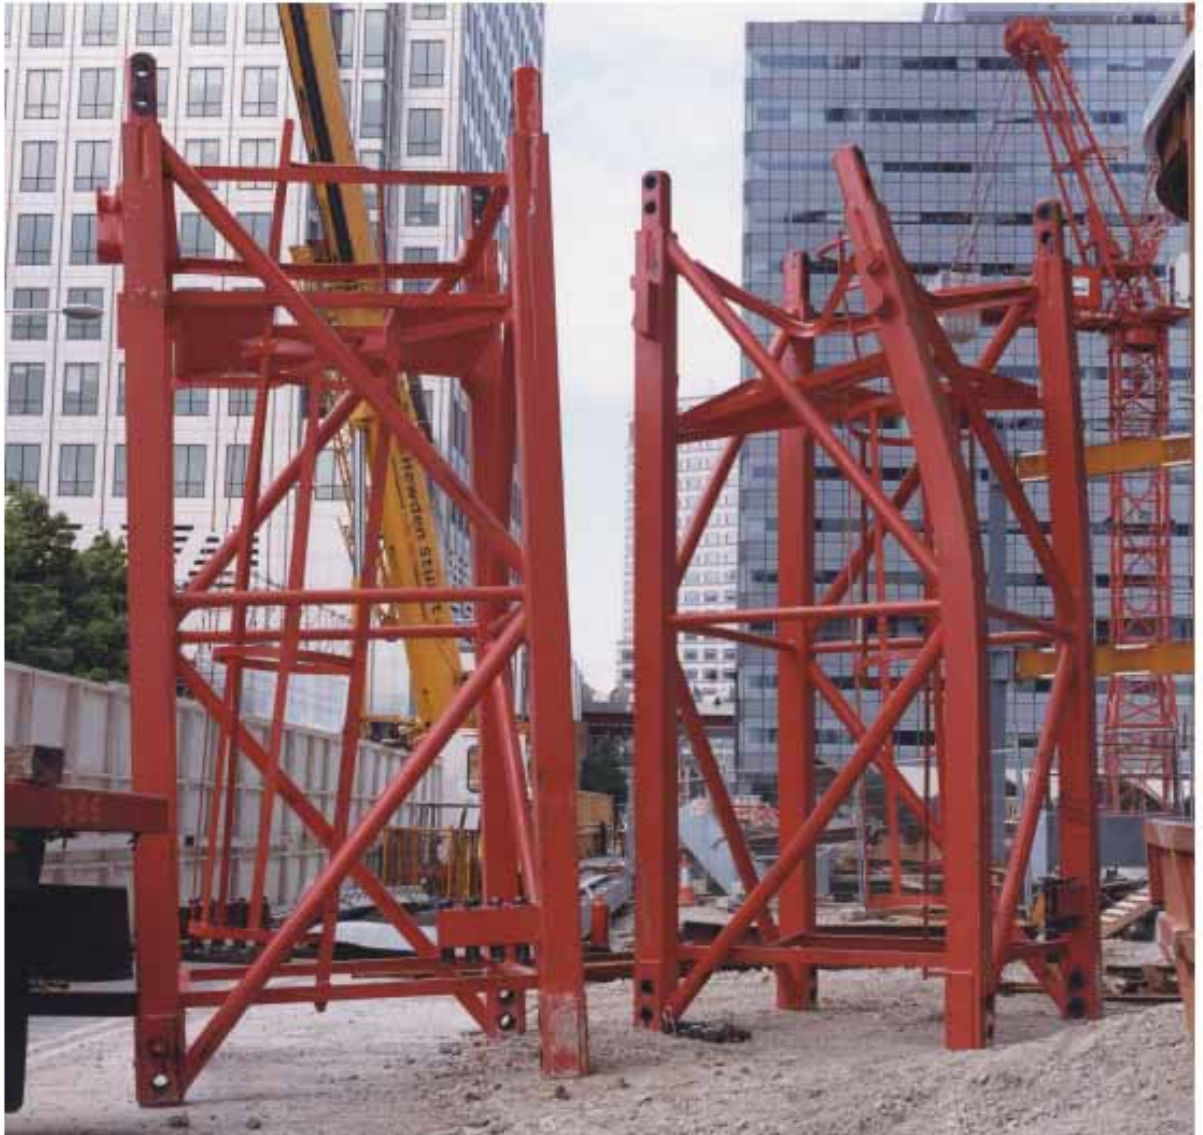
Figure 15 Two top mast sections of TC3 after recovery showing the pattern of damage

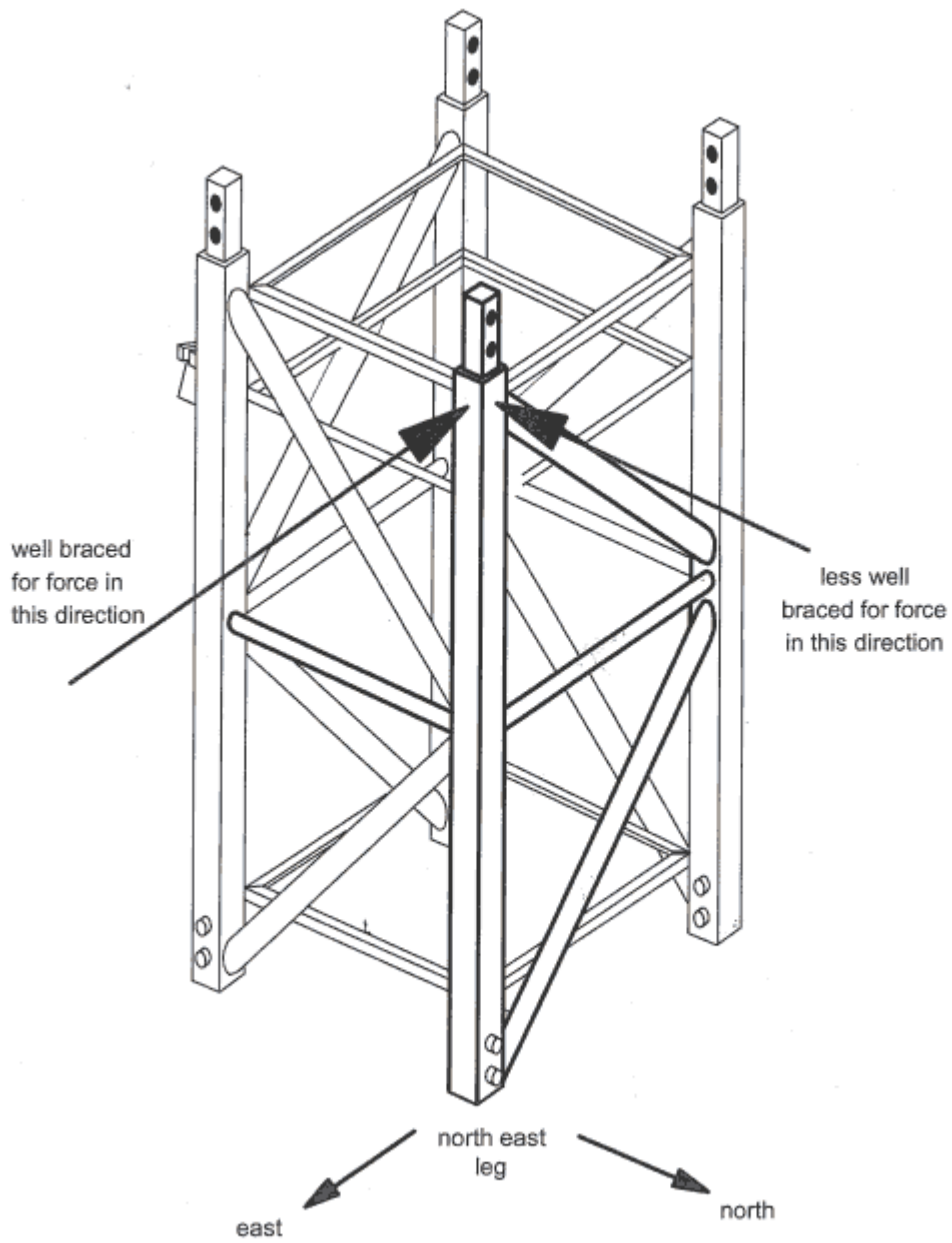
Figure 16 Drawing of top mast section illustrating the reason for the pattern of damage

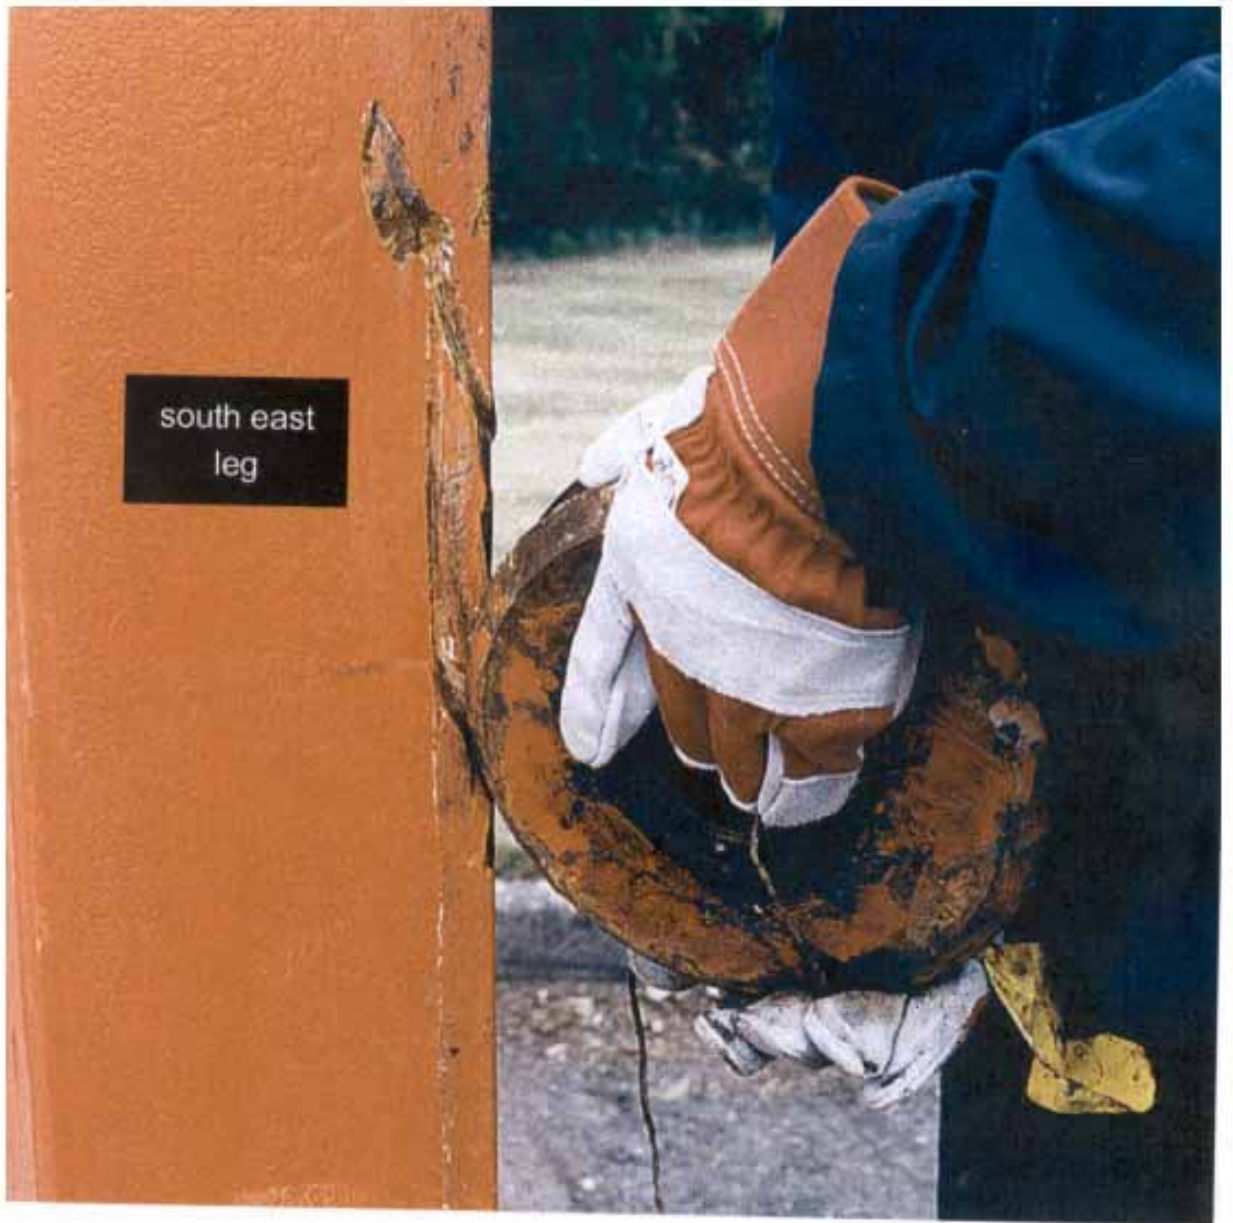
Figure 17 Guide Wheel being offered up to gouge marks on SE leg of mast section
