This safety alert is drawn up to spread the lessons learnt from the major oil release of October 25th, 2005 in an oil storage terminal. The oil storage terminal belongs to a large oil company and is an upper tier Seveso establishment.

This alert is based on the investigation of the company, for which several external experts were consulted, and the investigation of the Belgian authorities. After the accident history recommendations are formulated to prevent similar accidents in the future.

### 3. Construction information and history of the storage tank D2

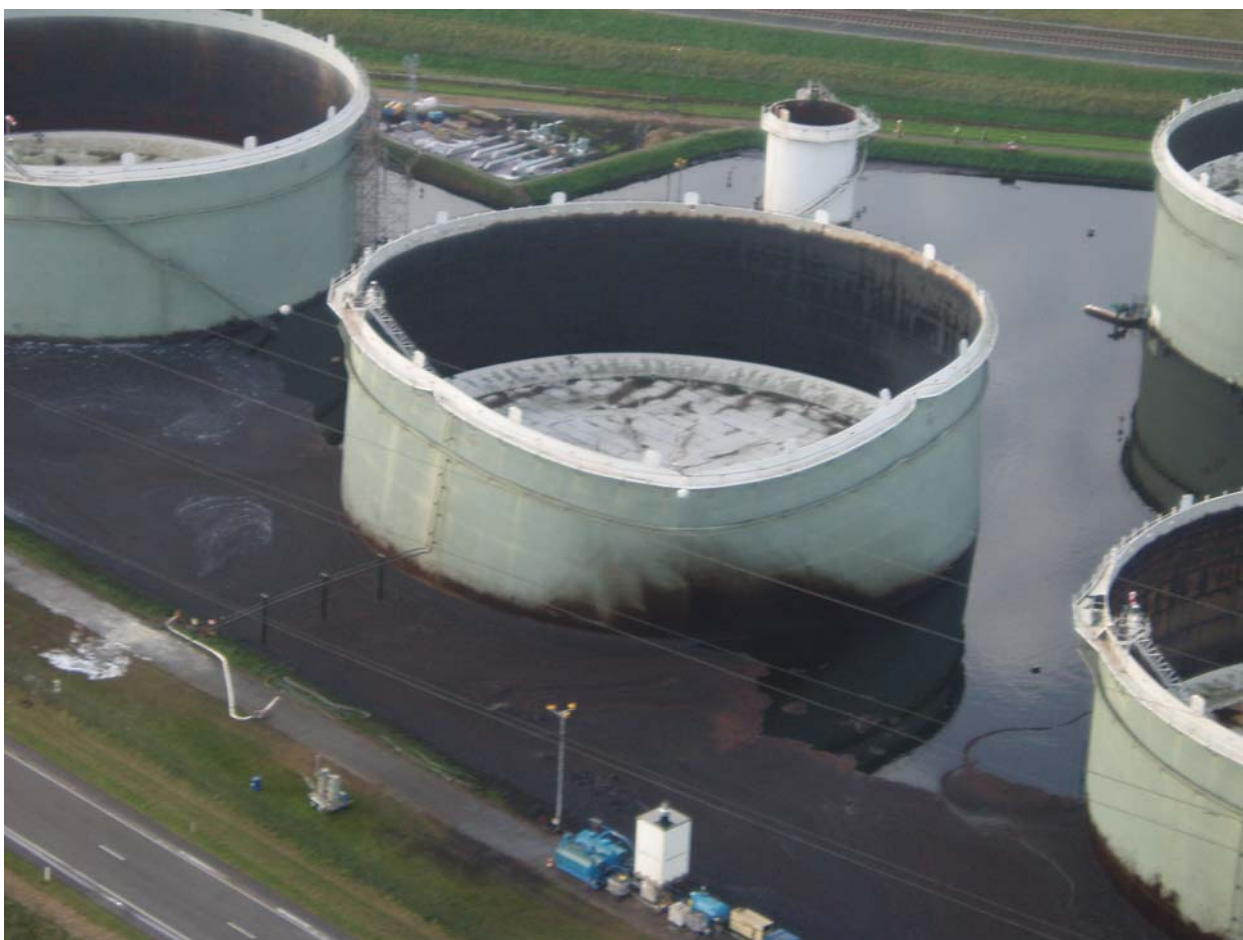
Because the content of the storage tank was released in such a short time, an enormous wave was created. This wave moved in the direction of the several meters high earth dike. Due to the height of the dike only a small amount of crude oil (approximately 3 m<sup>3</sup>) was ejected out of the bund. The released crude oil filled the whole bund (40 000 m<sup>2</sup> large) with crude up to a height of 1 m.

After the major accident all the crude oil stored at the terminal was immediately pumped to the refinery and the contents of the bund was pumped to the storage tanks D10, D11 and D4 by using the existing drain water pump system. Immediately measures were taken to perform all cleaning activities in the storage terminal in a safe manner.

*Figure 2: Picture of the situation in the bund the morning after the major accident*

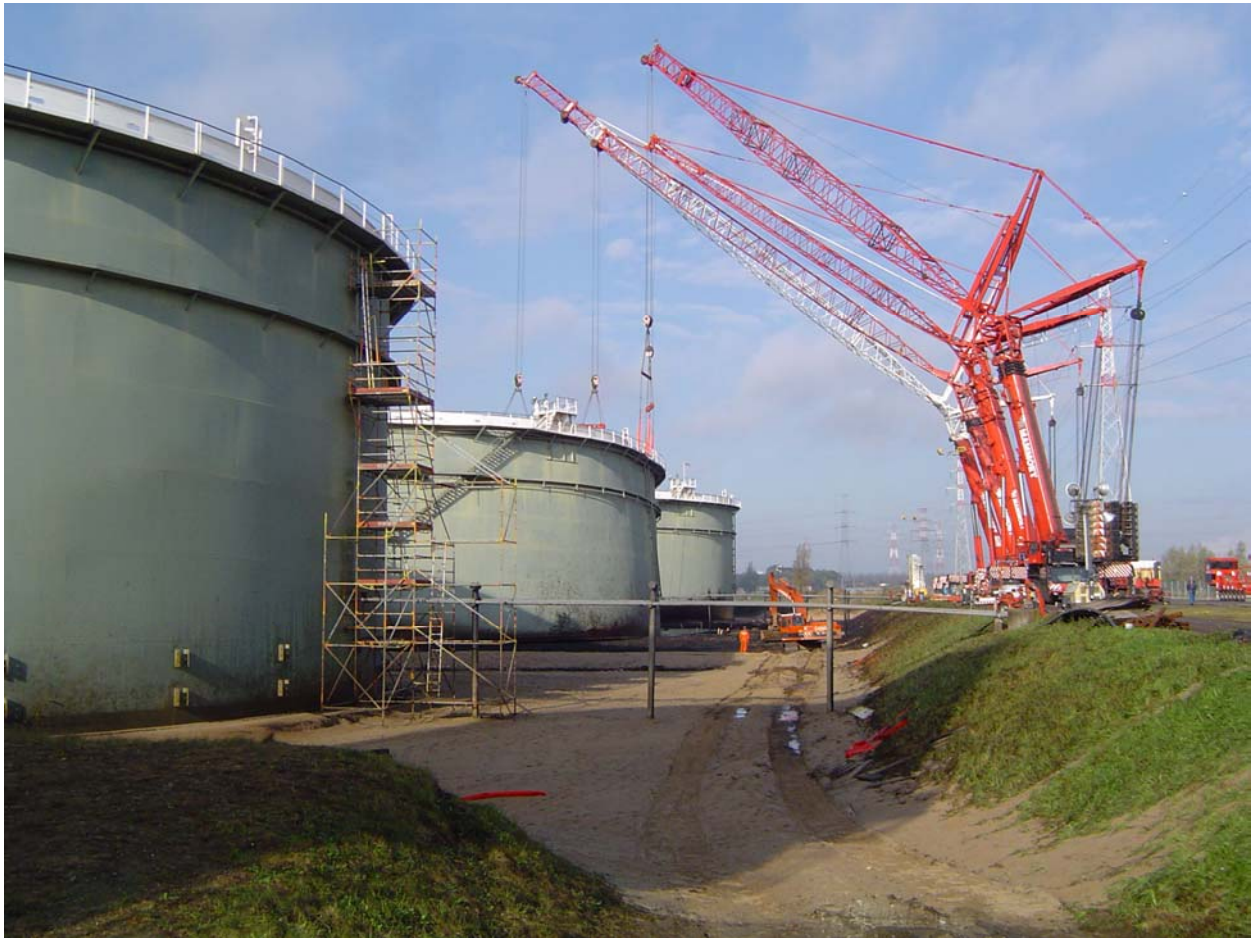
After the release the storage tank was leaning forward and a part of the foundation of the storage tank had disappeared.

The stability of all storage tanks was periodically measured. The stability of storage tank D2 on the place where the foundation was blown away, was achieved by hanging the storage tank on 4 large cranes (figure 3).

Figure 3: Picture of major cranes stabilising storage tank D2

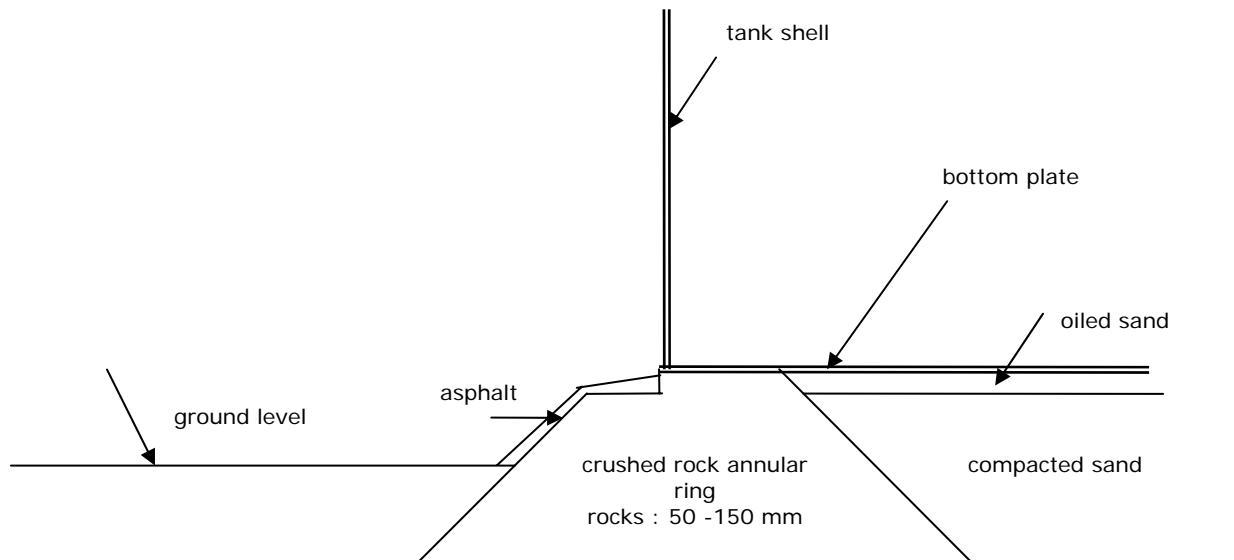
Figure 4: Schematic view of the tank foundation

The foundation of storage tank D2 consisted of a crushed rock annular ring. The rocks had a diameter between 50 mm and 150 mm. The crushed rock annular ring had a height of approximately 120 cm of which a part was below the ground level. The crushed rock ring had a width of approximately 340 cm at the bottom and 100 cm at the top. The shell was situated in the middle of the width of the crushed rock ring. The inner part of the annular ring was filled with compacted sand. Above this sand there was a layer of 5 cm consisting of oiled sand, to avoid external bottom corrosion. Figure 4 provides a schematic view of the foundation of storage tank D2.

The major release initially started with a small leak. Due to this small leak the compacted sand underneath the tank bottom was saturated with oil and a kind of quicksand of oil and sand is formed. This small leak has not been visually detected because the crushed rock annular ring had a lot of holes, which were initially filled with crude oil. In the second phase of the accident the resistance of the foundation under the tank was locally strongly reduced (due to the fluidisation of the sand bed) and due to the hydrostatic pressure of the crude oil on the tank bottom, the bottom has ruptured over the length of the gutter. The force of the out flowing crude oil was that large that it destroyed a part of the tank foundation and swept away part of the underground.

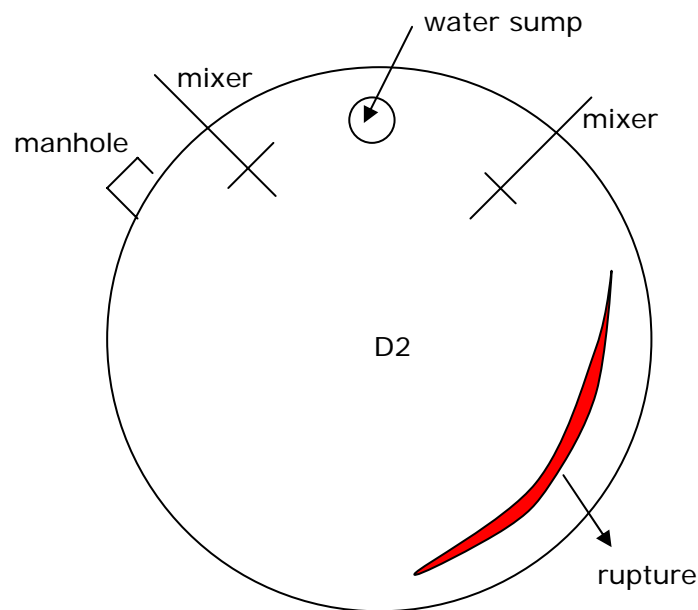
Figure 5 : Schematic view of the bottom of storage tank D2

The investigation of tank D2 showed that the bottom plates in a long, small circular band at approximately 1,5 m from the shell of the storage tank were extremely weakened due to internal corrosion. In this band the thickness of the bottom plates was nearly reduced to zero. This band had a length of approximately 35 m and a width of approximately 20 cm.

In this band the bottom of the tank formed a gutter. In this gutter uniform, internal corrosion was found and no pitting corrosion.

The bottom plates showed no external corrosion in the long, small band. The other bottom plates indicated no extreme corrosion.

During the exploitation of storage tank D2 a gutter was formed in the bottom of the tank. This gutter is situated at a distance of 1,5 m from the tank shell. Due to the formation of the gutter the present water could not longer flow to the drain water system to be removed. The accumulation of stagnant water in the gutter caused strong corrosion which strongly reduced the thickness of the bottom plates in that area.

As mentioned before, a gutter was situated in the tank bottom at a distance of 1,5 m from the tank wall. This is just beyond the annular plates on which the tank shell is welded. The first normal bottom plates after the annular plates have been teared during the accident. The gutter has been formed due to settlements in the tank foundation, which at that place consists of compacted sand. The gutter has probably been formed during the first hydrostatic tests on the storage tank. The moment a storage tank is loaded for the first time, the compacted sand settles. In the neighbourhood of the crushed rock annular ring, which consists of coarse rocks, it is difficult to compact the sand bed in an appropriate manner during construction. At the moment the storage tank is loaded for the first time, the sand in that area will be more compacted, but because of the existing holes in de crushed rock annular ring a part of the sand will disappear in the holes between the coarse rocks. Due to these phenomena a gutter is formed in the bottom plates nearby the crushed rock annular ring. Calculations based on a finite element method showed that based on the information about the foundation of the tank in combination with the underground under the tank foundation and the size of the storage tank, the forming of the gutter could be predicted.

In the gutter in the bottom of the tank, the present water could not longer flow towards the water sump. This situation of stagnant water in the gutter enabled very fast corrosion in the gutter with the rupture of the tank bottom as the major consequence.

The storage tank D2 had been totally demolished.

The parts of the bottom plates of the other storage tanks of which the thickness and/or the deformation do not fulfil the prescriptions of API 653 shall be repaired. The foundation of the other storage tanks was investigated to control if they still have enough stability (during the accident they were drawn in crude oil) to restart the exploitation of the storage tanks.

Before start-up all crude oil storage tanks shall be coated with a lining to stop the internal corrosion of the bottom plates.
