| <b>Health and Safety Executive</b> | | <b>Sector Information Minute</b> | |
| <b>Commercial and Consumer Services,<br/>Transportation and Utilities Sector<br/>(CACTUS)</b> | | <b>SIM 05/1999/52</b><br>(formerly SIM 03/1999/17) | |

**BICYCLES USED BY ROYAL MAIL DELIVERY STAFF**

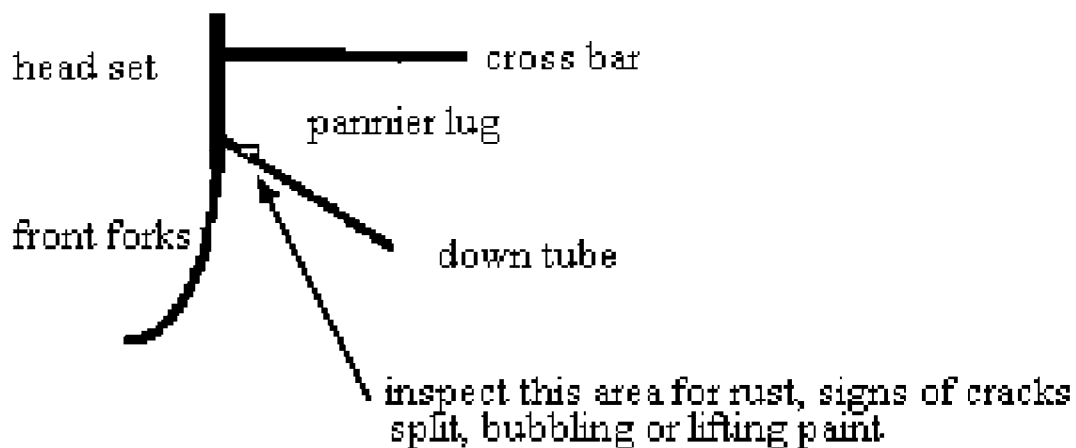
4 In 1992 Royal Mail produced its own bicycle specification which it tested against BS 6102 which is the standard for leisure bicycles, there being no appropriate standard for commercial bicycles. Frame failures in the cross bar version have begun to occur on those bicycles manufactured between 1992 and 1996. Each frame has a unique identification number which identifies its year of manufacture. The failure occurs where the down tube pushes up into the side leg of the head set, close to the pannier lug. Corrosion normally occurs on the upper surface of the down tube with a slowly propagating crack around the diameter of the tube which eventually leads to failure.

5 Currently there are 6,000 bicycles manufactured between 1992 and 1996. The current replacement programme should have removed these from service by March 2002. In the meantime a 'Cycle Safety Notice' has been released requiring all bicycles manufactured during this period to be examined every three months by a Royal Mail bicycle mechanic. Due to the slow propagation of the crack this is considered adequate. Each bicycle already has a maintenance log sheet which will be used to record this inspection. Any suspect frames are to be scrapped.

7 Further improvements have been made both in the design of the frame and the specification for the tube to remove the problem. The millennium model which is to be released shortly has the side leg of the head set extended further along the down tube to strengthen the area where failure has previously occurred. Currently there is no evidence to suggest there are any similar frame failure problems with bicycles manufactured after 1996, which have a better tube metal specification.
