HEALTH AND SAFETY EXECUTIVE

Examination of Crush Barriers from Pens 3 and 4

IR/L/MM/89/11

Date: 11 December 1989

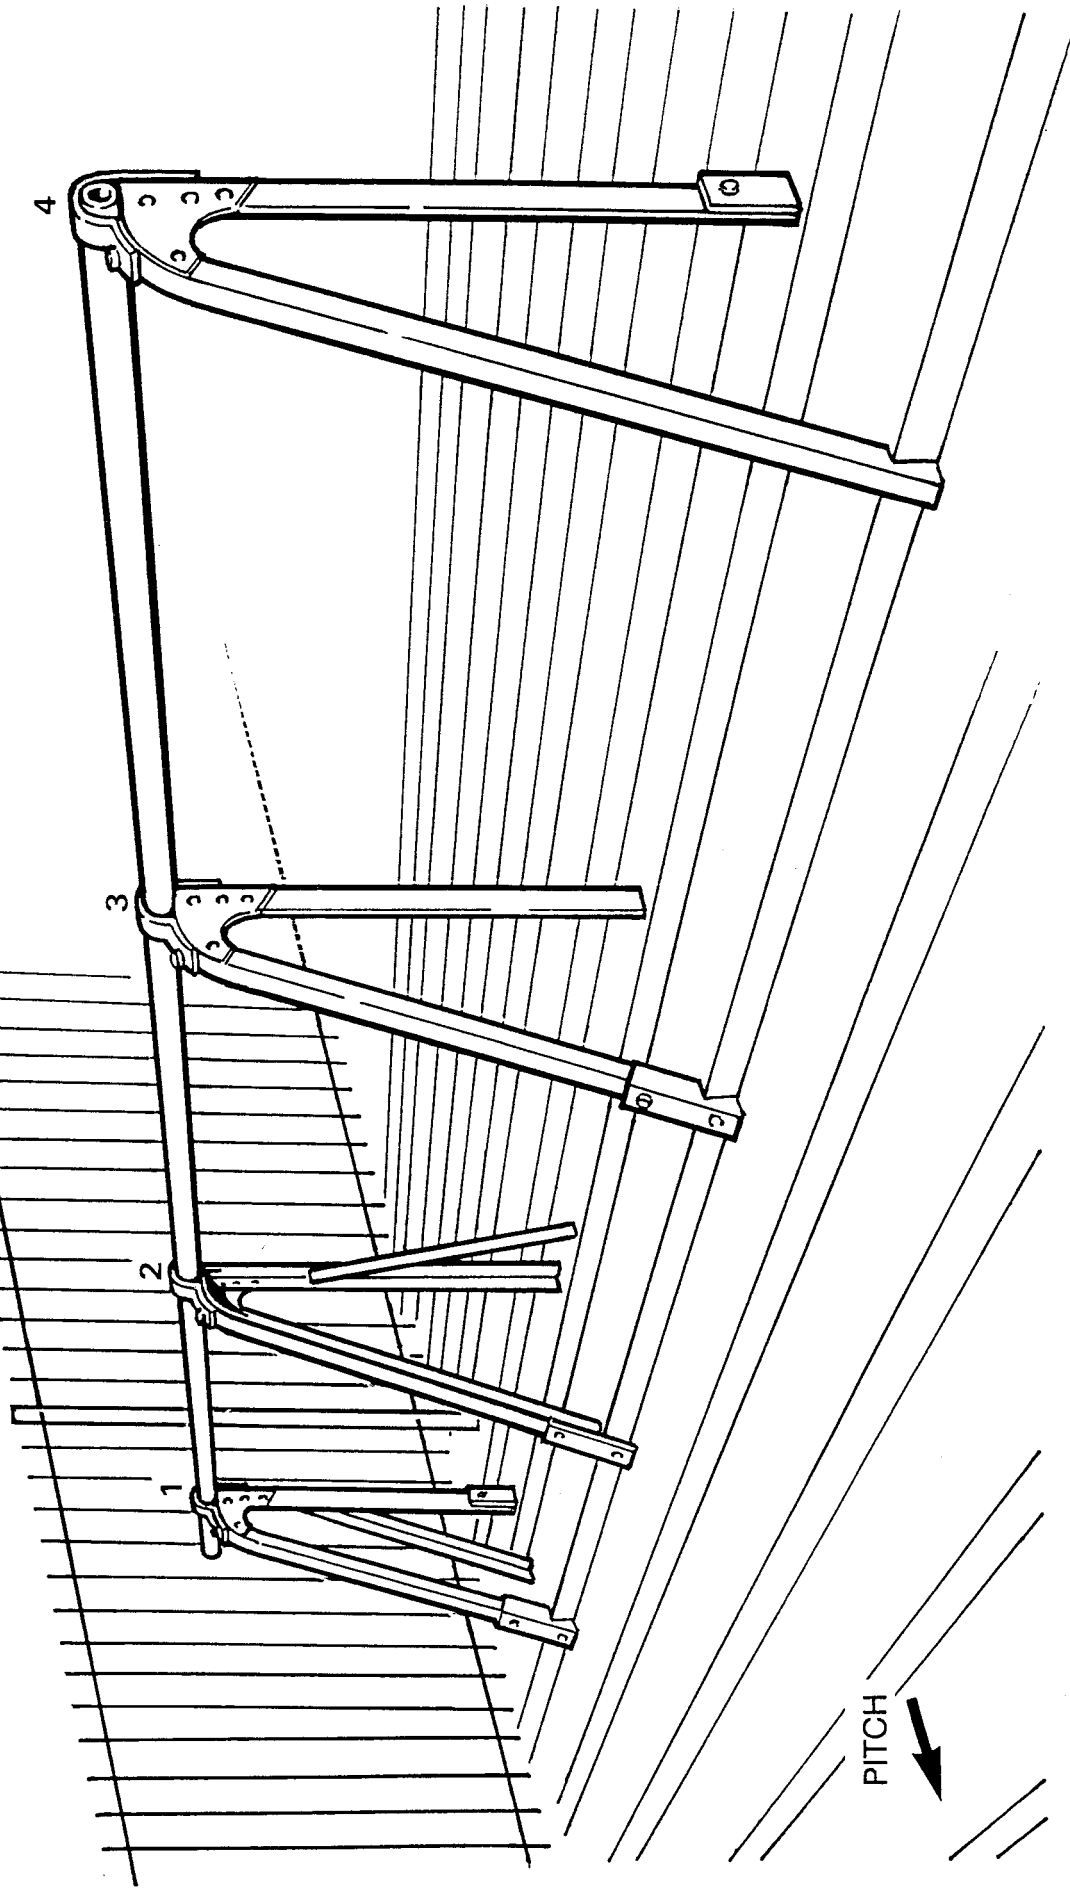
Fig. 1 - Reconstruction of Barrier 124A

Barrier 124A was located on the seventh, eighth and ninth steps of Pen 3 adjacent to Pen 2. The overall length of this barrier before collapse was estimated to be 7.5m including a tube overhang of 0.6m near the radial fence adjacent to Pen 2. The horizontal distance from this barrier to the perimeter fence at the front of Pen 3 was approximately 3.5m, and the distance of the tube end from the radial fence, separating Pens 2 and 3, was 28mm. There were no other barriers between barrier 124A and the perimeter fence. A sketch of this barrier, showing our opinion of its appearance before the incident, is shown in Figure 1.

Support 4, shown in the foreground of Figure 1, had been moved forward and twisted towards the front left-hand corner of Pen 3, viewed from the pitch. The lower portion of the front leg had remained straight, although by comparison with the front legs of other barriers, it appeared to have moved forward through an angle of 25 degrees approximately. In so doing the front leg had broken away from the edge of the concrete step in which it had been supported. Several pieces of detached concrete were observed nearby, two of which matched the fracture on the step, shown in Figure 3. The upper portion of the front leg had suffered localised bending and it had been twisted inwards with respect to the other supports on this barrier.

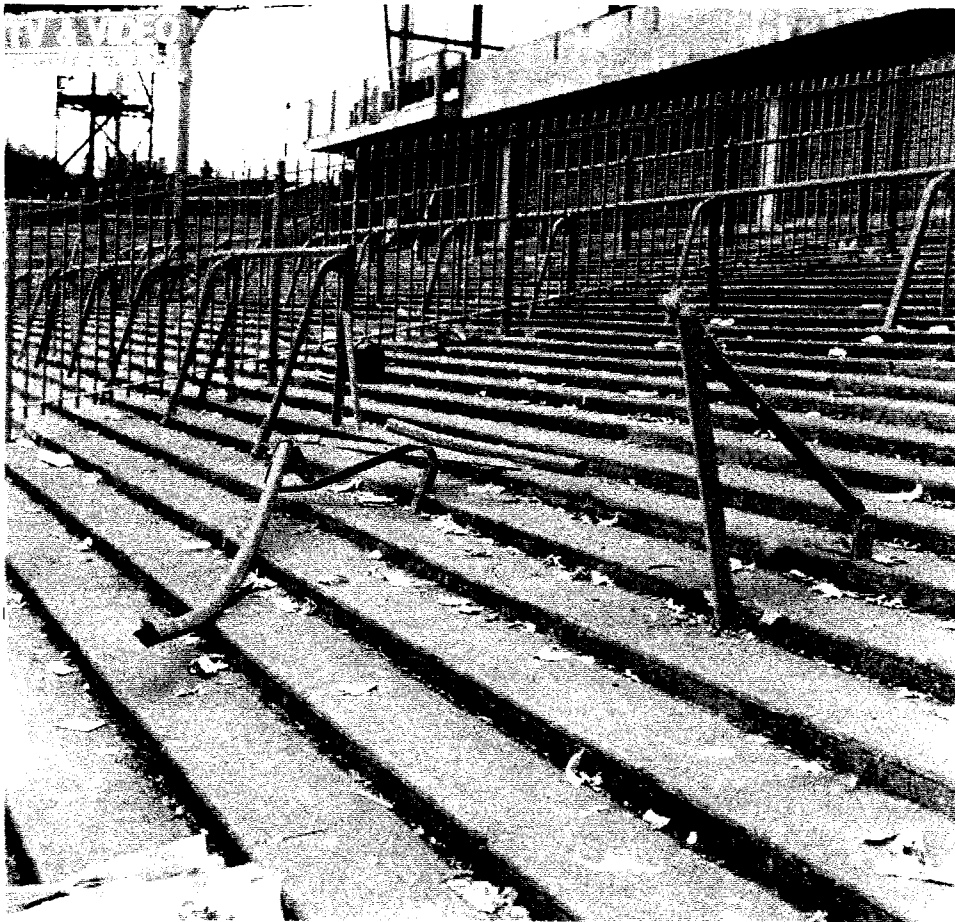
Fig. 2 - Barrier 124A on 17/4/89.

Figure 2 shows barrier 124A viewed from the pitch as it appeared on the morning of 17 April 1989. The detached length of tube had a transverse fracture at either end. One of these fractures matched the fracture on the length of tube in contact with support 2 and the other matched the fracture on the length of tube in contact with support 3. Hence it was possible to locate this detached length of tube in the correct position between supports 2 and 3. This detached length of tube had been bent symmetrically about its mid-point where the maximum deflection was 133mm.

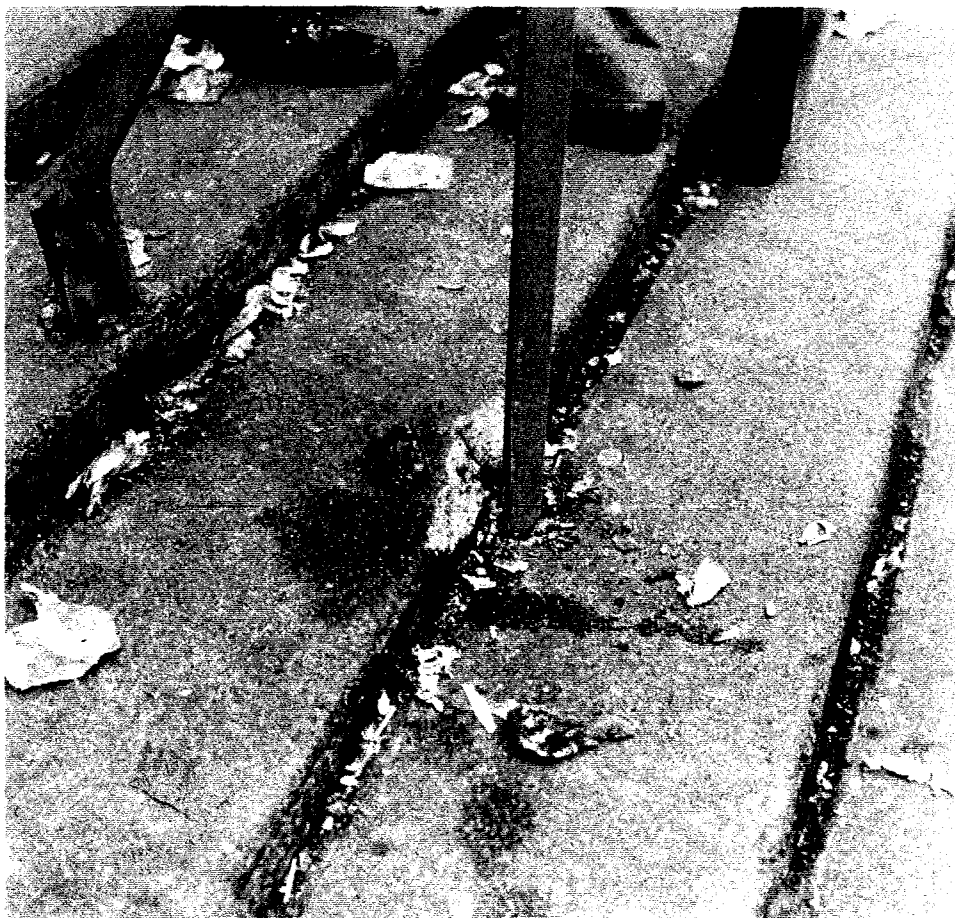
Fig. 3 - Front leg of support 4 on barrier 124A.

When the front foot of support 4 was exposed, considerable thinning and loss of metal was observed in the vicinity of the bend between the upright and the foot. This area was further weakened during core drilling and the remaining ligament of metal, approximately 5mm wide and 0.8mm in thickness, became detached during removal of the support. Part of the front foot was found to be in contact with a reinforcing wire in the concrete and a length of this wire was removed for possible future examination.

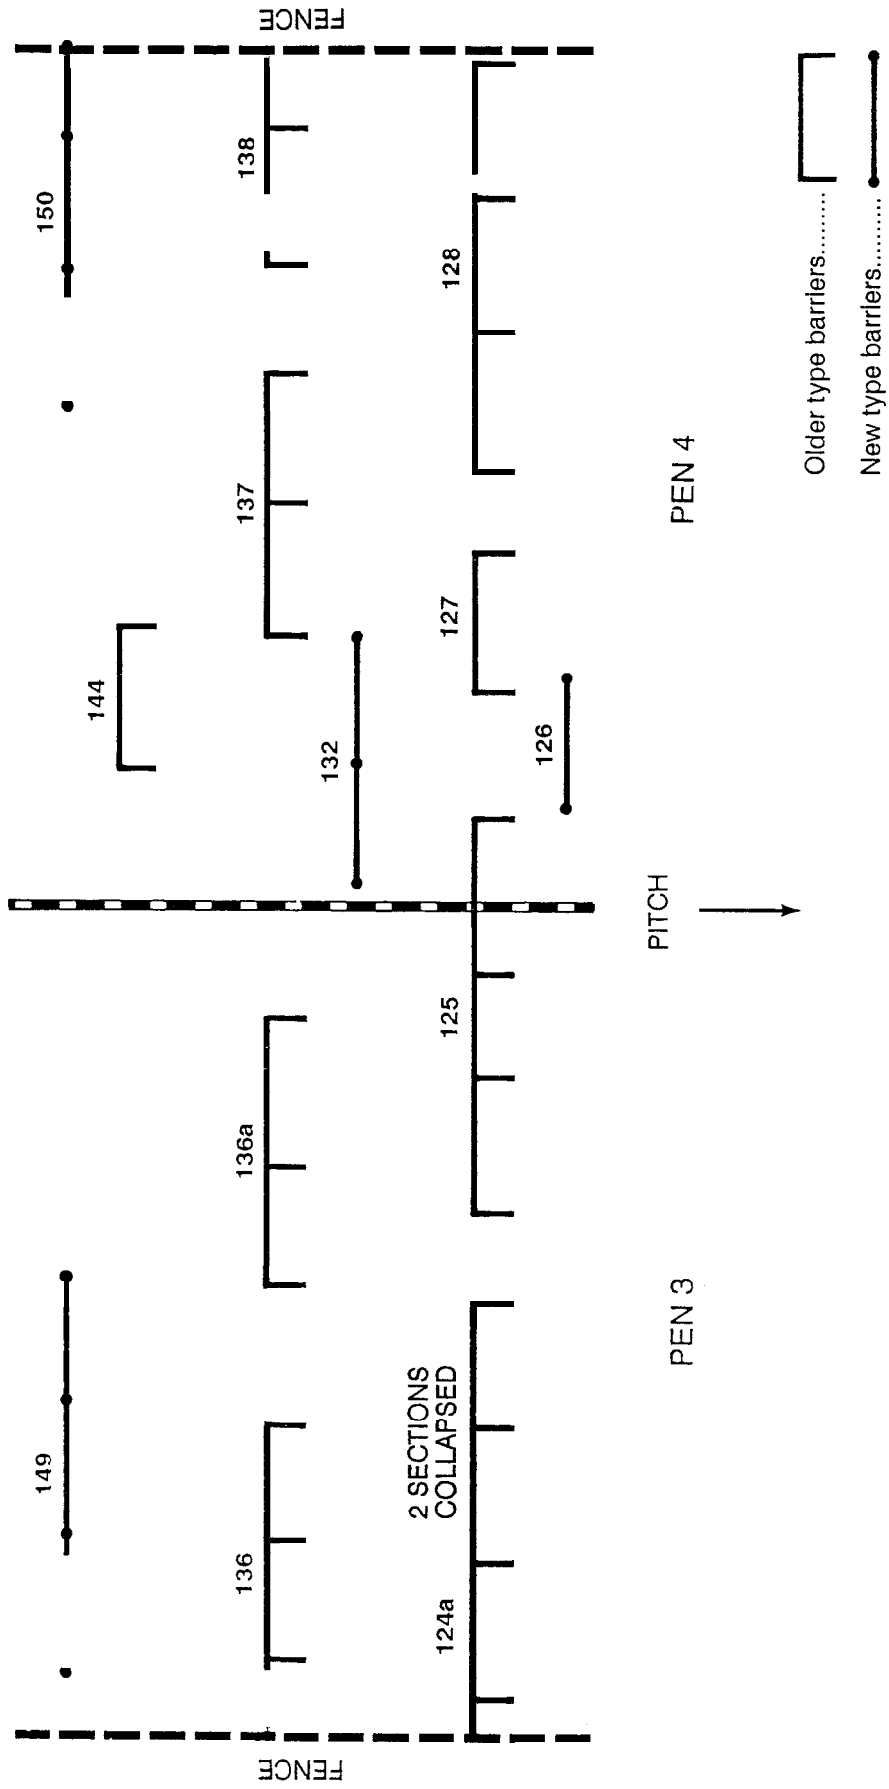
Fig. 4 - Layout of barriers in PENS 3 & 4

The remaining barriers in Pen 3 and those in Pen 4 were examined. The layout of all the barriers in Pens 3 and 4 is shown schematically in Figure 4. On each barrier the supports were numbered sequentially from left to right as viewed from the pitch. Several barriers had been fabricated with rectangular hollow section supports and these appeared to be somewhat newer than the rest. Most of the old-style barriers had been modified in some way, for example by reinforcing of the support legs and welding of the horizontal tubes. Corrosion was evident at all joints and intersections, and rust "jacking" had occurred at many of the gusset plate/support leg junctions.

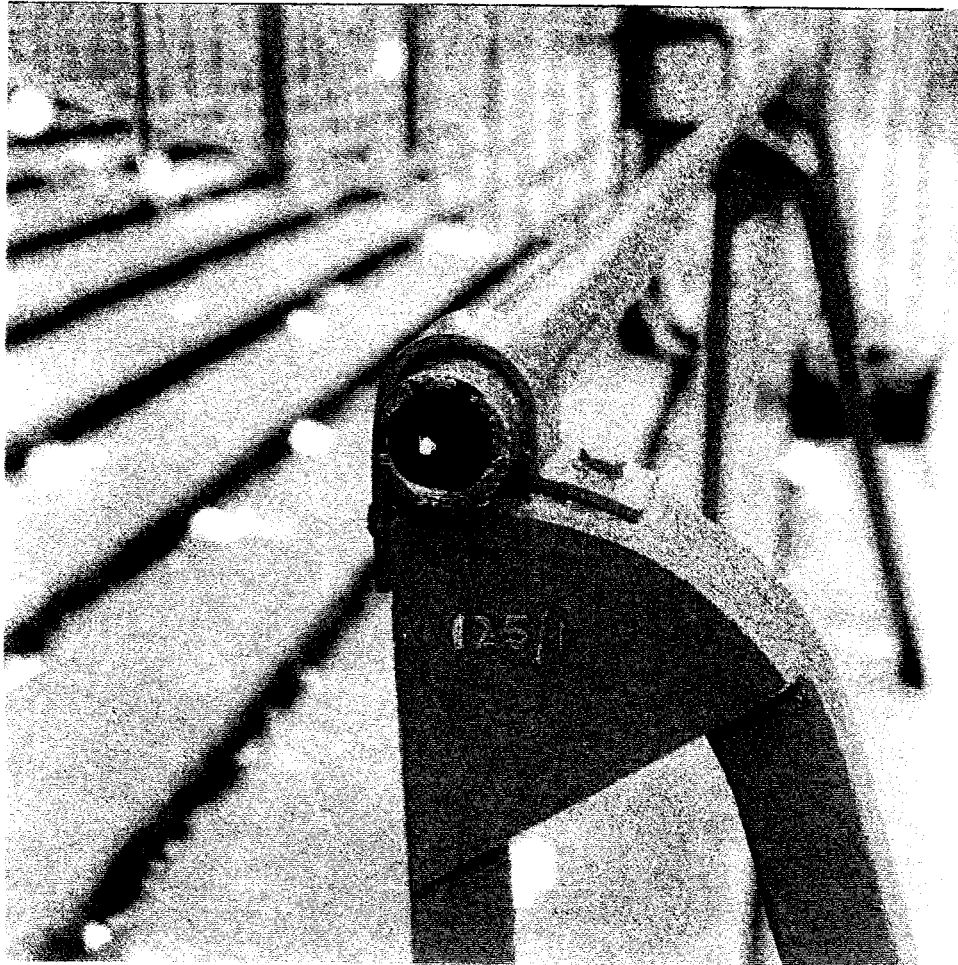
Fig. 5 - Barrier 125.

Most of the horizontal tubes on the older barriers were open-ended and in two cases (barrier 125 near support 1 and barrier 128 near support 1) holes in the tube wall, caused by corrosion under the support strap, were clearly visible. An example of this is shown arrowed in Figure 5 which depicts the end of barrier 125 adjacent to barrier 124A in Pen 3. The hole is approximately 25mm in diameter and its centre is 60mm from the end of the tube.

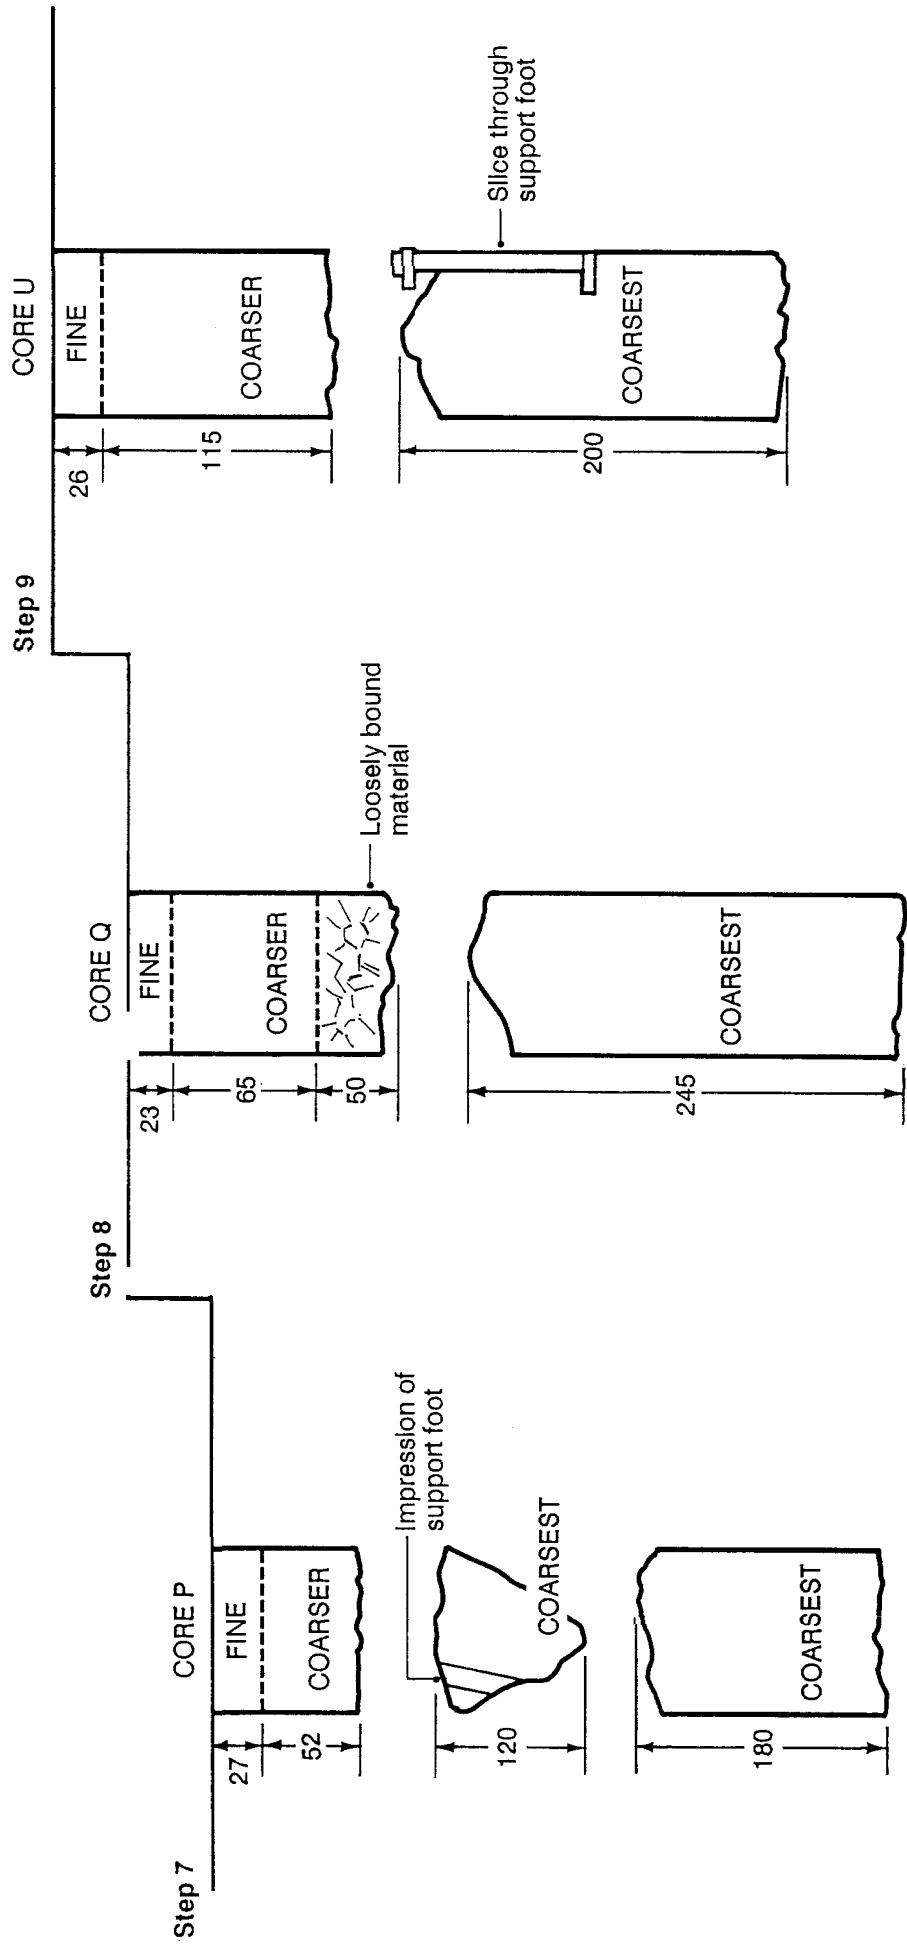
Fig.6 - Concrete cores

The three cores are shown schematically in Figure 6. They were taken at different positions along the terrace but, for convenience, they are shown here in the same plane. Core P was extracted in three pieces: a cylindrical upper piece, approximately 85mm in length, which was composed of an upper layer (27mm in thickness) containing relatively fine aggregate, typically a few millimetres in section and a lower layer (52mm in thickness) containing coarser aggregate, typically 5-10mm in section; an irregular shaped intermediate piece, with a maximum length of 120mm, which contained the coarsest aggregate, typically 20-30mm in section, and bore an impression of a section of barrier support foot; a cylindrical lower layer, 180mm in length also containing the coarsest aggregate (20-30mm in section)

In all cases the most severe sub-surface corrosion on the feet of supports 3 and 4 had been located near the lower end of the region of concrete containing the coarser aggregate. One possible explanation for this could be that the height of the terrace had been raised at some stage and the sub-surface corrosion may have occurred at or near the original junction between the support feet and the terrace. This would have reduced the effective height of the barriers.

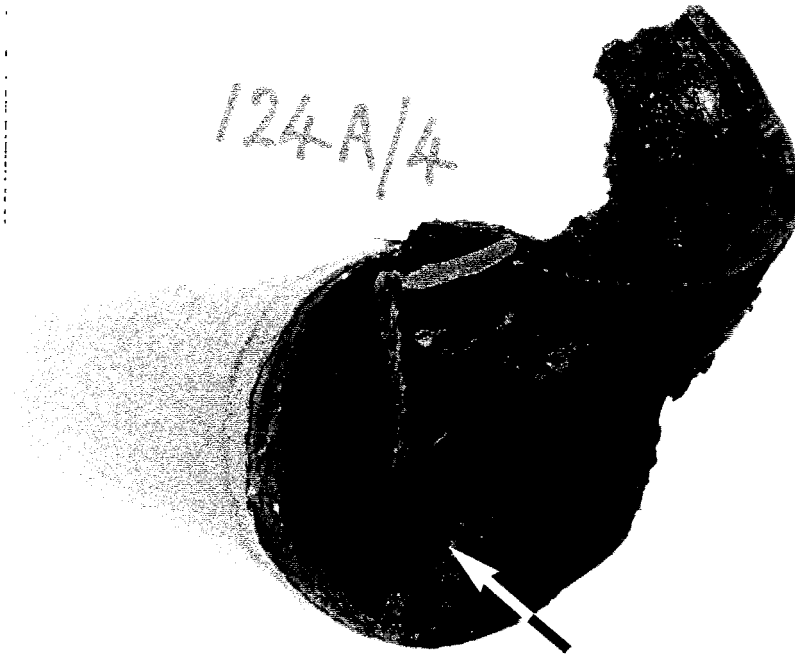
Fig. 10 - Fracture of tube at support 4.

At all the fracture positions much of the wall thickness of the tube had been reduced, mainly by external corrosion. The corrosion had occurred under the locating straps in areas, approximately 65mm wide, which were unpainted. The end of the tube at the position of support 4 had been open to the environment and additional corrosion at the internal surface of the tube had occurred. This had resulted in the formation of two holes through the wall approximately 10 and 20 mm in diameter under the strap. One of these holes, shown arrowed in Figure 10, appeared to have initiated the fracture and led to the detachment of the small piece of tube (arrowed in Figure 11) found on the steps, item CEN/1. These holes

were location at the 4 o'clock and 8 o'clock positions and their centres would have been approximately 50mm from the open end of the tube at support 4 before failure.

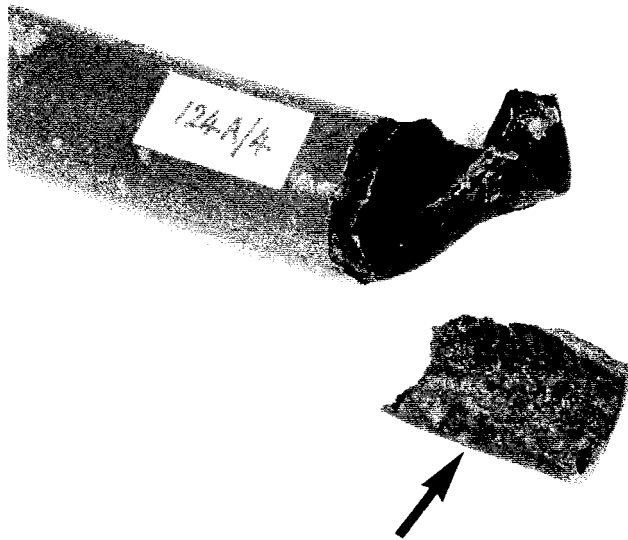
Fig. 11 - Tube at support 4 + CENII.

5.6 Two holes, caused by corrosion, had been present in the tube of barrier 124A at the junction with support 4 before the collapse occurred and these would have been visible to the naked eye.

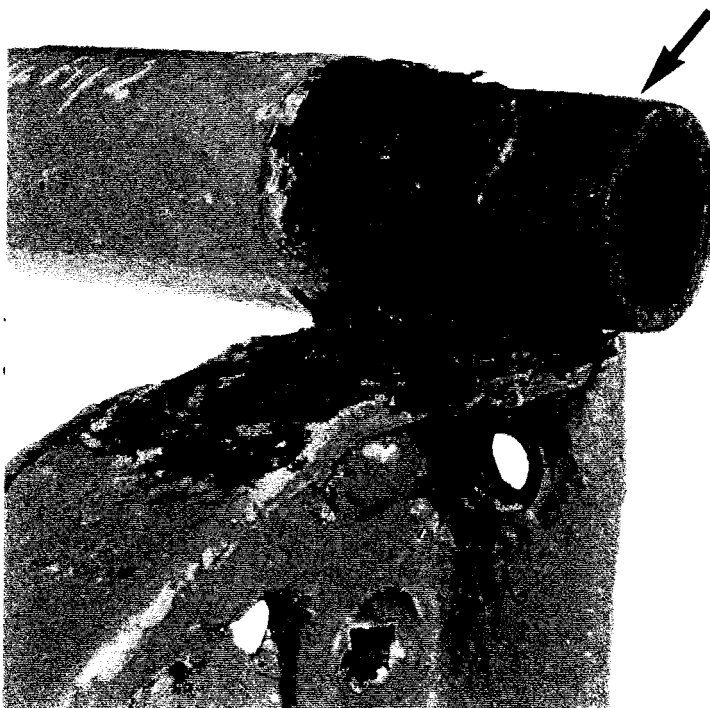
Fig. 12 - Tube on support 2.

The extent of corrosion of tube 1/2 under the strap at support 2 was disclosed when the strap was removed (Figure 12). Tube 1/2 was removed subsequently from supports 1 and 2 to permit closer examination. This revealed that two pieces of tube had been joined beneath support 2 by a part circumferential weld which also served to join the strap to the tube at this support. A 150mm long tubular insert (arrowed in Figure 12), with an outside diameter of 49mm and a wall thickness of 5mm, was located inside the main tube at a position corresponding with support 2. This reinforcement was retained by means of a tack weld on the inside of the main tube between support 2 and the adjacent circumferential weld in the main tube, which had been noted on site. Hence, neglecting the insert, the tube between supports 1 and 2 apparently consisted of three pieces joined by: a circumferential near support 1; a circumferential weld near support 2; a part circumferential weld beneath support 2.

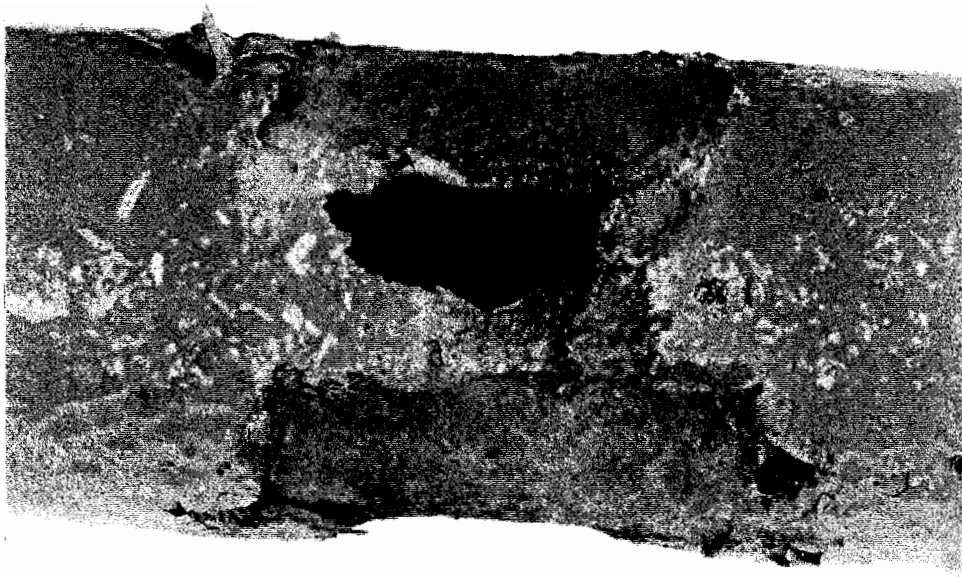
Fig. 13 - Hole in tube at support 1.

An oval hole, shown in Figure 13 and measuring 35 x 15mm, was revealed in the tube under the strap on support 1, at the 4 o'clock position when viewed from the end nearer support 1. This hole had apparently been formed by external corrosion of the tube under the strap.

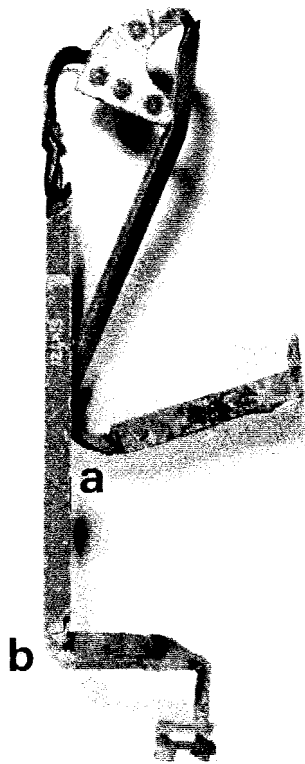
Fig. 14 - Support 3.

Supports 1 and 2 had not been deformed. Supports 3 and 4 are shown after excavation in Figures 14 and 15 respectively. Although the extent of the deformation of supports 3 and 4 was noted on site (see section 2.1 of this report), a number of additional features became apparent in the laboratory.

The legs of supports 3 and 4 had been corroded, particularly at the junctions with the concrete step and/or additional reinforcing angles. At these locations the residual thickness was in the range 3.1mm to 5.9mm, compared with a nominal thickness of 6.3mm elsewhere. A considerable amount of metal had been lost by corrosion from the sub-surface region of the supports. For example, on the rear leg of support 4, a ligament of metal 8mm wide and 2mm in thickness was all that remained of the original nominal 50 x 50mm angle section at a distance of 150mm below the surface.

Support 3	(a)	4.6 to 5.9 mm
	(b)	5.9 mm
Support 4	(c)	1.5 mm
	(d)	5.6 to 5.8 mm
