Investigation of the Explosion at Linfield Street Dundee 22nd of October 2000

**Issued by the
Hazardous Installations Directorate (HID)
Specialised Industries Division**

**A report of the investigation by the Health and Safety Executive of the explosion
and fire at 21 – 25 Linfield Street Dundee on the 22nd of October 2000.**

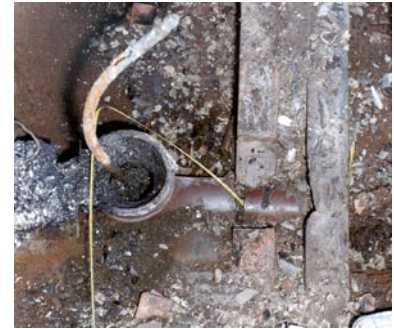
43. Excavation of the electricity cable was carried out and it was noted that the electricity cable entered the premises through a 4" fireclay duct. The duct consisted of two parts; a straight section and an elbow, which had been placed together but were not connected to each other. An examination of the duct while it was in place found that there was an air gap along the top of the duct. A steel tape was inserted in this gap from outside the house stairwell through to the gap at the join of the straight and elbow sections thus demonstrating a path

Figure 6 Electricity Duct with flexible tape inserted in air gap and electric cable rising inside to electric meter

existed from the footpath to the inside of the stairwell of No. 23 (see Figure 6). It was observed that the bitumen sealant, which was used to seal the duct (against gas and water ingress), had leaked out at the junction of the two sections of duct, this allowed the gap to form in the straight section of pipe.
