# **Investigation of the Explosion at Linfield Street Dundee 22nd of October 2000**

**Issued by the  
Hazardous Installations Directorate (HID)  
Specialised Industries Division**

**A report of the investigation by the Health and Safety Executive of the explosion  
and fire at 21 – 25 Linfield Street Dundee on the 22<sup>nd</sup> of October 2000.**

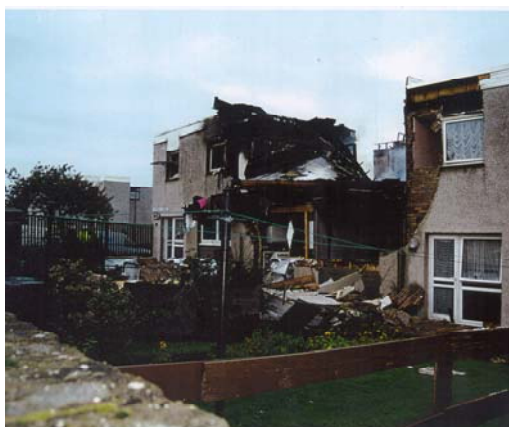
2. At approximately 08.50 on Sunday 22nd October 2000 an explosion and fire occurred at the terraced house at 23 Linfield Street, Dundee. The initial blast blew out some windows and sections of the walls from the upper floor, as well as completely inverting the flat roof of the property; the blast also caused damage to the adjacent properties (Fig 1). The damage to No. 25 Linfield Street resulted in cracks and the loss of part of the outer wall. At No. 21 the damage included distorting internal walls, causing the main upper bedroom door to jam and the breaching of fire spread prevention measures between No 23 and No 21.

Figure 1 View of No. 23 to the rear

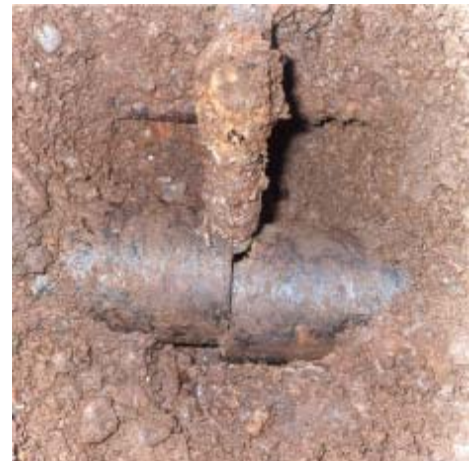
38. Once the main was exposed, it was observed that the 4" cast iron main had fractured at the service connection and a gap was clearly visible as shown in Figure 5.

Further excavation took place to expose the upper part of the gas main, leaving the bed of the main intact. Measurements were taken of the relative displacement of the two sections of the gas main and these measured 21 mm vertically and 3 mm horizontally.

Figure 5 Picture of Fractured Main

64. From these results, it was concluded that external forces (ground movement/settlement) overstressed the section of pipe outside No. 23 Linfield St. resulting in the failure of the 4" cast iron gas main at its weak point (the service connection to No. 23 Linfield Street). It was also identified that the previous fracture at

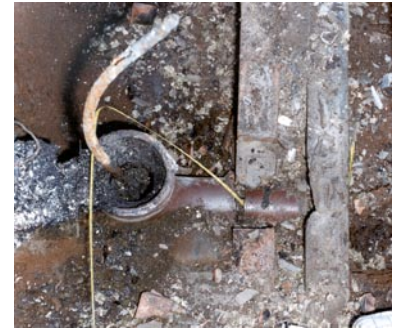
43. Excavation of the electricity cable was carried out and it was noted that the electricity cable entered the premises through a 4" fireclay duct. The duct consisted of two parts; a straight section and an elbow, which had been placed together but were not connected to each other. An examination of the duct while it was in place found that there was an air gap along the top of the duct. A steel tape was inserted in this gap from outside the house stairwell through to the gap at the join of the straight and elbow sections thus demonstrating a path

**Figure 6** Electricity Duct with flexible tape inserted in air gap and electric cable rising inside to electric meter

existed from the footpath to the inside of the stairwell of No. 23 (see Figure 6). It was observed that the bitumen sealant, which was used to seal the duct (against gas and water ingress), had leaked out at the junction of the two sections of duct, this allowed the gap to form in the straight section of pipe.

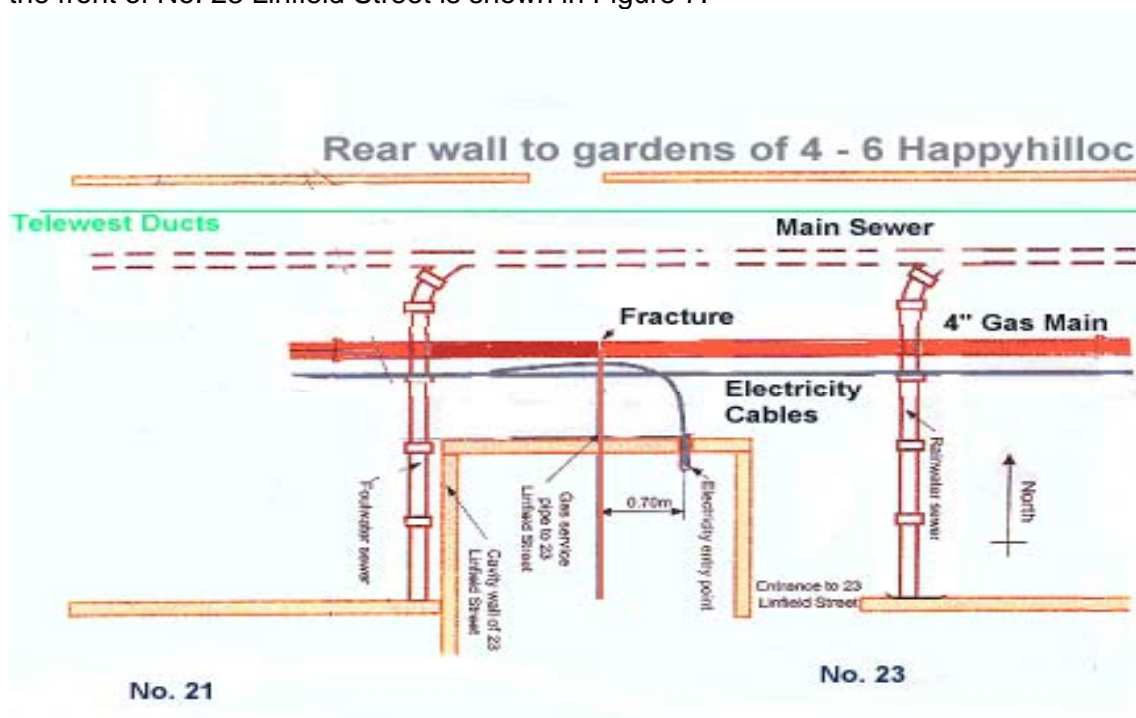
**Figure 7.** Layout of Utility Plant at the front of 21 –23 Linfield Street

44. Experience of past gas incidents has demonstrated that a major contributory factor has been either construction work on plant such as sewers<sup>14</sup>, or damage to sewers or water pipes which then cause soil erosion and undermining of gas pipes. It was therefore important to carry out an inspection of such adjoining plant. A request to identify any utility work undertaken, identified that the installation of a Telewest cable was the only significant work carried out in this area. The layout of the main utilities at the front of No. 23 Linfield Street is shown in Figure 7.

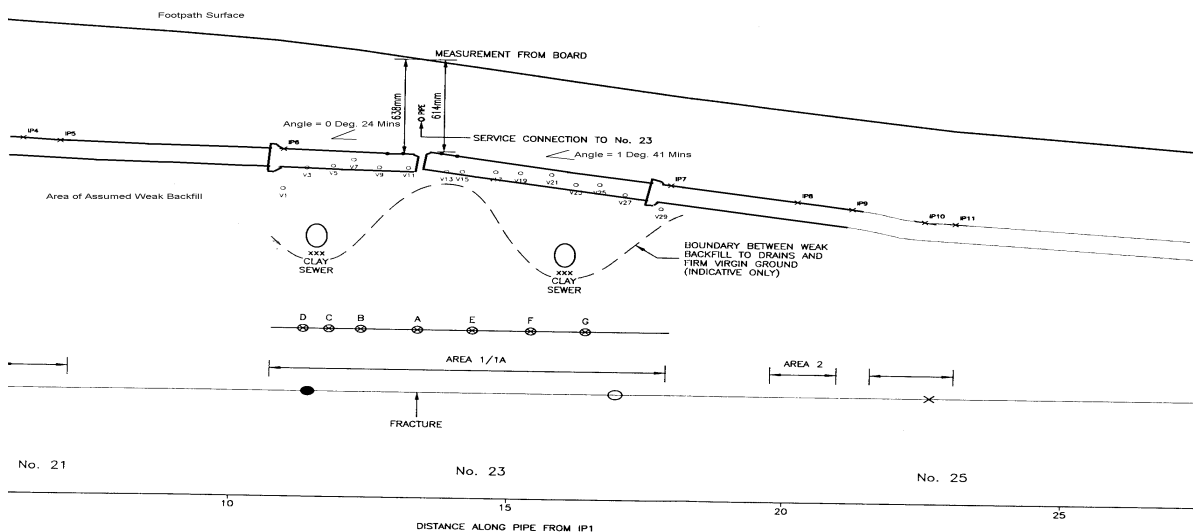
52. In housing estates such as this it is usual practice for drains to be laid first and, in the opinion of the HSE expert, there was evidence to support the fact that the drains had been laid prior to the gas main. A diagram indicating the areas of relatively firm and poorly compacted ground is shown in Figure 8.

**Figure 8:** Supporting Soil Conditions

53. The geotechnical engineer concluded from the results that the ground above the drains crossing the gas pipe had not been sufficiently compacted at the time of construction and that the gas pipe had subsequently been laid on an unsound bed. An examination of the construction requirements<sup>17</sup> for drainage was undertaken by an HSE specialist Inspector. He concluded that the drainage should have been constructed with a concrete surrounding to support the drains in their close proximity to property and that this had not been carried out.
