**PROGRESS ON BNFL'S RESPONSE TO THREE
REPORTS ISSUED BY HSE ON 18 FEBRUARY 2000
FEBRUARY 2001**

HM Nuclear Installations Inspectorate

February 2001

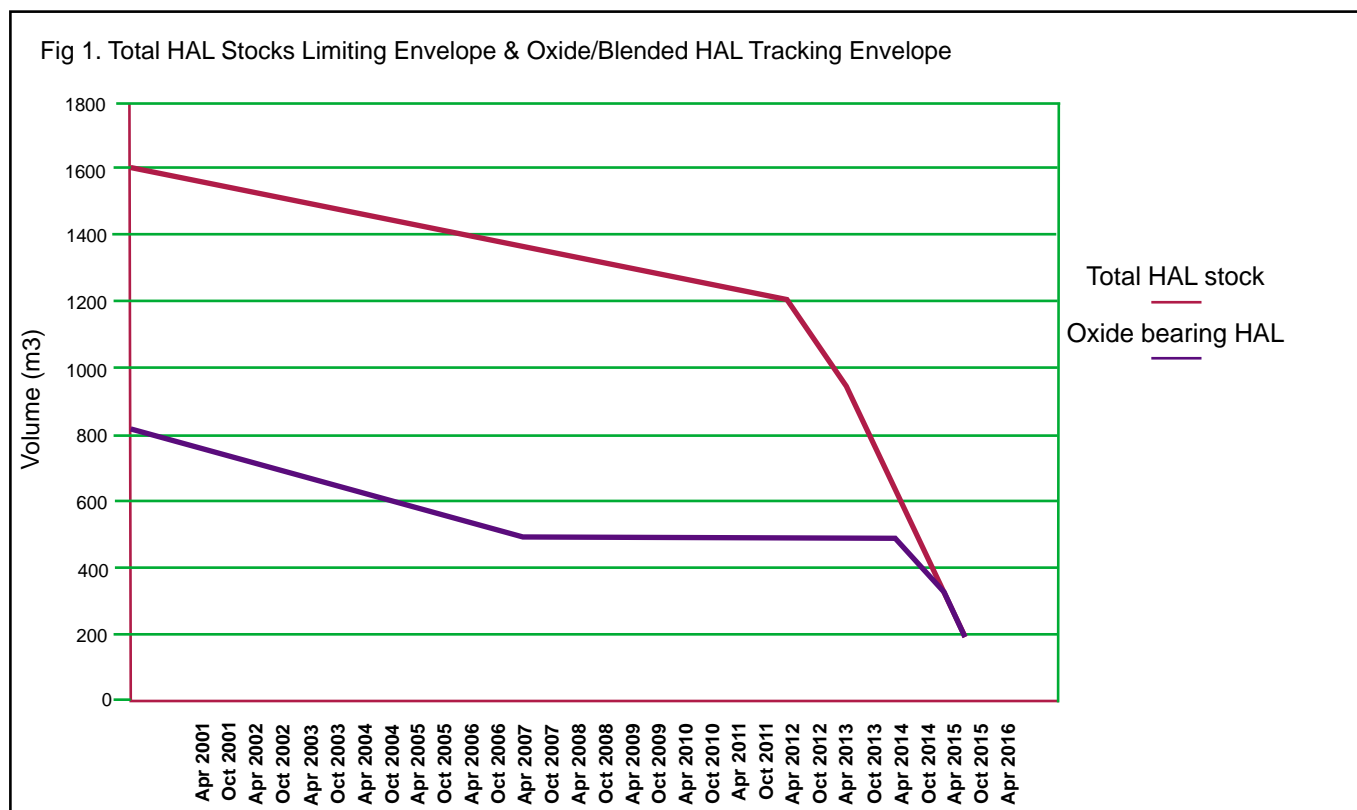
With the Specification the maximum permitted holding will reduce from 1575m³ by about 35m³ per year until 2012 when it is decreased rapidly to the buffer stock limit of 200m³ allowed in 2015. BNFL is expected to keep the actual volume below the upper stock reduction limits. This allows for the dilution that occurs from time to time, because of the additions of inactive water and acid for operational reasons. These do not contribute to the radioactivity in the tanks but add to the volume. We expect BNFL to control the real HAL quantities, i.e. Actual volume less the dilution, by standardising the volume for control purposes, once an agreed method is developed.

The major contributor to the hazard potential comes from Thermal Oxide Reprocessing Plant (THORP) derived HAL. Thus, we have also specified controls on the amount originating from THORP. As BNFL blends this material with Magnox HAL as soon as possible in order to optimise the HAL vitrification rate, the control relates to blended plus unblended HAL. The control level of such HAL will be reduced from 770 m³ currently to 500 m³ by 2007.

The limiting and controlling envelopes are replicated in fig 1 for illustration.
