Investigation of failure of crane rope from DSV DSND PELICAN

Prepared by the
Department of Engineering
The University of Reading
for the Health and Safety Executive

OFFSHORE TECHNOLOGY REPORT
2002/031

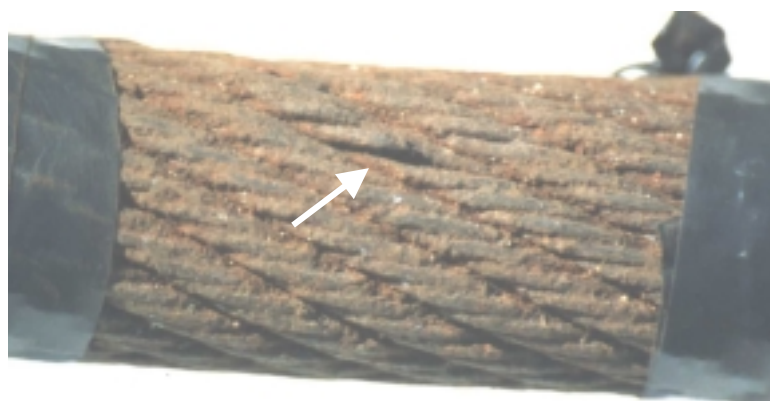
It was noted that the rope was heavily corroded and there was no externally visible lubrication (Figure 1). The rope was inspected for wire breaks, local damage, wear etc. No significant defects were found; minor damage and wire breaks along the examined rope lengths are listed in Table 1. It is not clear where the rope had been stored during the period between failure and delivery to Reading, but it is likely that some additional corrosion will have taken place. However, photographs taken at time of rope failure on board the vessel show the rope to be corroded throughout the construction at that time.

Figure 1
Typical external condition of the rope in the as received condition (length 1: 18.33m)
(Note the wire break in the middle of the figure)

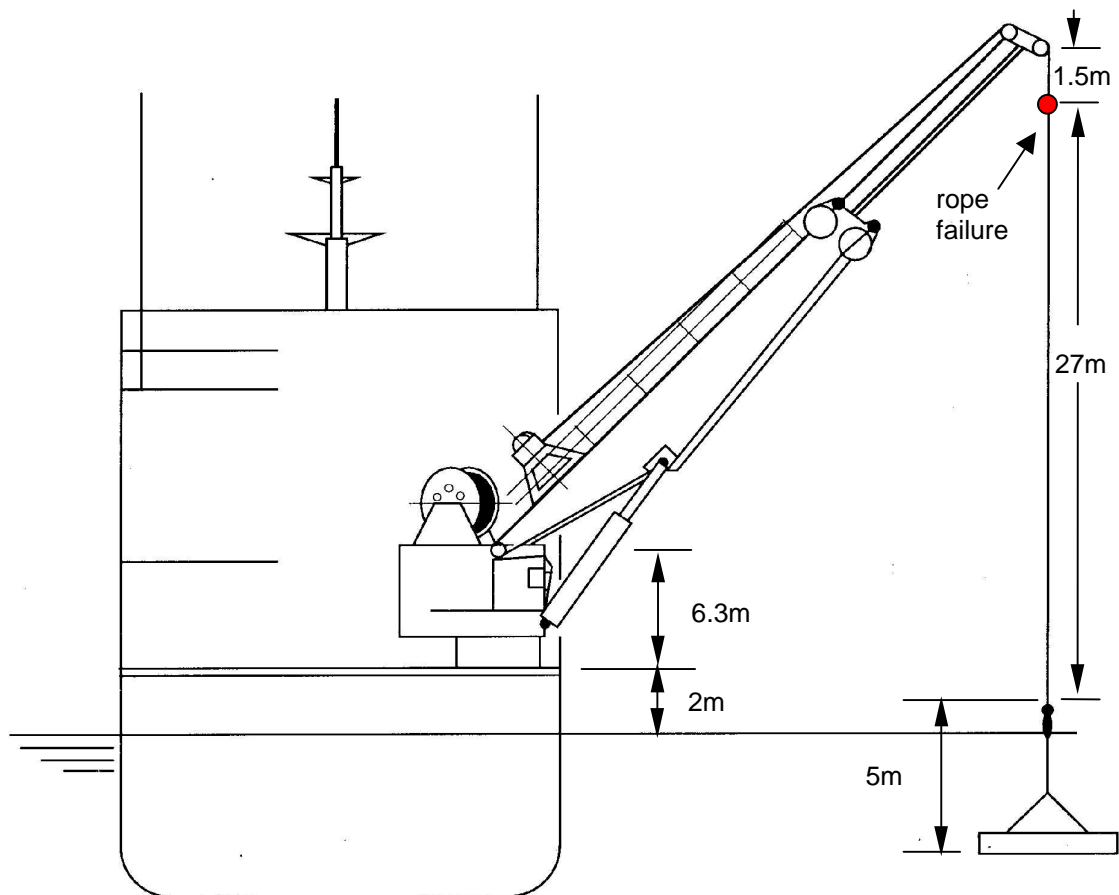
Figure 2

All of the above taken together, indicate that the break was likely to have been at a distance of some 27m from the headache ball (Figure 2). However, it should be noted that with so many uncertainties and approximations in the data, this distance is far from accurate and has a tolerance of several metres either way. Figure 3 shows the PELICAN at sea. It is interesting to note how the crane hook is tied back to the stern bollards to prevent unnecessary thrashing about. Figure 4 shows where the calculated point of failure on the rope (i.e. 27 m from the headache ball) would have been during storage of the crane.

Schematic drawing of the location of the rope failure during deployment (stern view)

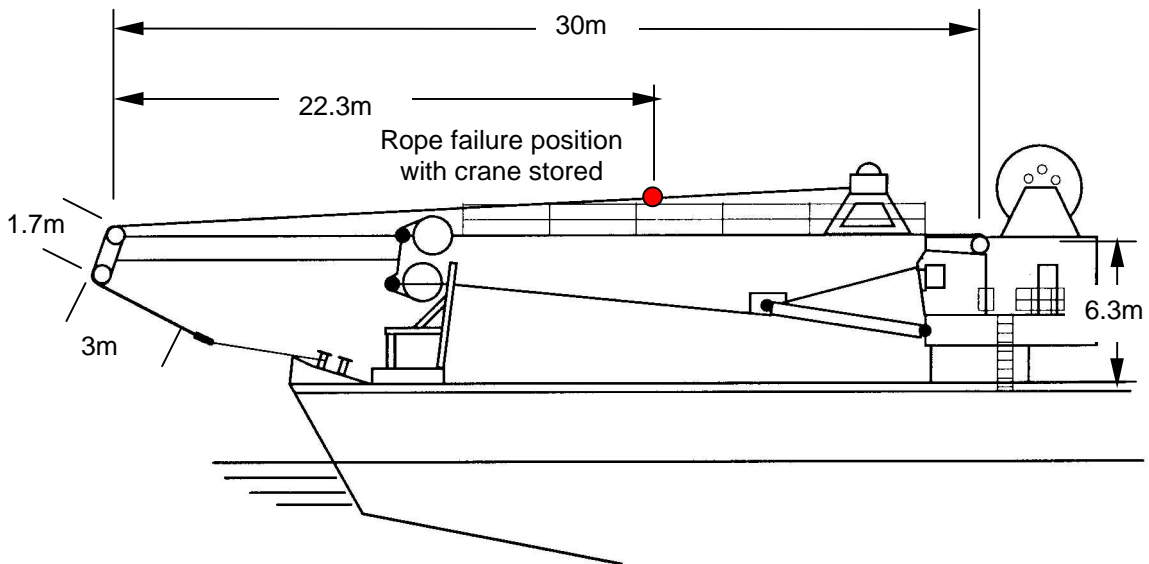
Figure 4
Schematic drawing of the position of the rope failure when crane stored (starboard view)

- Consideration is given to a ‘slip and cut’ policy, whereby the most severely corroded section of the rope (i.e. that on the crane boom when the crane is stowed) is periodically removed. It is not known how much rope was removed for each break load test, but it is unlikely to have been as much as this (about 35m).

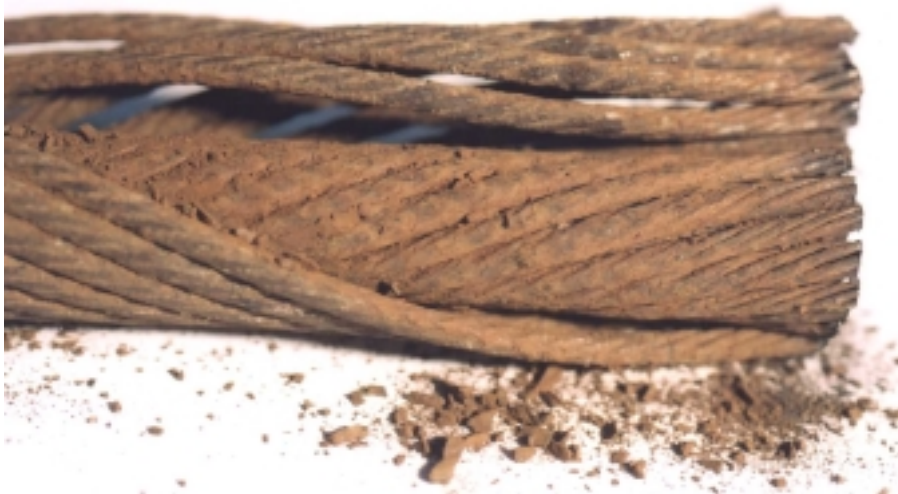
Figure 5

A sample of the rope away from the failure was also examined. This sample was taken from the longer sample, at a distance of 18.8m from the break. The condition of the rope was the same as the lengths either side of the failure, i.e. heavily corroded and dry at every layer in the construction, see Figure 5. No internal wire breaks were found which are characteristic of fatigue damage for this type of rope construction. It should be noted that although the storage conditions of the rope between failure and delivery at Reading could have allowed some additional corrosion, the state of internal lubrication would not have changed. Once internal lubrication and galvanising protection has been lost, internal corrosion of such ropes can proceed rapidly.

Internal condition of the rope 18.8m from the failure

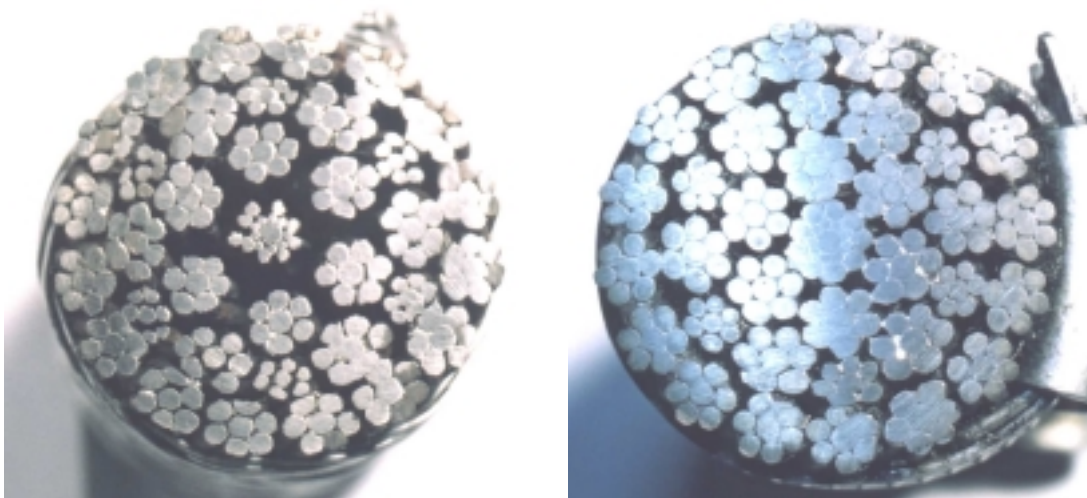
Thus the PELICAN rope has lost approximately 22% of its metallic area due to corrosion. As a first approximation, the rope strength will be reduced proportionately, i.e. the corroded rope strength would be 39 tonnes. This calculation assumes that the corrosion is evenly distributed through the rope and along each wire; if proportionately more metal was lost from the outer strands then the strength of the rope could be degraded further. There is also considerable variation in the level of corrosion along the wires. Thus although the mean loss of area is 22%, the actual loss will inevitably be proportionally much higher than this.

Figure 6 shows a comparison of the cross section of the rope removed from near to the failure (left) and from the end of the rope stored on the winch drum, which may be considered to be representative of the rope in the “as new” condition. Attention is drawn to the extraordinary loss of metallic cross section on the core strand, especially considering that this is at the heart of the rope where galvanising and residual lubricant are most likely to remain.

Figure 6
Cross sections of corroded (left) and "as new" (right) rope

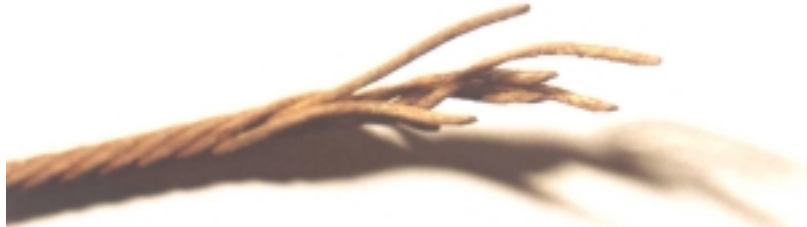
Figure 8

Examples of typical corrosion induced wear and tensile failures are shown in Figures 8 and 9. Figure 10 shows the very local wear induced at the strand cross over points (for a selection of wires). This degradation, taken in connection with the comments in section 4.3 on the distribution of the loss of metallic area, confirms that the loss of breaking strength would have been much greater than 22%.

Typical appearance of corrosion induced wear strand failure

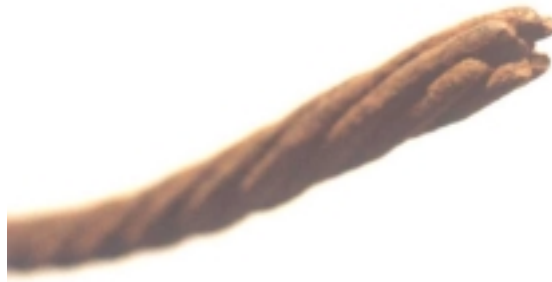
Figure 9

Typical appearance of tensile load induced strand failure

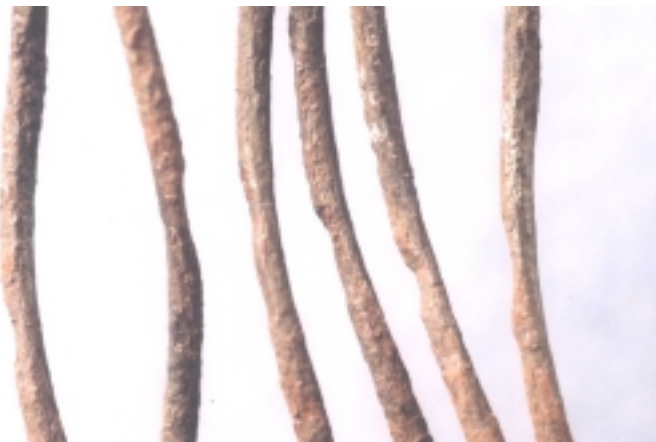
Figure 10

Local loss of metallic area in wires caused by corrosion induced wear

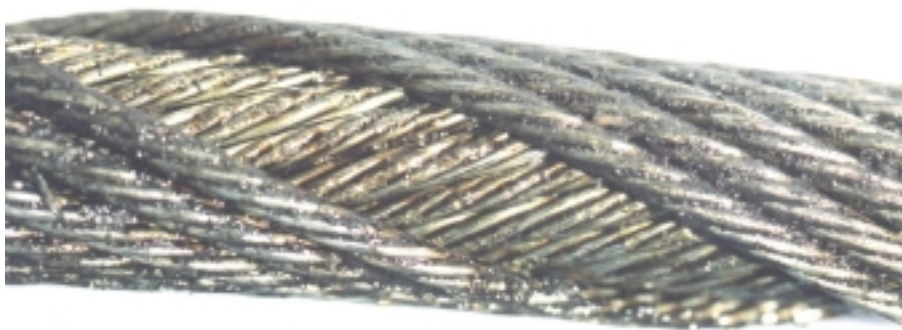
A length of rope was cut from the rope a distance 2m from the hawse hole on the winch drum and its condition compared with that of the rope in the failure region. The rope on the drum has had comparatively little exposure to sea water and air, and the surface lubricant was still present and in good condition. Inspection of this sample confirmed that the rope had originally been galvanised. Internal examination of the rope revealed the internal lubricant to be present and in good condition throughout the construction. Figure 11 shows the rope sample with three of the outer strands removed. The lubricant is clearly visible.

Figure 11
Internal condition of the rope from the winch drum

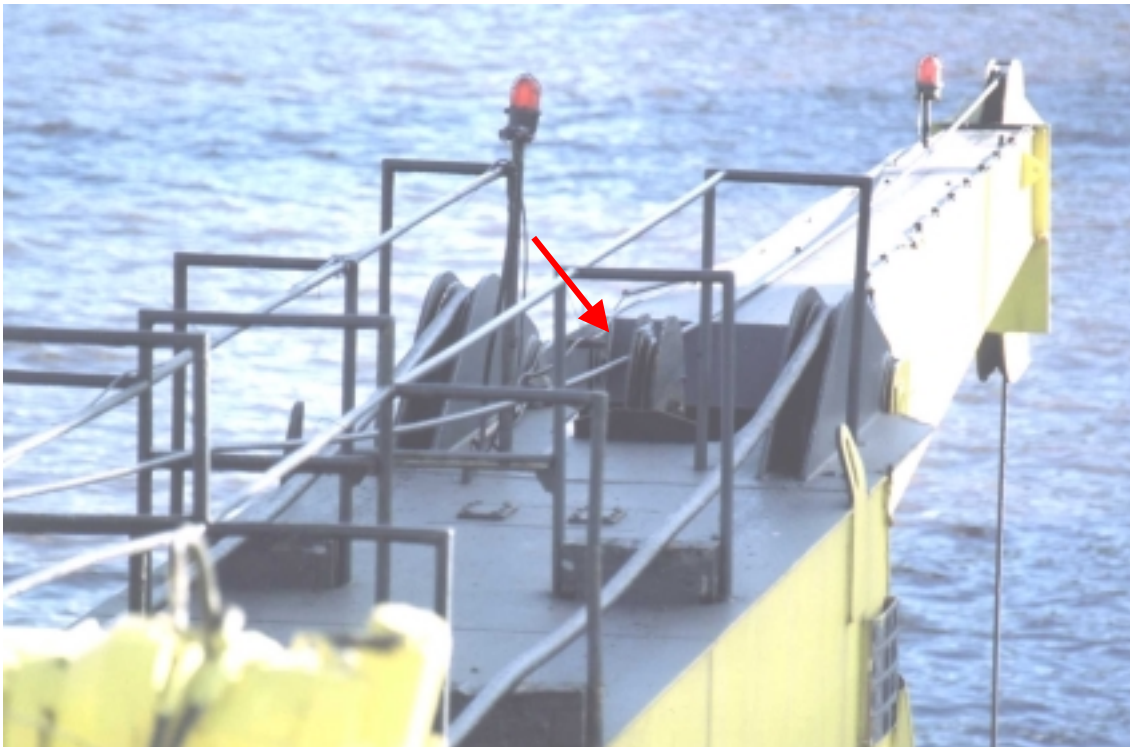
Inspection of the crane and vessel led to the conclusion that there was no source of increased local corrosion (e.g. vent pipes in the vicinity of the rope; points where sea water could collect and immerse part of the rope). There was a possible source of local rope abrasion: a sheave fitted in the upper surface of the crane, against which the whipline rope could rub or catch, see Figure 12 (although this sheave is some 12m from the estimated location of the wire break when the crane is in its stowed position, the estimates of wire break location are somewhat vague, as described in section 3.3 above). However, inspection of the broken rope did not indicate that the failure was due to local external wear or damage, so it is unlikely that this potential clash was significant in the incident under investigation. It is worth noting, though, that this structural detail is a potential source of abrasion to the whipline rope, and the rope should be checked with particular care for local damage during the annual crane inspection.

Whipline lying alongside redundant sheave fitting
