Example D

Accident

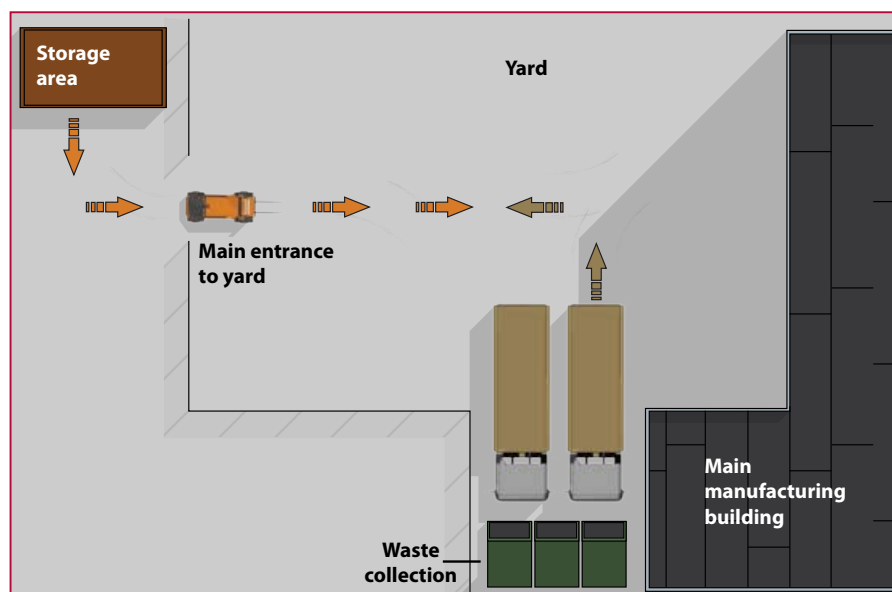
The yard was poorly lit and it did not have designated traffic lanes for either industrial trucks or vehicles. Mark drove his forklift straight across the yard's unmarked, dirt roadway towards the main production building. At the time of the incident, a large industrial dump truck was routinely parked in the yard after having collected waste material. The driver of the dump truck entered his vehicle, checked his mirrors, and started reversing. Although the dump truck was fitted with reversing alarms, the driver later said that they failed to detect that the forklift was in its path. The dump truck driver moved about five feet when the truck suddenly came to a halt. The driver came out of the truck and found the forklift behind the dump truck tipped over onto its side. The forklift operator, who was not wearing his seat belt, was trapped underneath the forklift.

The site consisted of a main production building and waste collection area, both of which were accessed through a yard. The yard was a large area packed with dirt and had several unmarked roadways running through it. Routine operations on the site involved the transport of bulk material to the main production building by forklift trucks. The storage area was located just outside the entrance to the yard. Solid, rock-like waste was also collected on the mill site by large industrial dump trucks. There was a designated parking area for dump trucks located in front of the waste collection area.
