This safety alert is drawn up to spread the lessons learnt from the major oil release of October 25th, 2005 in an oil storage terminal. The oil storage terminal belongs to a large oil company and is an upper tier Seveso establishment.

## 1. Description of the oil storage terminal

### 3. Construction information and history of the storage tank D2

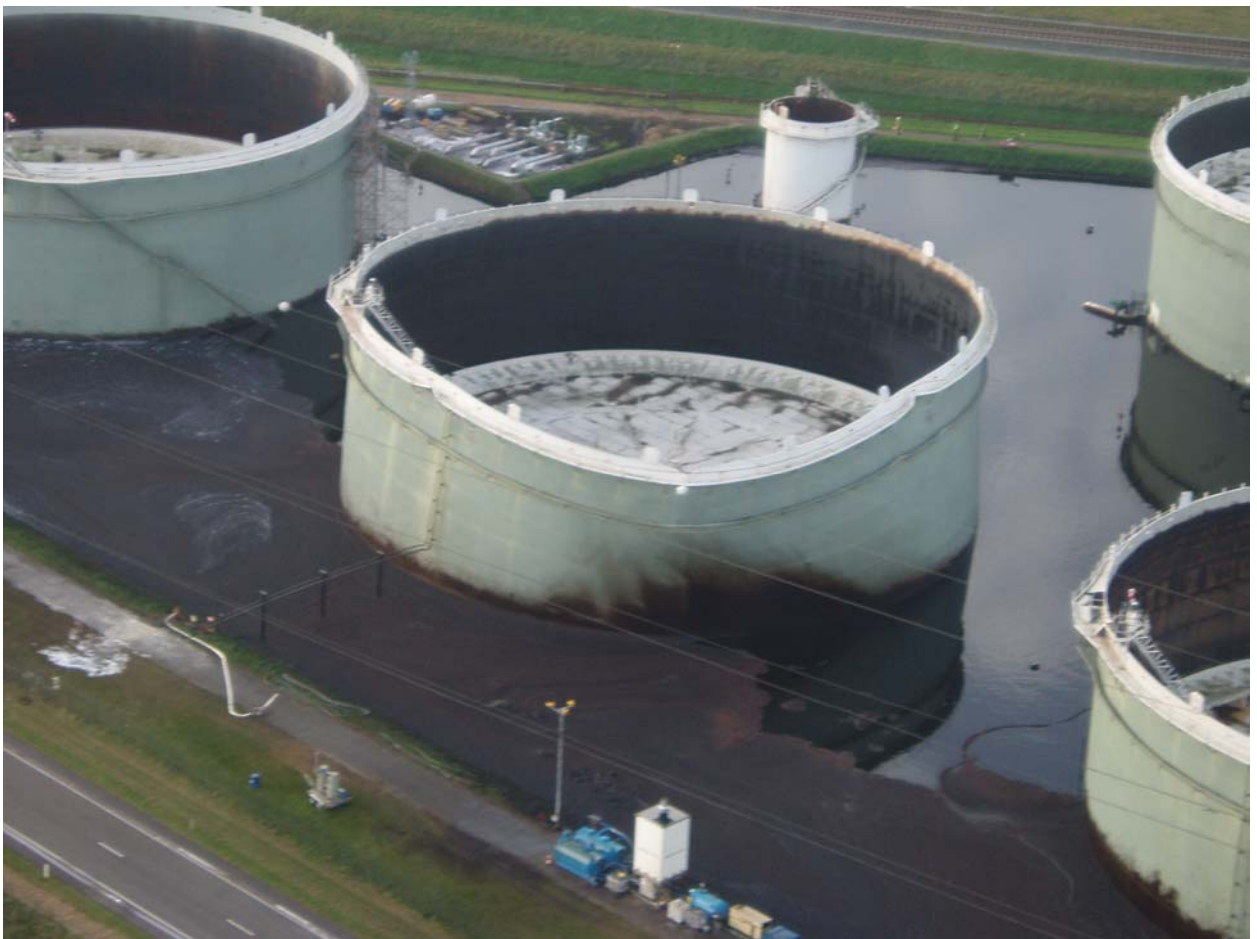
Because the content of the storage tank was released in such a short time, an enormous wave was created. This wave moved in the direction of the several meters high earth dike. Due to the height of the dike only a small amount of crude oil (approximately 3 m<sup>3</sup>) was ejected out of the bund. The released crude oil filled the whole bund (40 000 m<sup>2</sup> large) with crude up to a height of 1 m.

*Figure 2: Picture of the situation in the bund the morning after the major accident*

After the major accident all the crude oil stored at the terminal was immediately pumped to the refinery and the contents of the bund was pumped to the storage tanks D10, D11 and D4 by using the existing drain water pump system. Immediately measures were taken to perform all cleaning activities in the storage terminal in a safe manner.

In the afternoon of October 27<sup>th</sup>, 2005 the major part of the bund was empty. On October 28<sup>th</sup>, 2005 activities were started to reduce the smell. The smell was effectively reduced by covering the entire bund with sand. Where possible the sand layer was placed by trucks and bulldozers. Between the tanks the sand layer was placed by blowing sand in these areas.

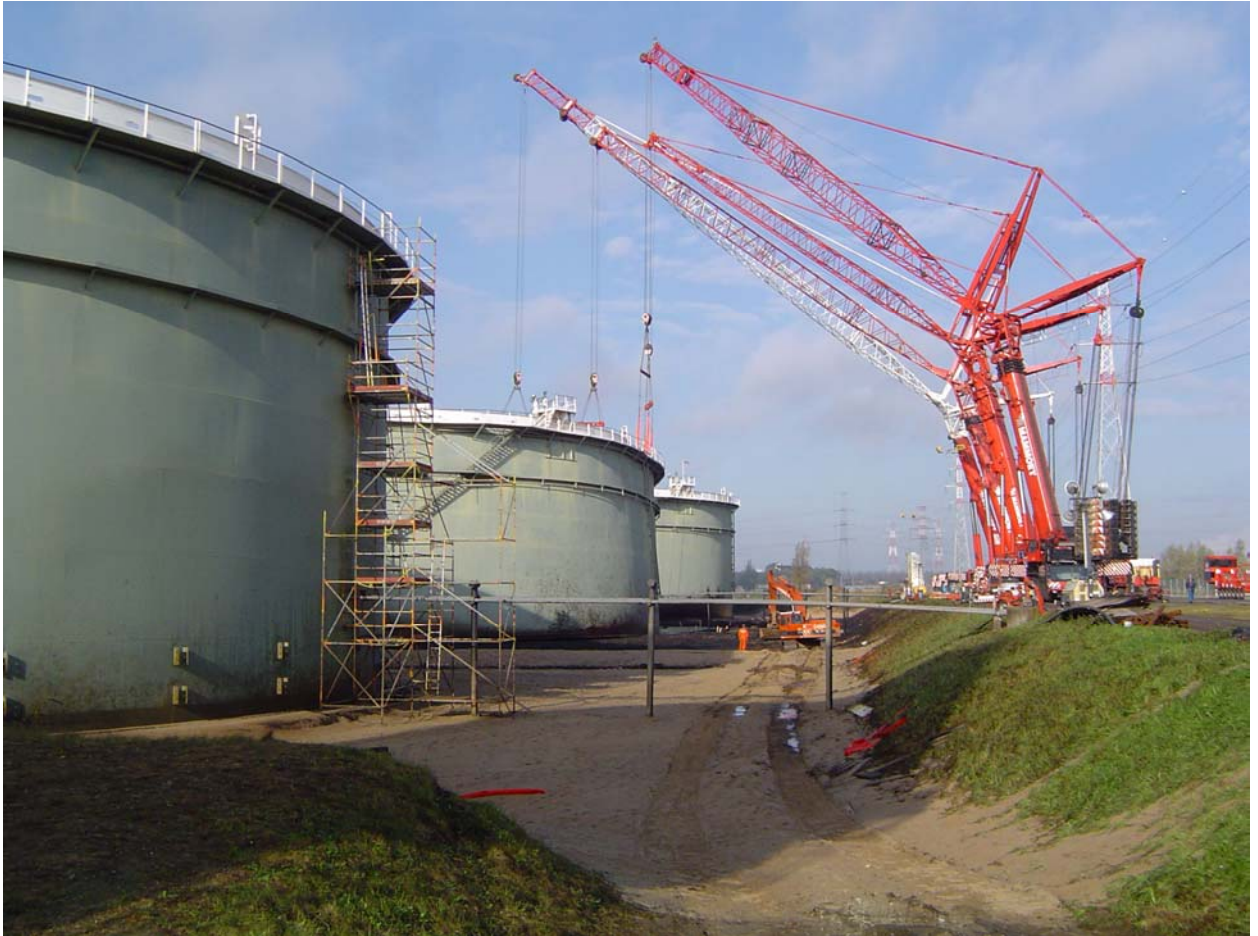
After the release the storage tank was leaning forward and a part of the foundation of the storage tank had disappeared.

Figure 3: Picture of major cranes stabilising storage tank D2

The stability of all storage tanks was periodically measured. The stability of storage tank D2 on the place where the foundation was blown away, was achieved by hanging the storage tank on 4 large cranes (figure 3).

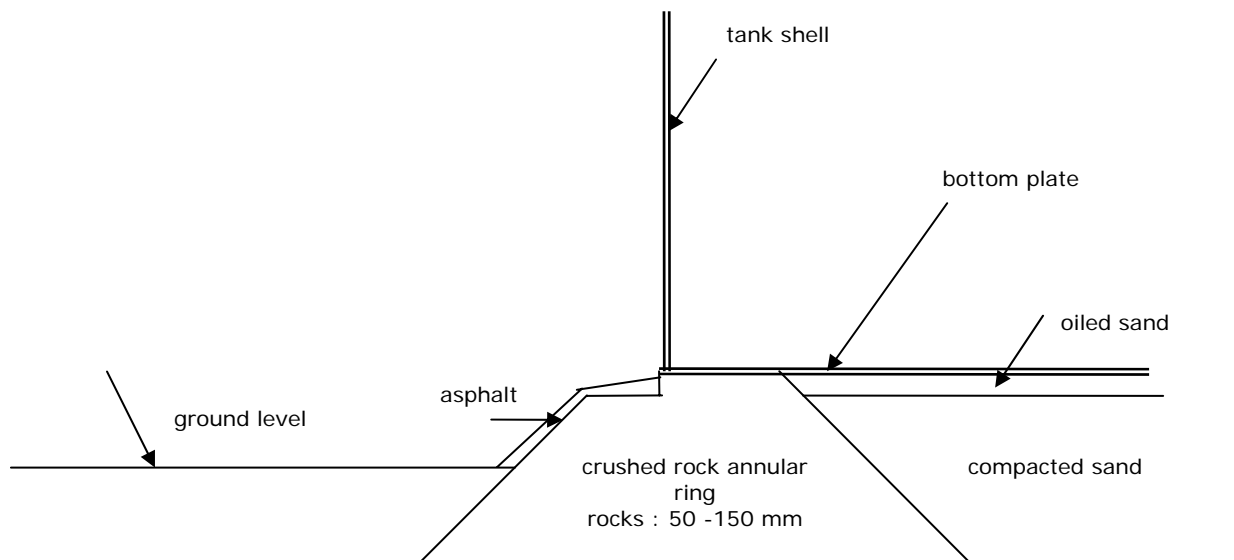
Figure 4: Schematic view of the tank foundation

The foundation of storage tank D2 consisted of a crushed rock annular ring. The rocks had a diameter between 50 mm and 150 mm. The crushed rock annular ring had a height of approximately 120 cm of which a part was below the ground level. The crushed rock ring had a width of approximately 340 cm at the bottom and 100 cm at the top. The shell was situated in the middle of the width of the crushed rock ring. The inner part of the annular ring was filled with compacted sand. Above this sand there was a layer of 5 cm consisting of oiled sand, to avoid external bottom corrosion. Figure 4 provides a schematic view of the foundation of storage tank D2.

The major release initially started with a small leak. Due to this small leak the compacted sand underneath the tank bottom was saturated with oil and a kind of quicksand of oil and sand is formed. This small leak has not been visually detected because the crushed rock annular ring had a lot of holes, which were initially filled with crude oil. In the second phase of the accident the resistance of the foundation under the tank was locally strongly reduced (due to the fluidisation of the sand bed) and due to the hydrostatic pressure of the crude oil on the tank bottom, the bottom has ruptured over the length of the gutter. The force of the out flowing crude oil was that large that it destroyed a part of the tank foundation and swept away part of the underground.

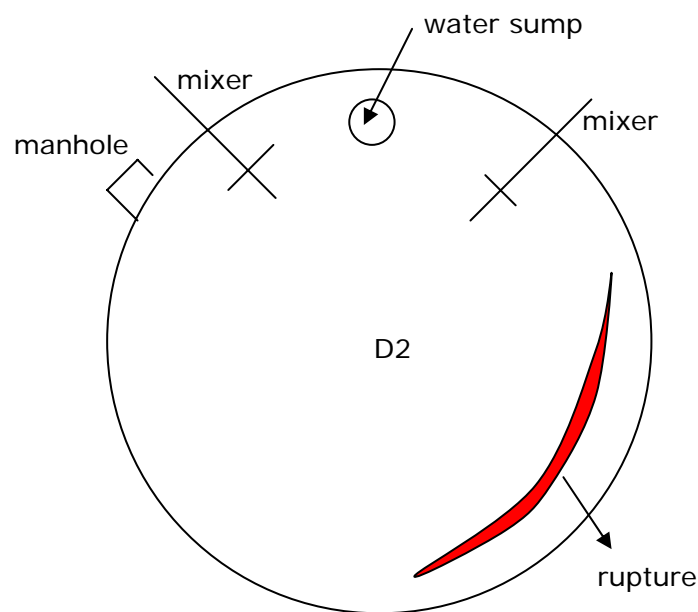
Figure 5 : Schematic view of the bottom of storage tank D2

The investigation of tank D2 showed that the bottom plates in a long, small circular band at approximately 1,5 m from the shell of the storage tank were extremely weakened due to internal corrosion. In this band the thickness of the bottom plates was nearly reduced to zero. This band had a length of approximately 35 m and a width of approximately 20 cm.

In this band the bottom of the tank formed a gutter. In this gutter uniform, internal corrosion was found and no pitting corrosion.

During the exploitation of storage tank D2 a gutter was formed in the bottom of the tank. This gutter is situated at a distance of 1,5 m from the tank shell. Due to the formation of the gutter the present water could not longer flow to the drain water system to be removed. The accumulation of stagnant water in the gutter caused strong corrosion which strongly reduced the thickness of the bottom plates in that area.

As mentioned before, a gutter was situated in the tank bottom at a distance of 1,5 m from the tank wall. This is just beyond the annular plates on which the tank shell is welded. The first normal bottom plates after the annular plates have been teared during the accident. The gutter has been formed due to settlements in the tank foundation, which at that place consists of compacted sand. The gutter has probably been formed during the first hydrostatic tests on the storage tank. The moment a storage tank is loaded for the first time, the compacted sand settles. In the neighbourhood of the crushed rock annular ring, which consists of coarse rocks, it is difficult to compact the sand bed in an appropriate manner during construction. At the moment the storage tank is loaded for the first time, the sand in that area will be more compacted, but because of the existing holes in de crushed rock annular ring a part of the sand will disappear in the holes between the coarse rocks. Due to these phenomena a gutter is formed in the bottom plates nearby the crushed rock annular ring. Calculations based on a finite element method showed that based on the information about the foundation of the tank in combination with the underground under the tank foundation and the size of the storage tank, the forming of the gutter could be predicted.

The parts of the bottom plates of the other storage tanks of which the thickness and/or the deformation do not fulfil the prescriptions of API 653 shall be repaired. The foundation of the other storage tanks was investigated to control if they still have enough stability (during the accident they were drawn in crude oil) to restart the exploitation of the storage tanks.

Before start-up all crude oil storage tanks shall be coated with a lining to stop the internal corrosion of the bottom plates.
