Joint Industry Programme on carbon monoxide issues

A review of carbon monoxide incident information for 1997/8 produced from the full investigation of incidents which had resulted from the use of piped natural gas and LPG within Great Britain

Prepared by
Advantica Technologies Limited
(formerly BG Technology)
for the Health and Safety Executive

CONTRACT RESEARCH REPORT
375/2001

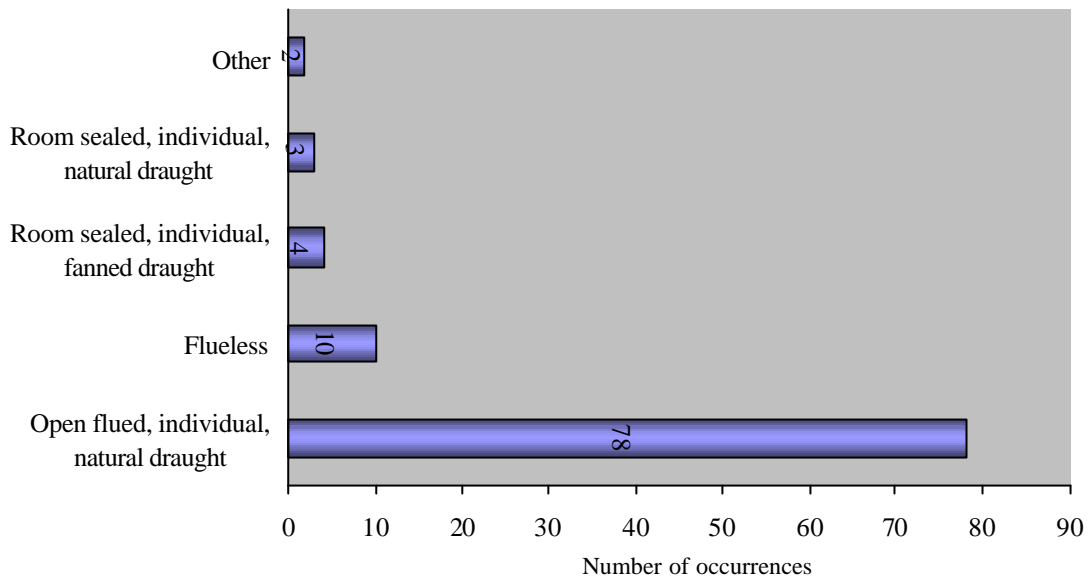
Figure 17 - Incidents by flue type

The majority of appliances were open flued, natural draft (78 incidents - 80%). Flueless appliances featured in 10 incidents and there were 7 room sealed flues, 4 of which were fanned. Of the 2 remaining cases one was an integral open flue the other a shared open flue. Flueing details are given in Figure 17.

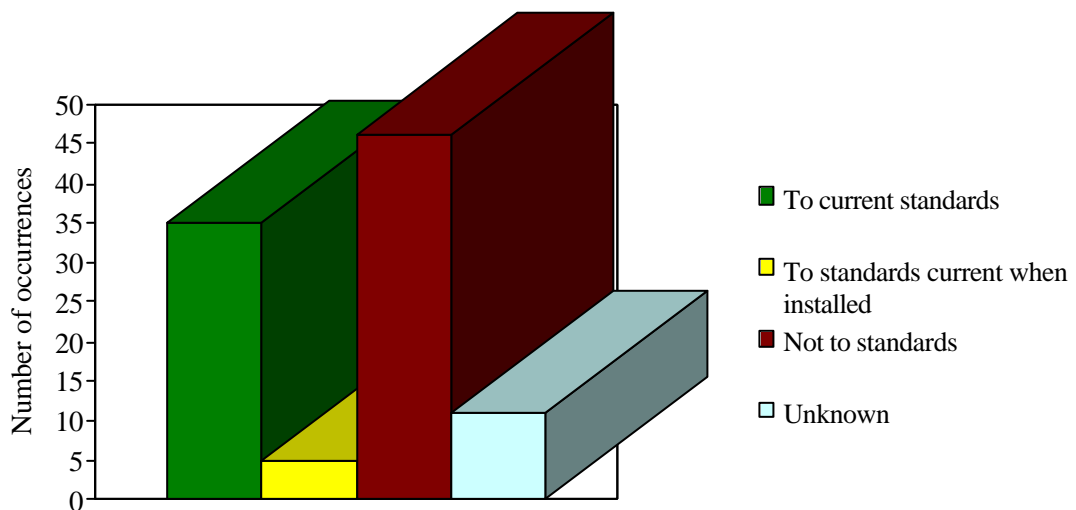
Figure 18 - Flues to standard

The analysis of flues to standard is given in Figure 18. There were 36% of flues to current standards, 5% to standards applicable at the time of installation, 11% were not known and 47% were not to any appropriate standards.

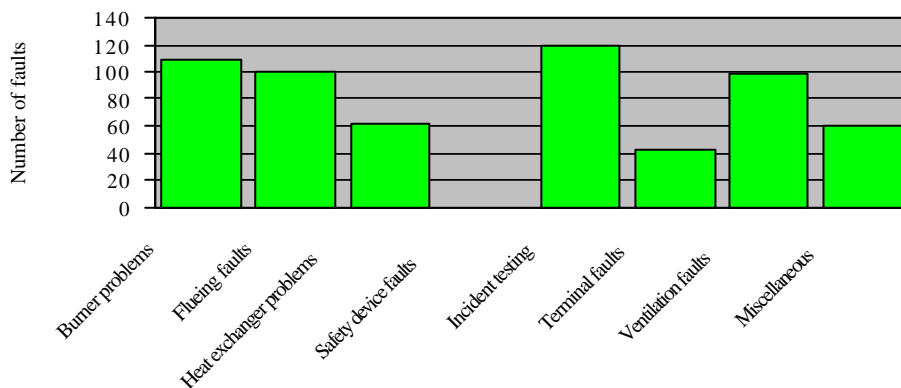
Figure 19 - Main fault groups

Fault group	Number of faults	Fault group	Number of faults
Burner		Incident testing	
Corrosion	1	High CO/CO2 ratio	63
Defective flame picture	26	Failed spillage test	40
Linting	50	Overrated	10
Over-pressure	13	Underrated	7
Under-pressure	4	Terminal	
Other	15	Down draught	14
Flue		Bad siting	22
Blockage	10	Unapproved design	3
Corrosion	1	Other	4
Flue not to any standard	46	Ventilation	
Installation defect	42	Air vent/vents ineffective	17
Other	2	Air vents obstructed - intentionally	11
Heat exchanger		Air vents obstructed - unintentionally	3
Blockage - shale	15	Compartment/cupboard not to any standards	18
Blockage - soot	27	No permanent ventilation provided	15
Cracked	0	Ventilation provided was not to any standard	34
Other	20	Miscellaneous	
Safety device		Local topography	3
Failed CO alarm	0	Weather	29
Failed down draught detector	0	Signs of spillage	28
Failed vitiation device	0

In the majority (73%) of cases CO was proven to be able to enter the incident property when tested in the as-found condition and to be the likely cause of the incident.
