# **Performance of diving equipment**

Prepared by **the Health and Safety Laboratory**  
for the Health and Safety Executive 2006

**RESEARCH REPORT 424**

**N Bailey, J Bolsover, C Parker & A Hughes**  
Health and Safety Laboratory  
Broad Lane  
Sheffield  
S3 7HQ

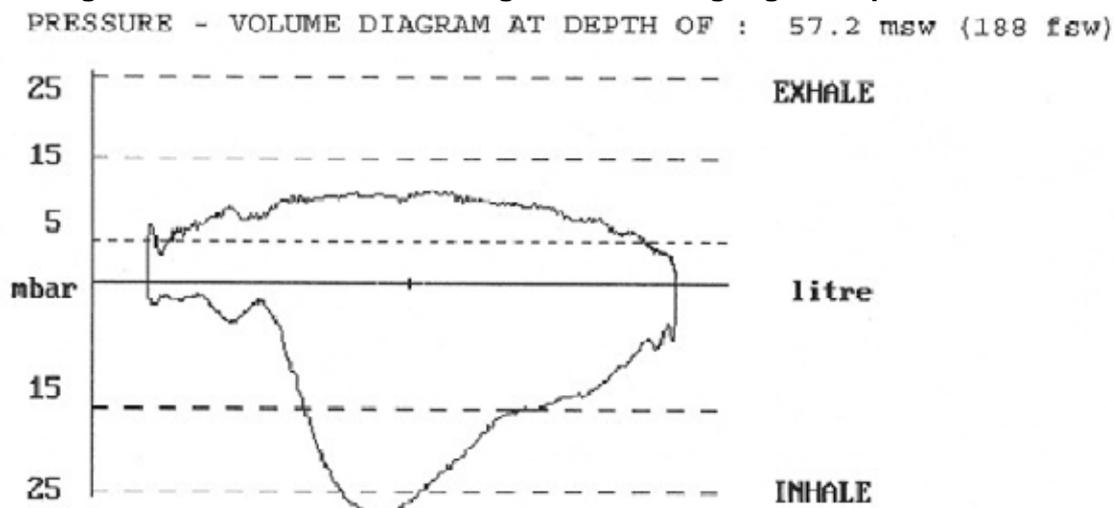
**Figure 1. Pressure – volume diagram describing regulator performance**

The important factors of this type of test may be derived from a pressure-volume diagram such as that shown in Figure 1, where the inner set of dashed lines shown at +/- 15 mbar is the Preferred Limits and would be considered comfortable to breathe. The outer set of dashed lines shown at +/- 25 mbar is the Maximum Acceptable Limit above which the diver would find it extremely difficult to breathe. The area bounded by the P-V diagram is also proportional to work of breathing and is a further important measure of how easy or difficult the demand regulator is to breathe from. In this example, the regulator exceeds the 25 mbar limit during inhalation.

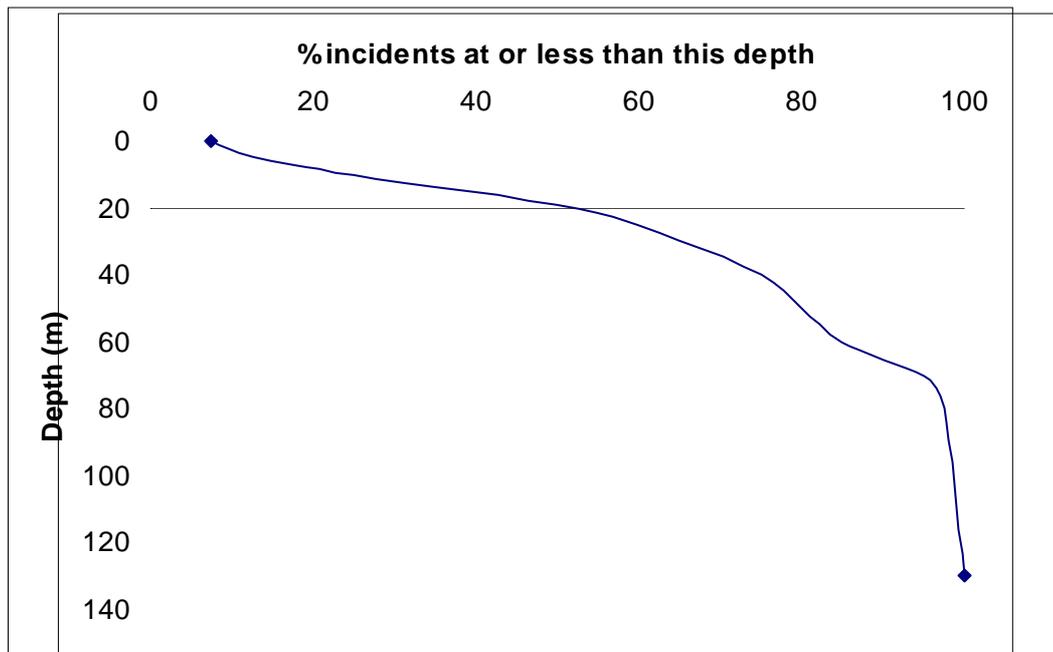
**Figure 2. Incident depth distribution**

The range and distribution of depths at which the various incidents occurred (where known) was from 0m (surface) to 130m, distributed as shown in Figure 2.

Incidents appear to be relatively evenly distributed over the range 0 to 80m, with a single outlier at 130m. Twenty one percent of incidents involved depths greater than 50m, the maximum depth to which EN 250 specifies equipment performance. All but one of these (case 12) were fatalities.

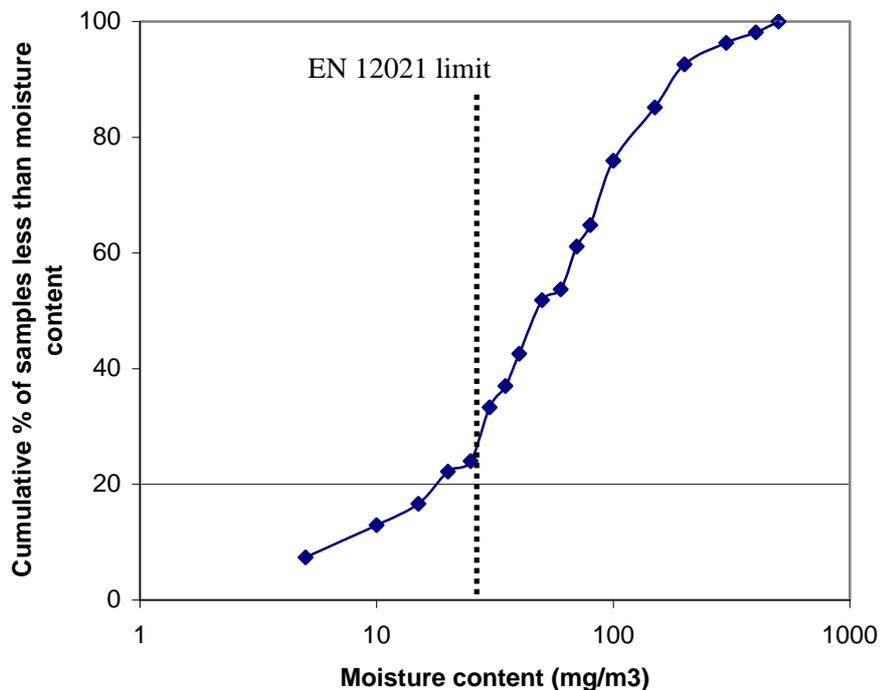
**Figure 3. Measured moisture content of air in cylinders up to 200 bar**

**Moisture content of compressed air** – In the 54 cases where the moisture content of air was measured, 41 were found to exceed the limit specified in EN 12021. For filling of cylinders, the moisture content of air should not exceed 25 mg/m<sup>3</sup> (equivalent to a dew point measured at atmospheric pressure of -51°C). The distribution of measured moisture contents is shown in Figure 3. In practice, it appears that more than ¾ of the air samples tested do not comply with this Standard.

Owing to the moisture content of the air and the prevailing temperatures, approximately 60% of diving cylinders tested would probably have had small quantities of condensed water inside at the time of the incidents. A few may also have been sufficiently wet to allow condensation and freezing in the medium pressure parts of the air supply system (see Figure 4). However, there is no clear link to the reported incidents, other than detection of odour in the wetter samples.

Assuming the low moisture levels specified in EN 12021 are in fact necessary (as they would appear to be from a theoretical point of view), better means of control of moisture in the output of cylinder filling compressors appears to be needed. This aspect should already be under control through the requirements of COSHH.

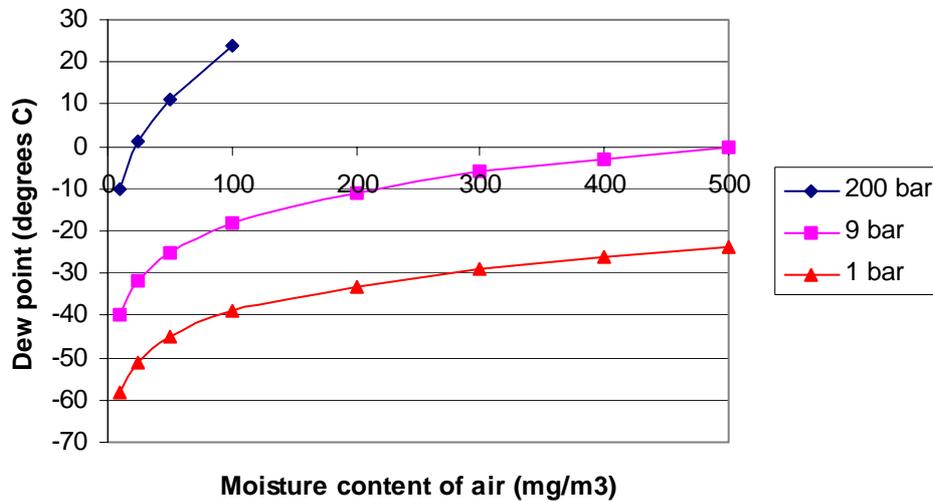
**Figure 4. Dew point as a function of moisture content of the air and applied pressure**

These moisture limits are primarily intended to prevent condensation, corrosion and damage to pressurised storage cylinders, and condensation and freezing in regulators owing to cooling from release of pressure. For the highest moisture content measured here ( $430 \text{ mg/m}^3$ ), condensation of moisture should not occur at temperatures above  $-26^\circ\text{C}$  at atmospheric pressure. However, for the same air at a typical cylinder pressure of 200 bar, condensed moisture will be present in the cylinder at the observed water temperatures; condensation will also be present in the medium pressure parts of the system (typically 9 bar) if the temperature of any surface falls below approximately  $-2^\circ\text{C}$ . Temperatures close to this latter value can easily be achieved during use, particularly if the equipment is submerged in relatively cold water. The total quantity of water involved is small – in this worst case a total mass of just over 1g, if all the moisture in a full cylinder was condensed out.
