The underlying causes of falls from vehicles associated with slip and trip hazards on steps and floors

Prepared by the **Health and Safety Laboratory**
for the Health and Safety Executive 2006

RESEARCH REPORT 437

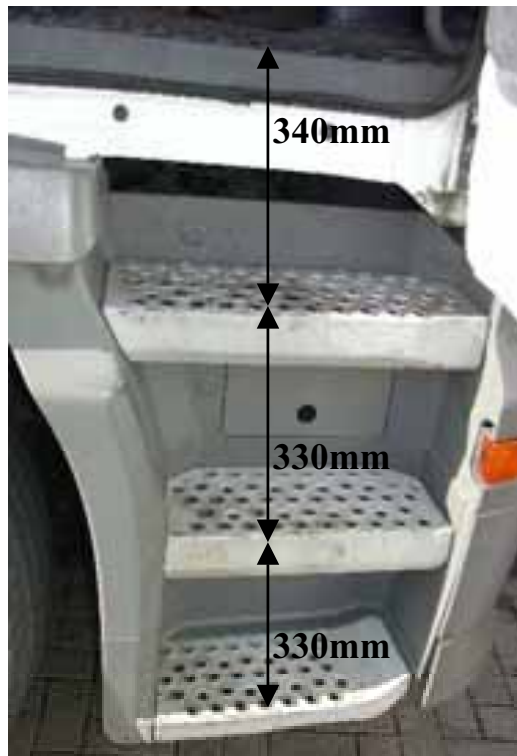
Figure 1 – Cab steps with consistent step heights.

In general terms Standards relating to access state that rise (step height) shall be constant wherever possible (BS EN ISO 14122-3:2001, Safety of machinery – Permanent means of access to machinery – Part 3: Stairways, stepladders and guard-rails). In relation to industrial stairs, BS5395-3:1985 (Stairs, ladders and walkways – Part 3: Code of practice for the design of industrial stairs, permanent ladders and walkways) states that consistency of rise (step height) and going (step depth) is of great importance for user confidence and safety. In terms of step risers (step height), maximum spacings of 400mm for steps and ladders and 250mm for stairways are recommended (BS EN ISO 2867:1999, Earth-moving machinery – Access systems).

It seems intuitive that cab steps should be made as consistently as possible and within recommended dimensions as specified in related British and International standards. This will be especially important in circumstances where drivers are exposed to different cabs on a regular basis and may not be accustomed to the differences in dimensions between vehicles. Caws et al (1999) commented on the differences in quarry vehicle designs. They described how drivers that changed vehicles infrequently might expect handholds and step positions to be the same as their usual vehicle; any design differences may thus increase the chance of an accident.

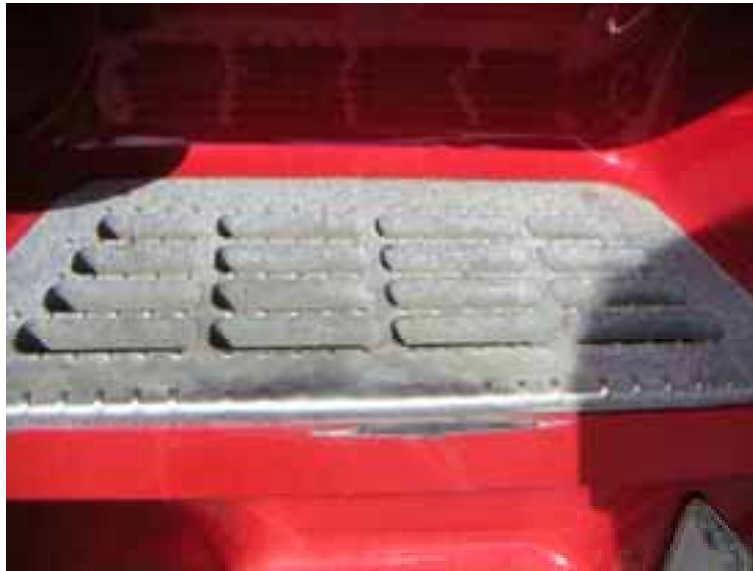
Figure 3 – High levels of wear is usually seen on the outer edges of cab steps.

For adequate slip resistance in clean water wet conditions, a minimum Rz surface microroughness of 20 µm is required. More viscous contaminants, such as dirty water, oil, grease, require more roughness to provide adequate slip resistance (see Appendix E). This higher level of roughness was only present where surfaces had been modified, such as with the addition of abrasive materials.

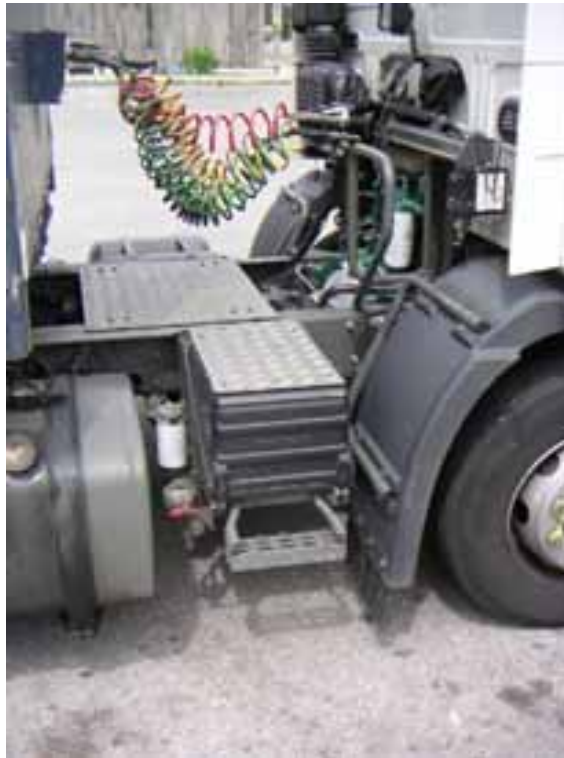
Figure 5 – 5th wheel area of an LGV

Due to its position next to the diesel tank(s) on the vehicle, the surfaces in the 5th wheel area tend to become contaminated with diesel. Drivers reported that it is easy to spill when refuelling and it was observed that on many vehicles the diesel tank and surrounding area was contaminated with diesel. Where steps are inset into the fuel tank, this makes it difficult, firstly to position the foot firmly in the constrained space of the foothold, and secondly to avoid slipping due to potential contamination by diesel.

The surfaces used in covering the 5th wheel area (including battery unit) tend to be profiled metal or plastic surfaces. Often, a ‘patchwork’ of surface materials is used such that there is very little consistency. Profiled surfaces generally offer less slip resistance in wet or contaminated conditions than is perceived by designers. Where a physical interlock with cleats on the shoe occurs, slip resistance is good. In the worst-case scenario where there is no interlock of the shoe sole cleats with the profiled surface, it is the surface microroughness of the peaks of the profile that is critical. Where a mixture of surfaces are used, a particular shoe may interact well with one surface, and poorly with another, giving the operator an inconsistent level of grip. Often, slip accidents occur when there is a significant change in available friction, such as when walking from a good, slip resistant surface to a slippery surface e.g. when walking from a dry surface to a wet surface that has just been mopped. Consistency in surfaces used adjacent to one another eliminates this potential hazard.

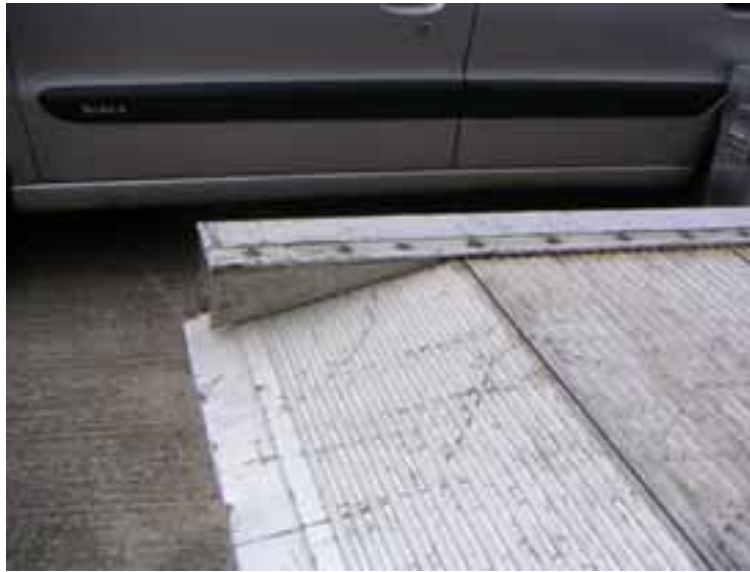
Certain tail lift designs introduce a potential trip hazard (see Fig 6). It may be foreseeable, that a driver unloading goods may walk backwards, and trip over this 'lip'. Similar platforms without this lip are in use, suggesting it could easily be redesigned to eliminate this problem.

Figure 6 – Tail lift design that could result in a trip.

In some cases, the design of tail lifts was such that the edging might pose a trip hazard (see Fig 6)

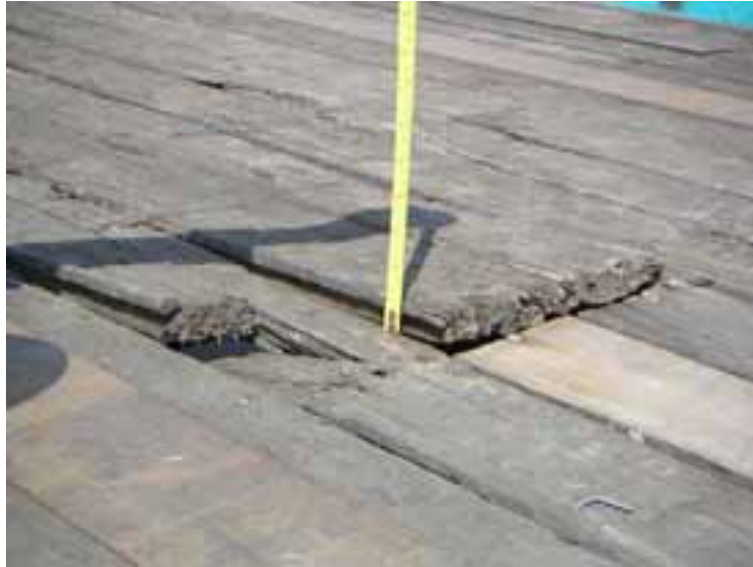
The condition of the trailer surfaces varied between vehicles and related to the state of repair of the trailer. The surface often becomes damaged with wear and tear from the load. Forklift trucks may also dent the side impact barriers and the wooden surface of the load. Some of the wooden planks were in a very poor state of repair with broken planks and protruding nails presenting foreseeable trip hazards (Fig 7).

Figure 7 – Damaged plank presenting a trip hazard.

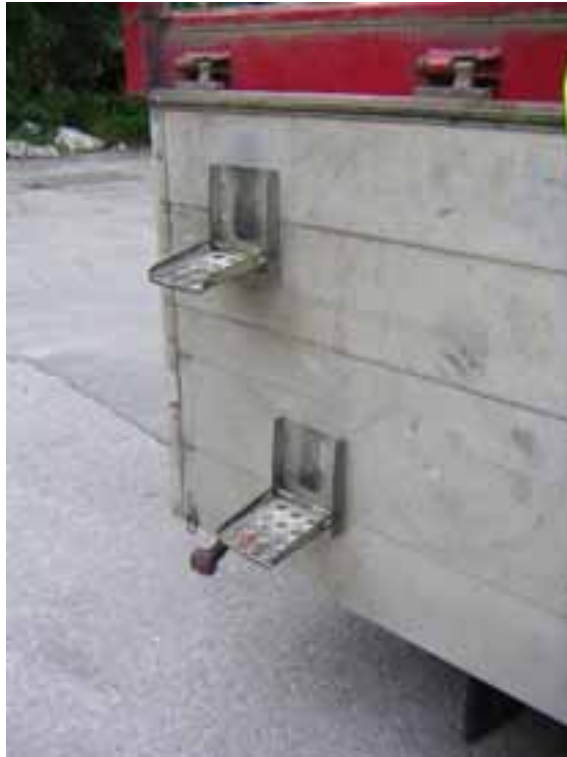
A number of builders merchants' vehicles were assessed with additional access systems to their load area. In a selection of vehicles, two single steps were fastened to the drop down side barriers, such that they could be used for accessing the load area (Fig 8). It should be noted that when this photo was presented to drivers at one of the focus groups, they thought that the steps looked flimsy and would not be particularly durable. Also, fold out ladders were provided at the rear of the vehicle, which could be stowed away when the vehicle is in motion.

Figure 8 - Fold out steps on drop-side flatbed trailer

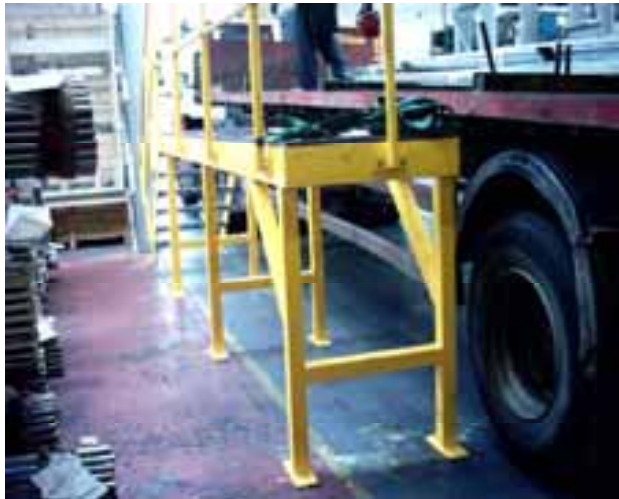
On one of the visits, information was gathered regarding premises that had carried out alterations to its unloading area, to assist flatbed drivers (Fig 9). The premises had installed a platform to enable drivers to walk up a set of stairs and carry out strapping down and unloading from the side of the vehicle on the platform. This not only improved access, but eliminated the possibility of a fall from height whilst undertaking these tasks. Drivers that had visited these premises were satisfied with the modification and hoped that its occurrence would become more widespread.

Figure 9 – Platform to assist the loading and unloading of steel.

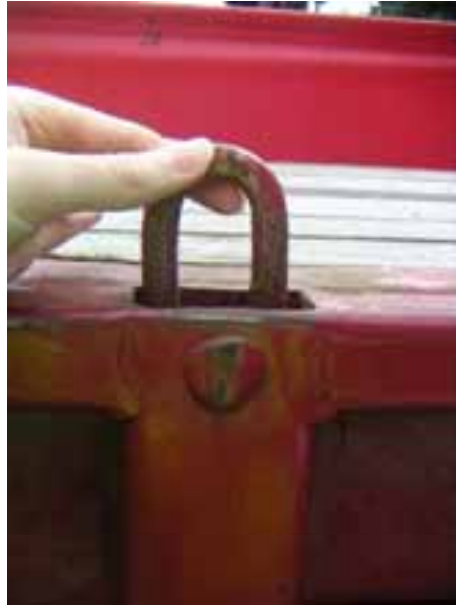
Some companies had vehicles where the fastening clips for load ties could drop down into the vehicle body rather than stand proud and pose a trip hazard (see Fig 10).

Figure 10 - Retracting fixing eye to avoid trip hazard

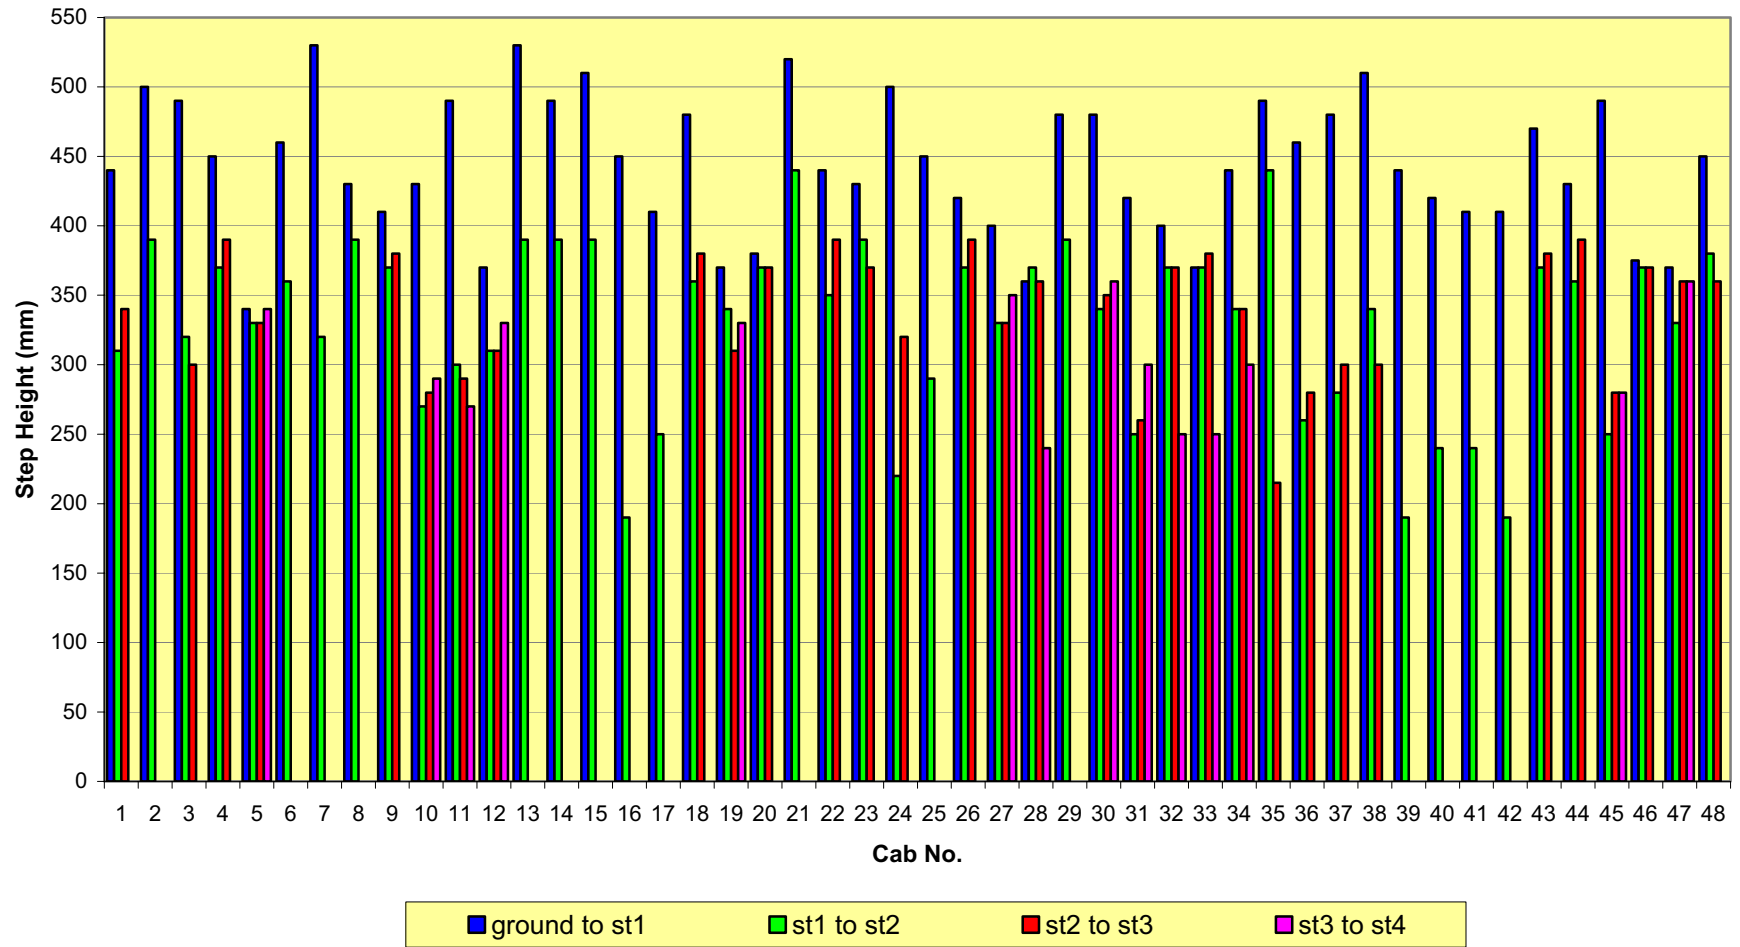
Figure 11 - Cab Step Height

A chart of the step heights for all of the cabs can be found in Appendix A, Figure 11. The largest step height was always between the ground and the first step. The smallest ground to first step height measured was 340mm, the largest was 530mm. Only four of the cabs measured had consistent step heights (cabs 5, 20, 46, 47), whilst the majority had inconsistent step heights. The majority of step heights (46 out of 48) were less than 400mm, with most falling in the range 250-400mm.

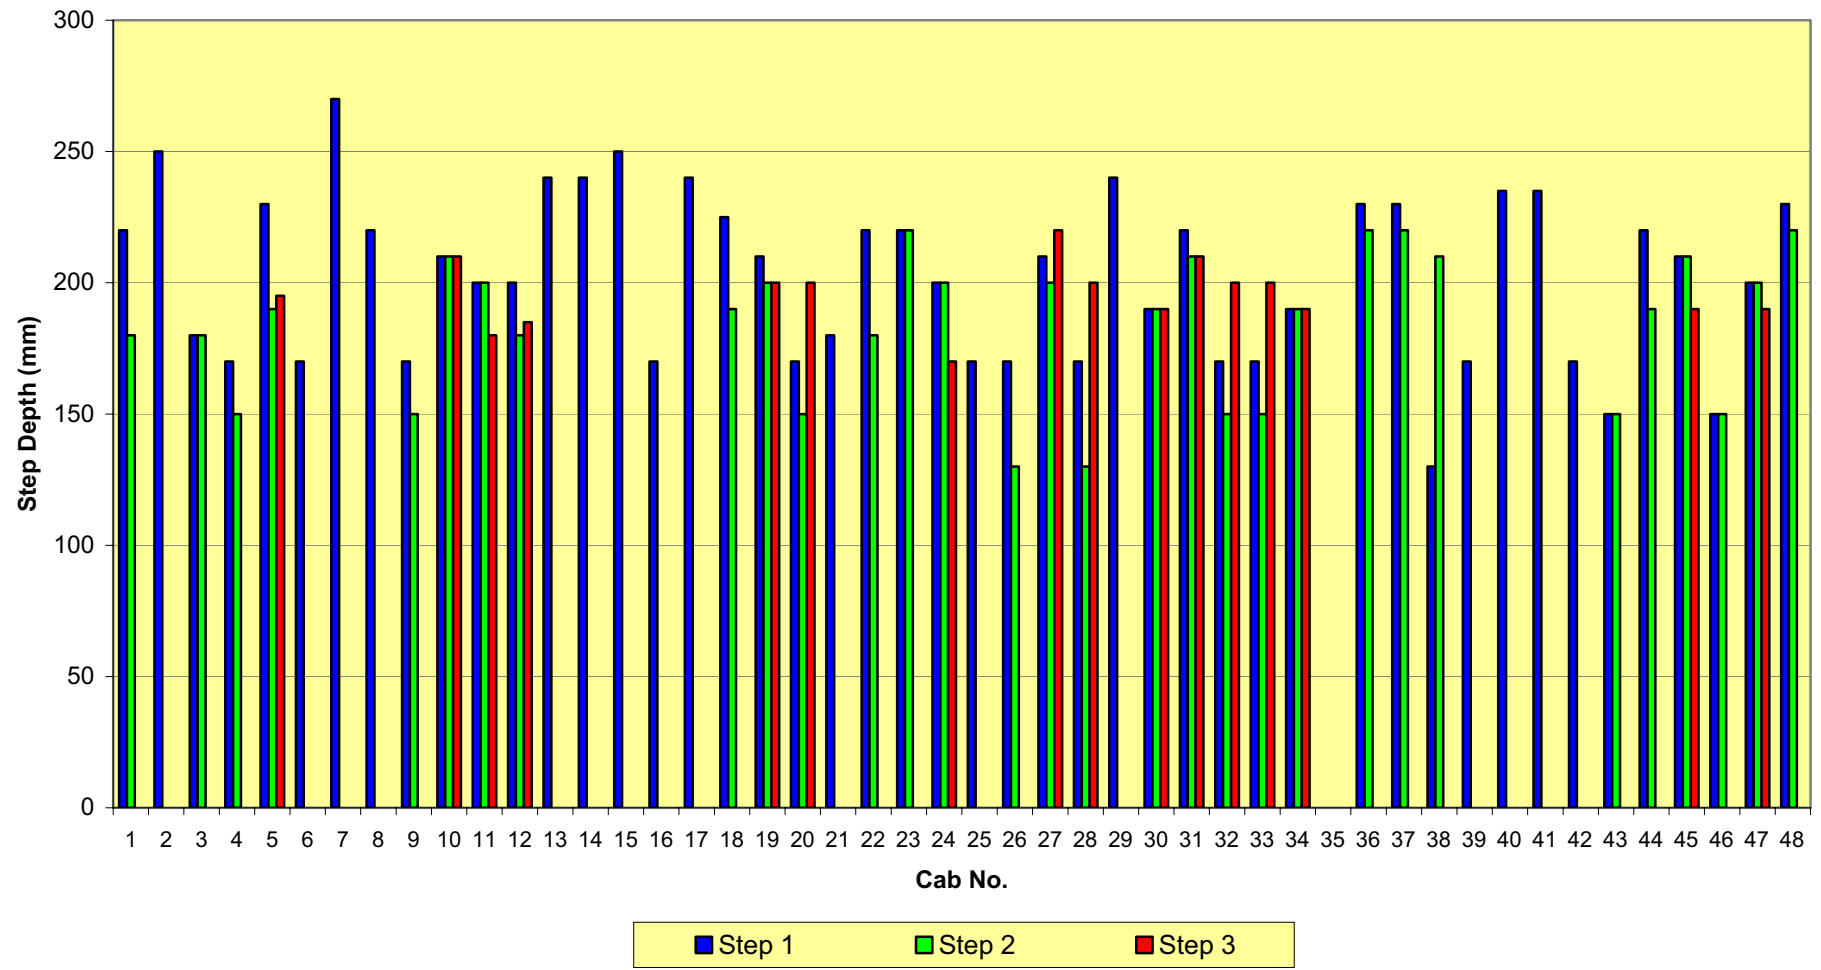
Figure 12 - Cab Step Depth

A chart of the step depths for all of the cabs can be found in Appendix A, Figure 12. The smallest step depth measured was 130mm, the largest was 270mm. In general terms, the larger the step depth the better the likelihood that a user can gain a good footing on the surface. 14 of the 48 cab steps measured had step depths less than 200mm. Figure 2 below, demonstrates how altering the depth of a stair tread affects the contact area made with the sole of the shoe. In addition, the lower schematic shows how restrictions on the height of a toehold can reduce the contact area made between the shoe sole and the step surface. BS EN ISO 2867:1999 recommends that tread depths should have basic dimensions of 200mm for steps and ladders and 300mm for stairs.

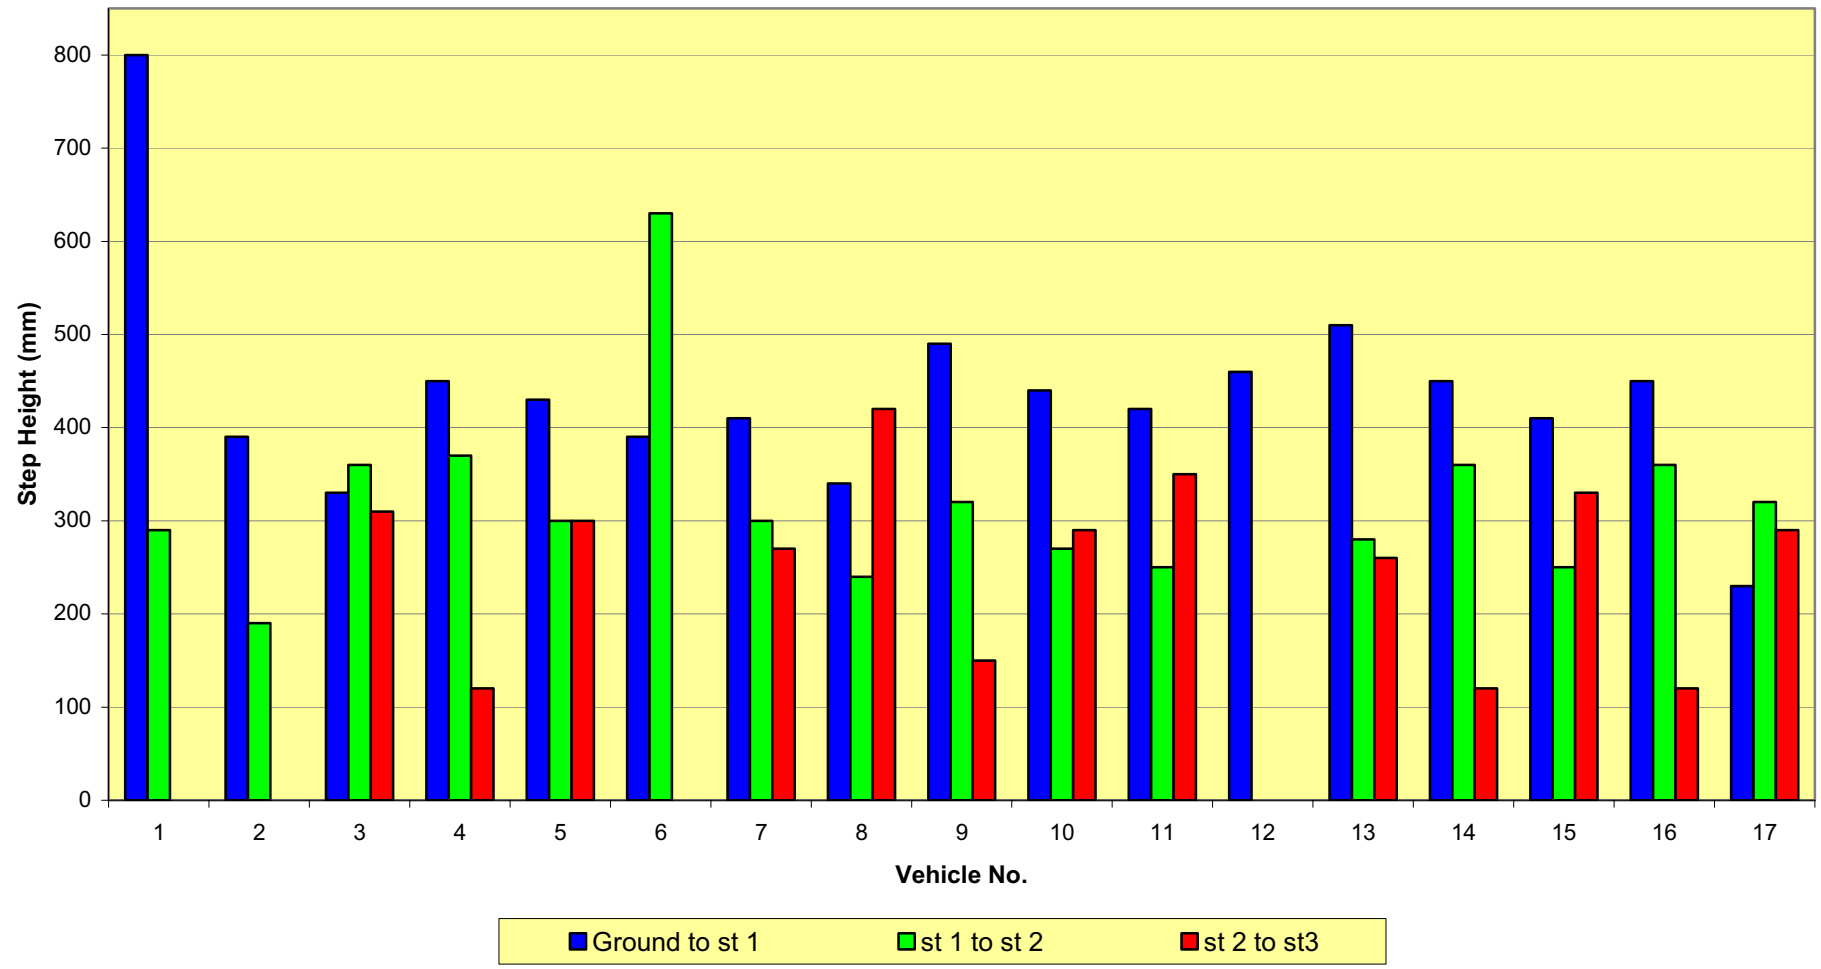
Figure 13 - 5th Wheel Step Height

Step height data for the 5th wheel area is presented in Appendix A, Figure 13. In all cases, the first step height was the greatest. A first step height of 800mm was recorded in one case, which is above the maximum step height of 700mm recommended in BS EN ISO 2867:1999 for earth moving machinery. The lowest step height measured was 120mm. In some cases, there was considerable variation in step heights for the 5th wheel region (e.g. see vehicle 9 in Figure 13). The step depths measured in the 5th wheel area tended to be relatively narrow, with 100mm being a common measure.
