Mobile Elevated Work Platform (MEWP) incident analysis

Prepared by the **Health and Safety Laboratory**
for the Health and Safety Executive 2013

Christine Leah
David Riley & Amy Jones
Harpur Hill
Buxton
Derbyshire
SK17 9JN

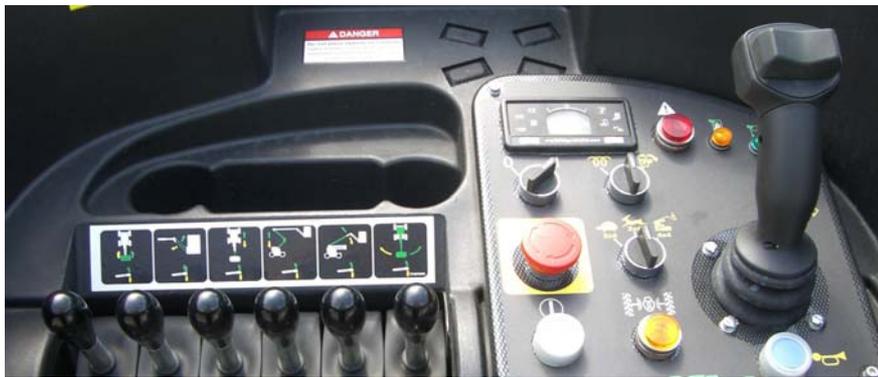
Photograph 1 - Platform control panel for an articulating boom

The controls in Photograph 1 include a range of identical levers, side by side, for the movement of the boom functions. Pictograms above the levers identify which part of the boom the lever operates. The incorrect selection of a lever could result from the following range of human error types:

1. Slip – where the operator does the right action but on the wrong lever, or the wrong thing on the right lever;
2. Lapse – where the operator forgets to take account of something, such as their orientation if the platform is rotated on the end of the boom when operating the slew control, or that the boom is slewed when operating the drive controls;
3. Rule-based mistake – where the operator moves a control in the wrong direction believing it to be right.

NB: The first two errors are more likely to occur when there is a demand on attention elsewhere, such as looking around to check for obstructions or wheel alignment, etc.

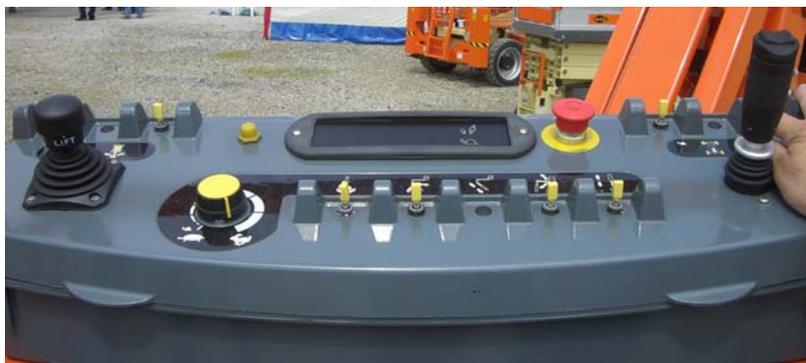
Photograph 2 - Platform control panel for another articulating boom

The control panel within Photograph 2 has raised areas between the toggle switches, to try to stop them being activated if something/someone was leaning on the control panel. This is an example of how manufacturers have noted that accidental/inadvertent operation of controls is an issue and tried to design the issue out. This may also help to prevent damage to the controls themselves.
