Example D

Accident

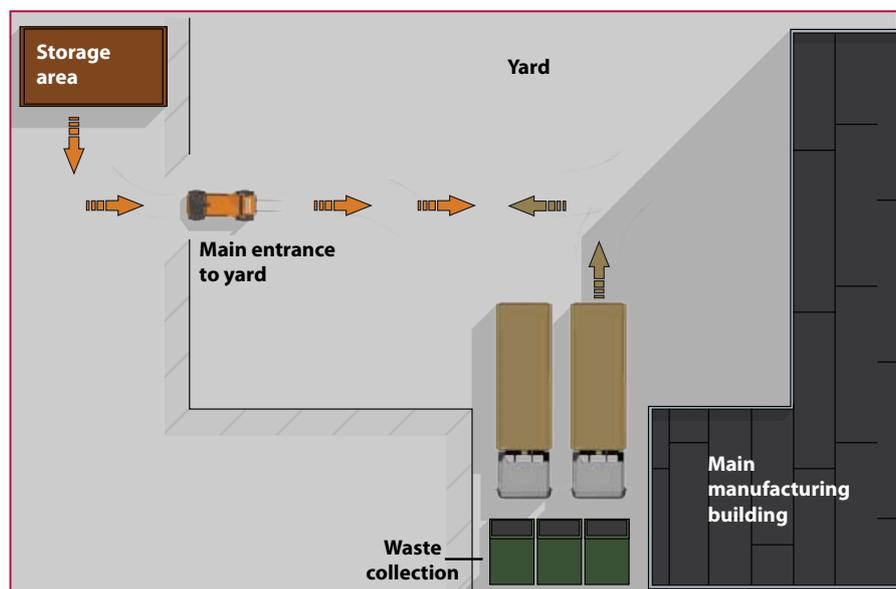
The site consisted of a main production building and waste collection area, both of which were accessed through a yard. The yard was a large area packed with dirt and had several unmarked roadways running through it. Routine operations on the site involved the transport of bulk material to the main production building by forklift trucks. The storage area was located just outside the entrance to the yard. Solid, rock-like waste was also collected on the mill site by large industrial dump trucks. There was a designated parking area for dump trucks located in front of the waste collection area.
