**PUBLIC REPORT OF
THE FIRE AND EXPLOSION AT
THE CONOCOPHILLIPS
HUMBER REFINERY
ON 16 APRIL 2001**

Prepared by the Health and Safety Executive

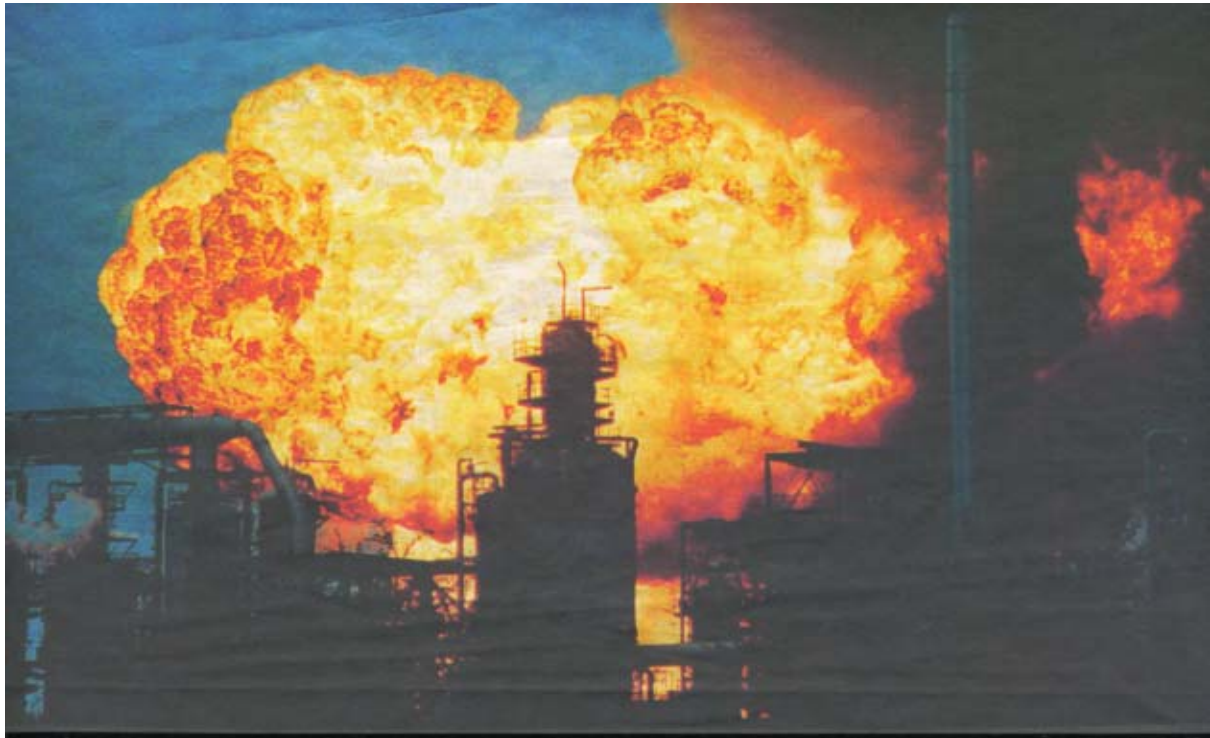
Initial release and explosion

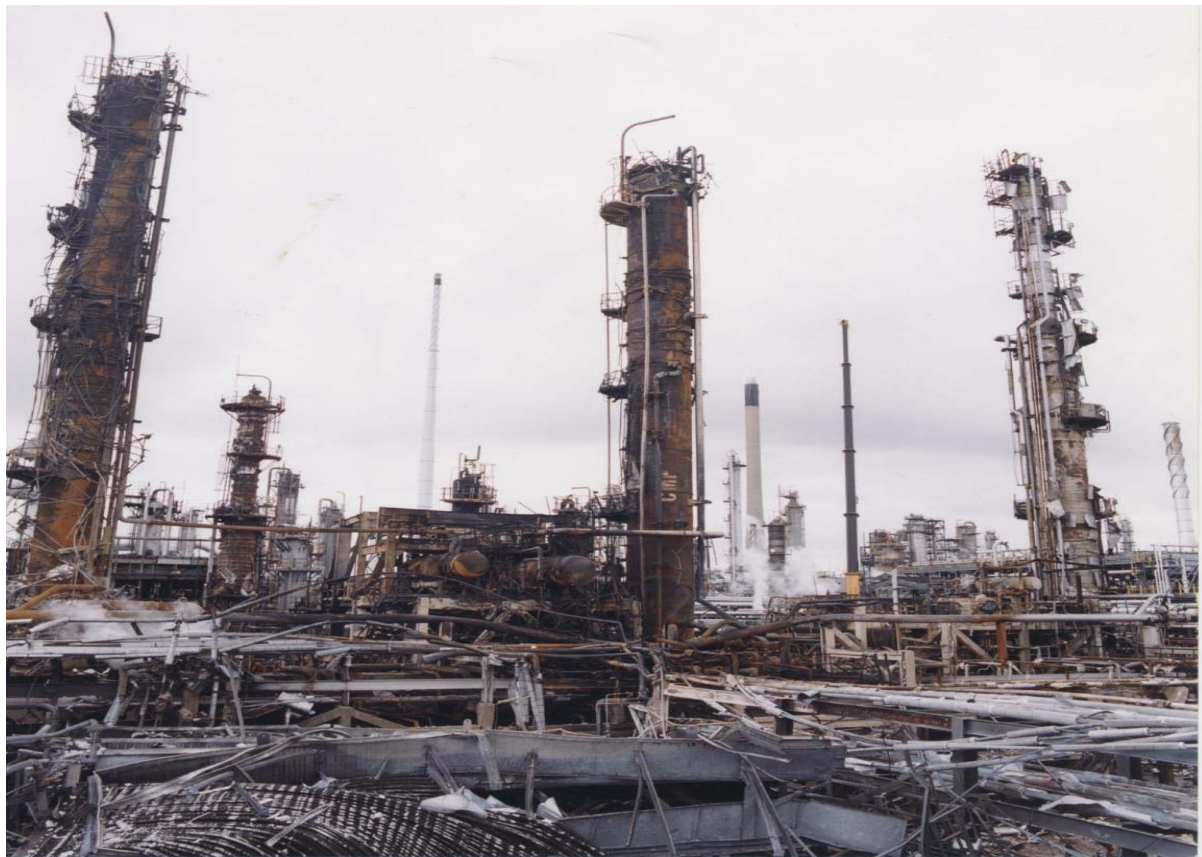
In addition buildings normally occupied on the Refinery, up to 400 metres away from the source of the explosion, were badly damaged. The contractor's canteen building suffered severe damage, had it been occupied at the time of the explosion people could have been severely injured by the flying glass. The staff canteen, the inspection services building and the toilet block suffered blast damage with windows blown in, doors and ceilings damaged and some cracking and displacement of brickwork.

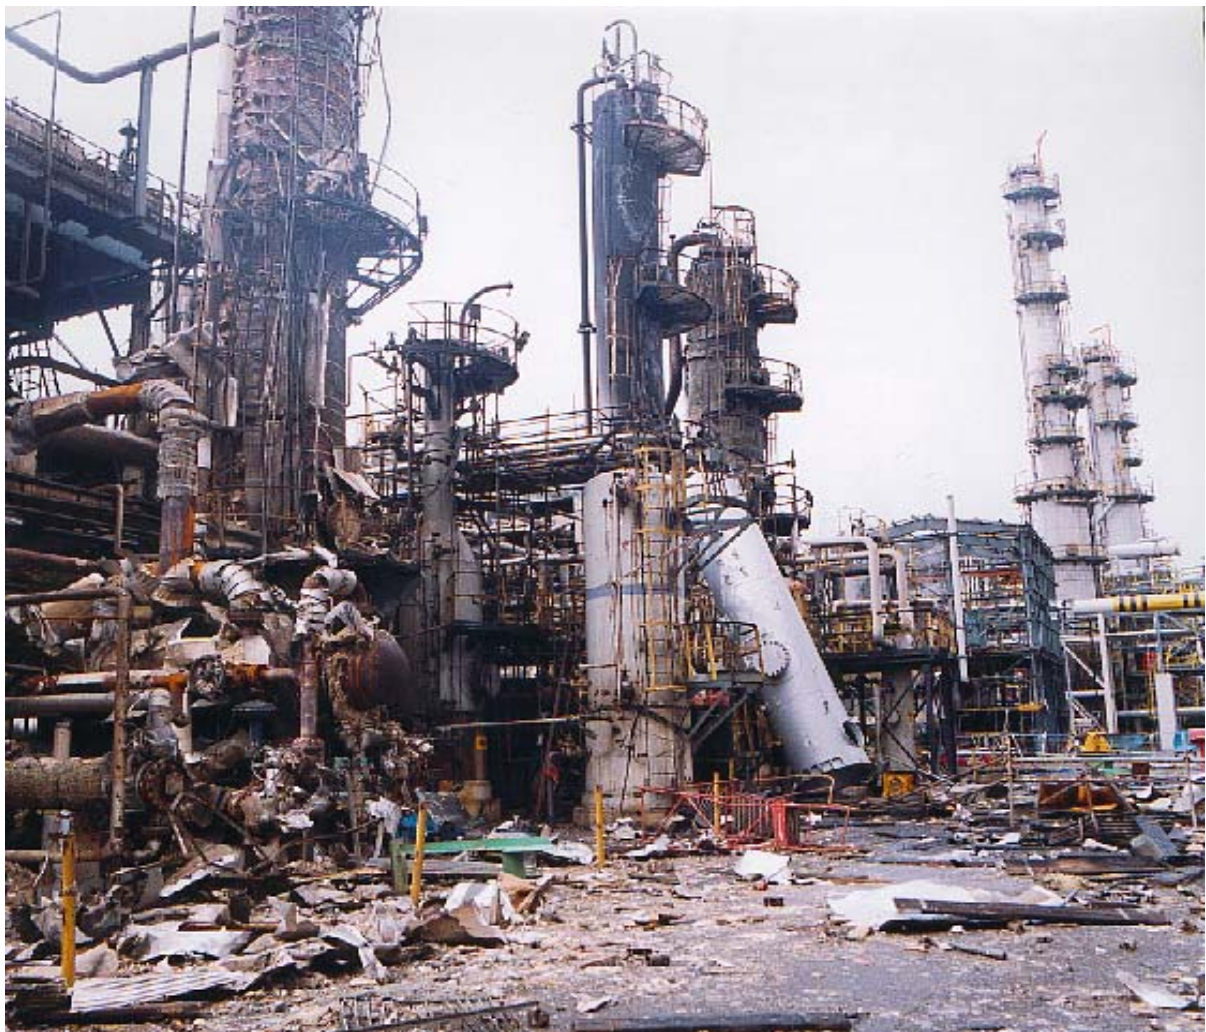
Figure 5 – Close up views of damage to the SGP

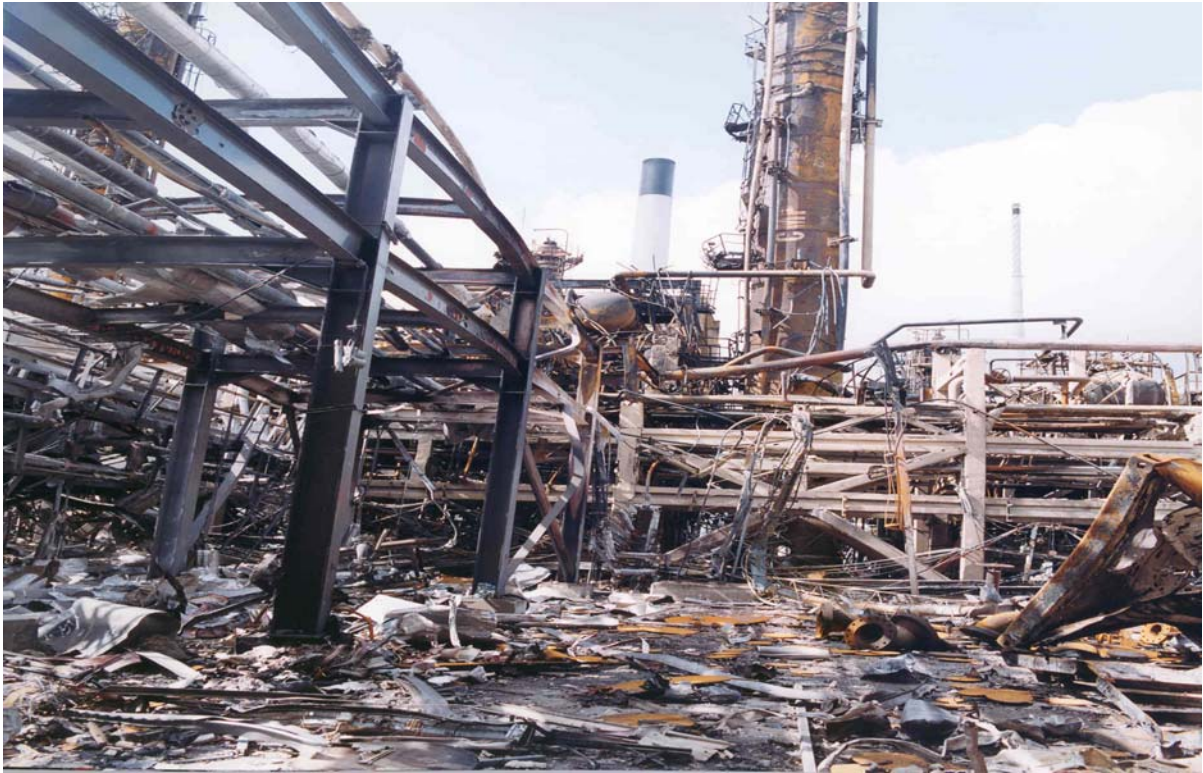
Figure 6 – Close up views of damage to the SGP

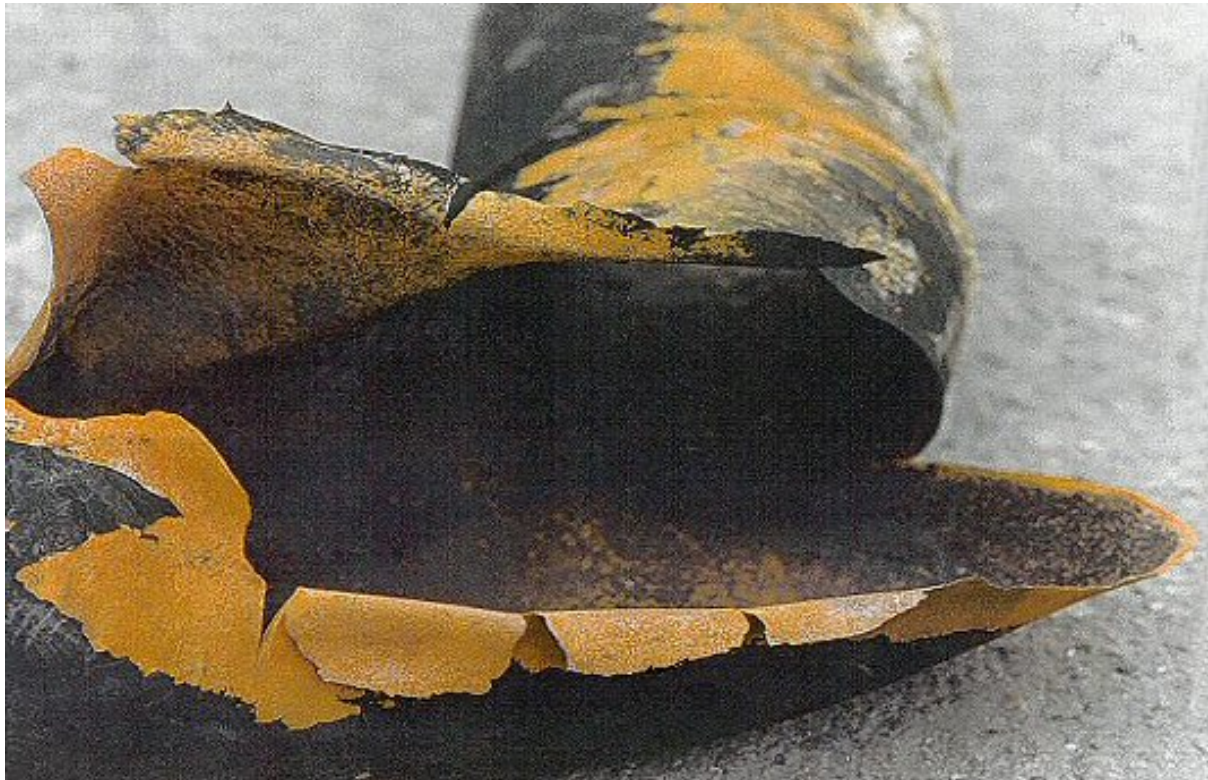
Water washing provision on the SGP

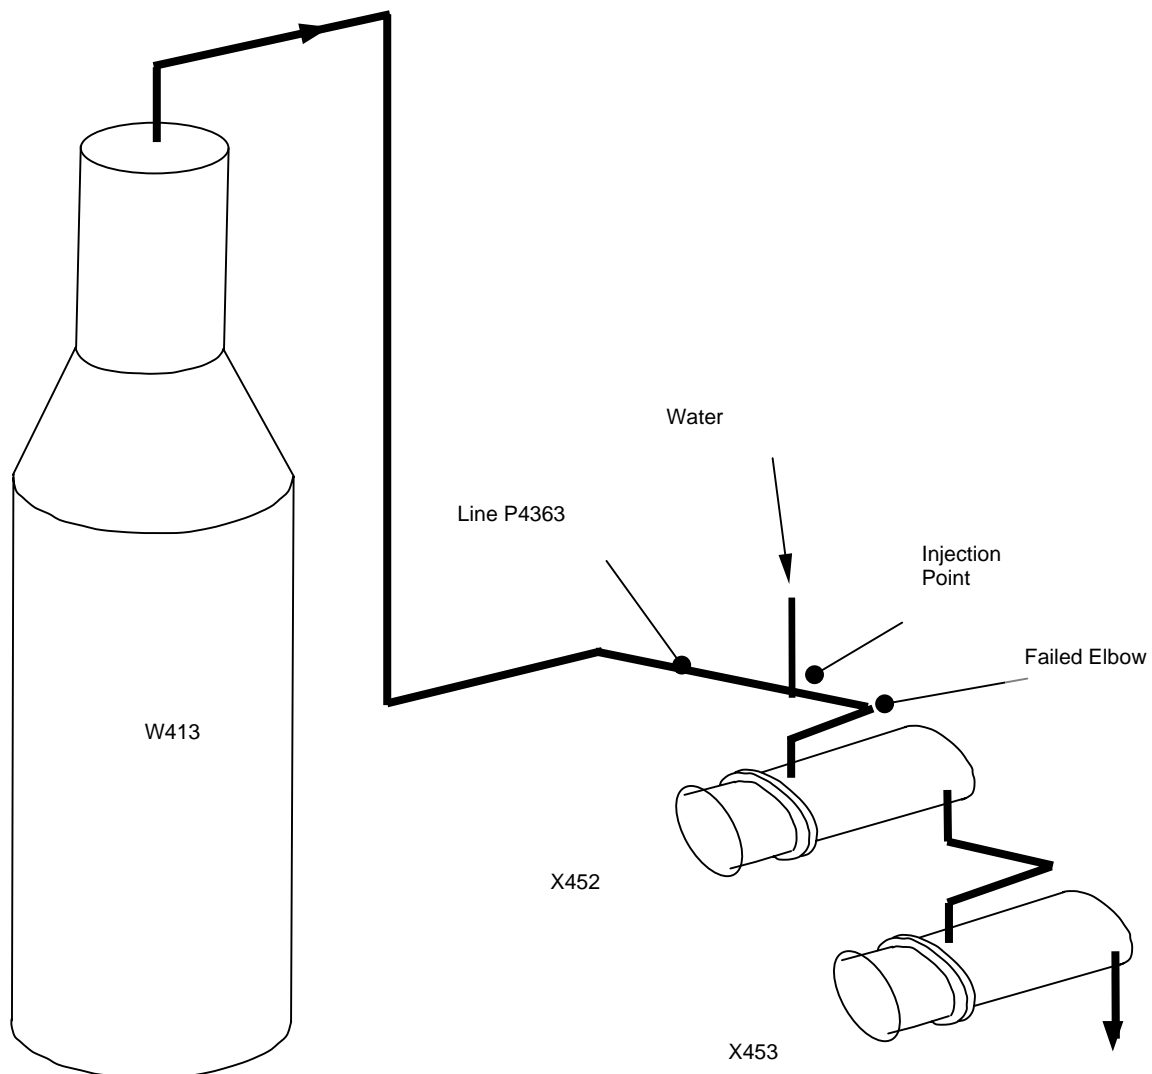
Figure 9 – In-situ failed elbow and injection pipework connection (broken off)

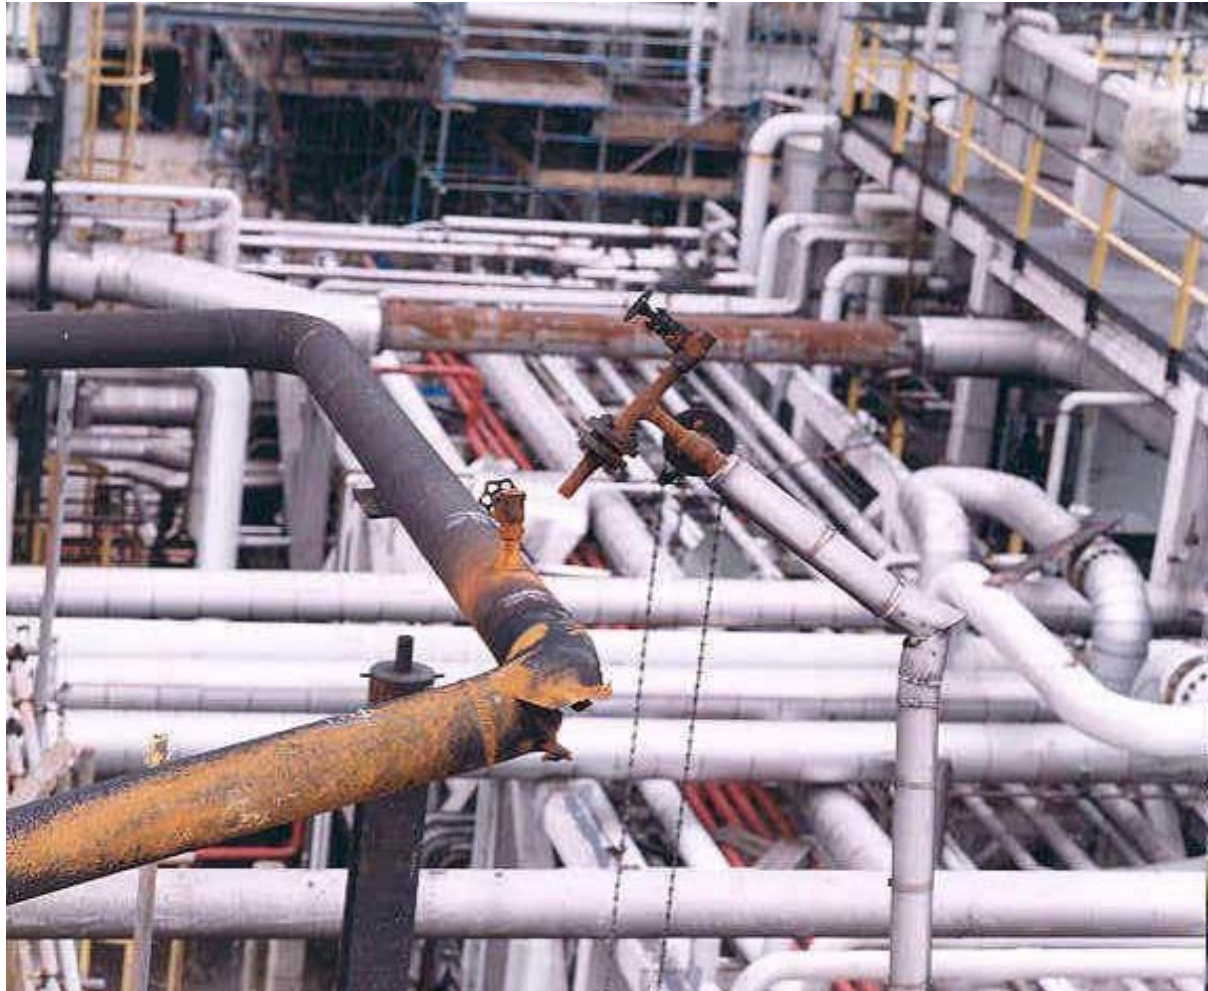
The modification had the hallmarks of a 'quick fix' to solve the symptoms of the immediate problem of fouling. Using an existing vent valve to connect the water into P4363 was expedient, and meant that there would have been little or no downtime required for this modification.
