# **The effects of local joint flexibility on the reliability of fatigue life estimates and inspection planning**

Prepared by **MSL Engineering Ltd**  
for the Health and Safety Executive

**OFFSHORE TECHNOLOGY REPORT**  
**2001/056**

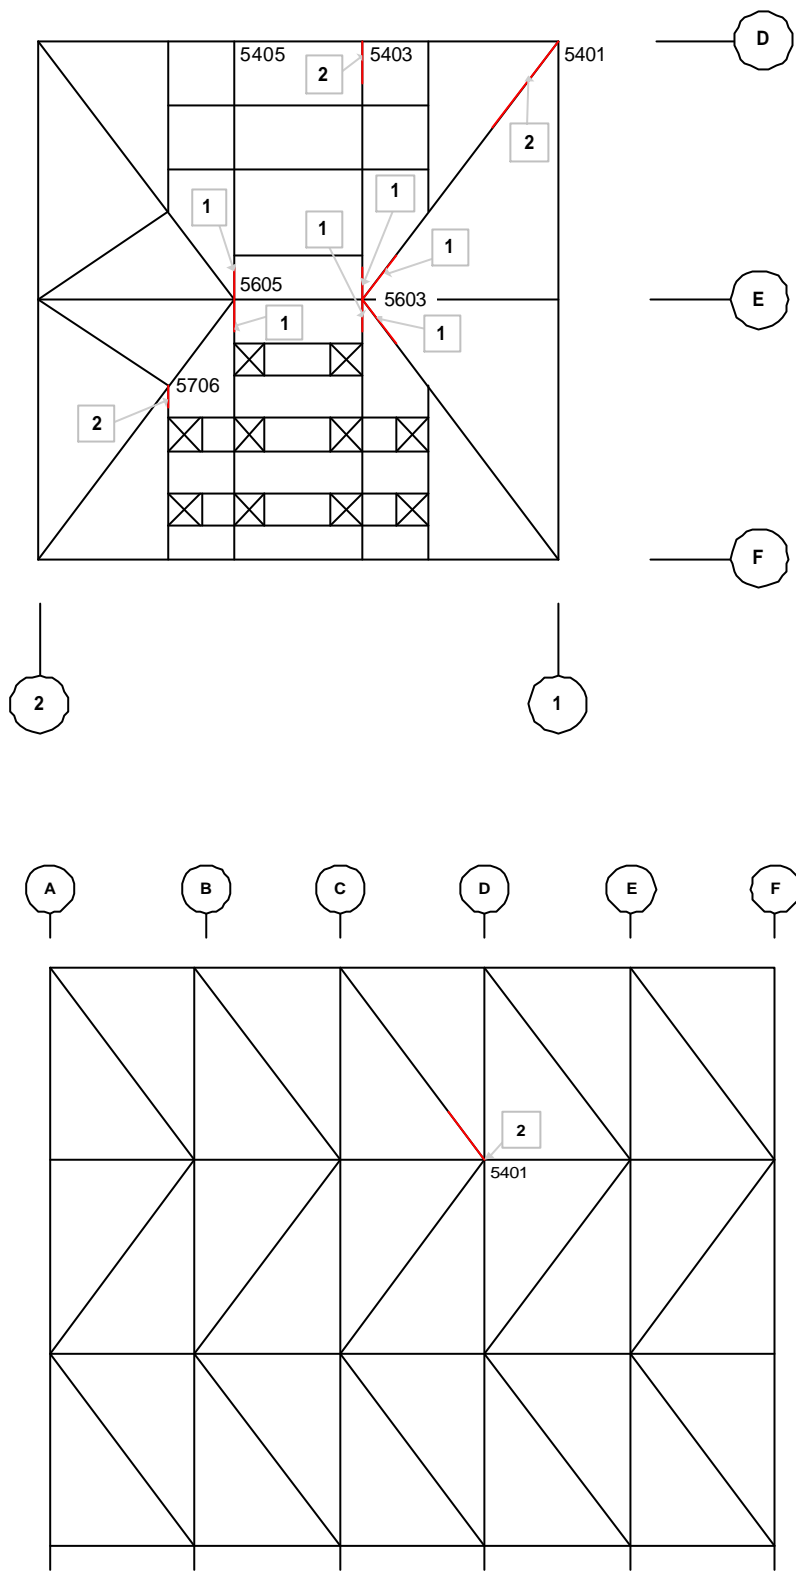
**Figure 5.2**  
**Location of Category 1 and 2 Joints on CGF (top) and Frame 1 (bottom)**

The locations of the Category 1 and Category 2 joints are shown in Figure 5.2. It can be seen that nine of the ten joints are located amongst the conductor guide framing at the -24' elevation. The joint with the crack indication (5405) was modelled, consistent with the Wimpey analysis, as rigid since a grouted repair clamp has been installed. Nevertheless the identical adjacent brace connection (5403) has a similar rigid joint fatigue life prediction and hence it can be deduced that the LJF fatigue life of joint (5405) would also be similar to that of joint (5403) and hence identified as a Category 2 joint. The only Category 1 or Category 2 joint, from the flexible joint analysis, not amongst the conductor guide framing is joint 5401 on

longitudinal frame 1 at the intersection with transverse frame D, also at -24' elevation. This joint was also found to have a crack indication during underwater inspection.
