HSE Information Sheet

Advice on acceptance criteria for damaged Passive Fire Protection (PFP) Coatings

Offshore Information Sheet No. 12/2007

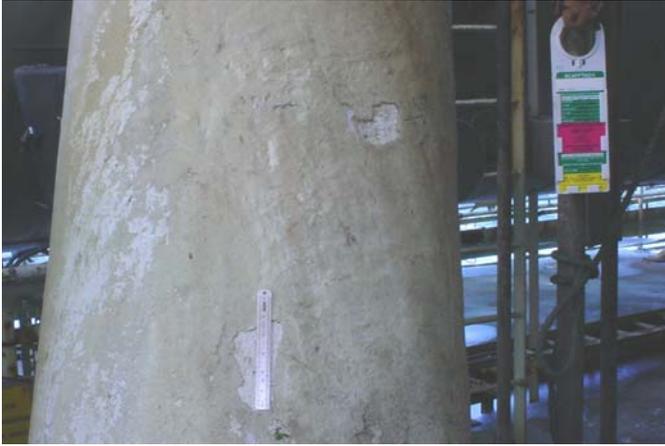
Surface cracks, chips, gouges, scrapes, spalling and topcoat loss with reinforcement unexposed,

Severity Level 2 if in area of extreme physical exposure or where accelerated damage can occur

OR **Severity Level 3** in located in protected environmental locations.

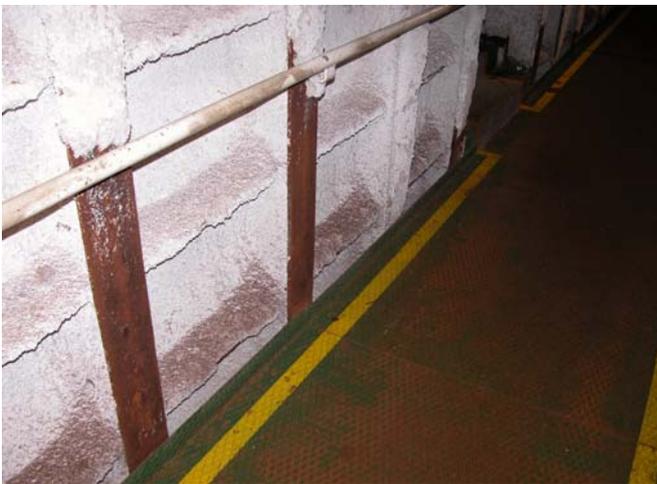
Unretained and disbonded material on supporting webs of fire/blast wall.

Severity Level 1 if it will lead to a significant proportion of the protected element becoming exposed to any fire.

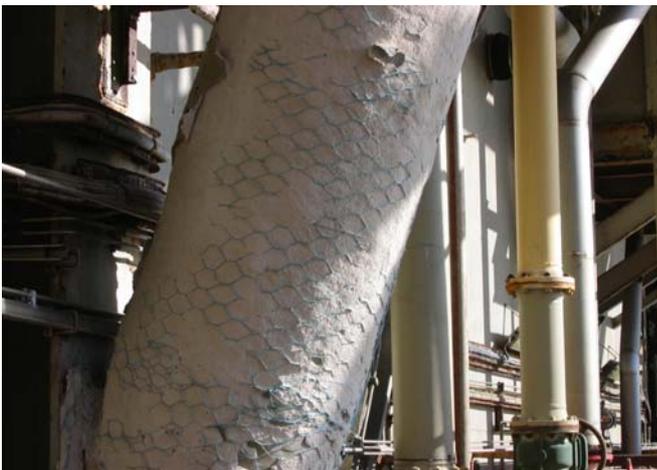
PFP eroded with retention mesh exposed but intact

Severity Level 2 provides some protection, is present in an area of high structural importance, and will lead to deterioration of material.
