**OFFSHORE TECHNOLOGY  
REPORT - OTO 98 153**

**Report on EESC Visit  
to  
ESVAGT  
(Danish Offshore Rescue Service)**

*Date of Issue : August 1998*

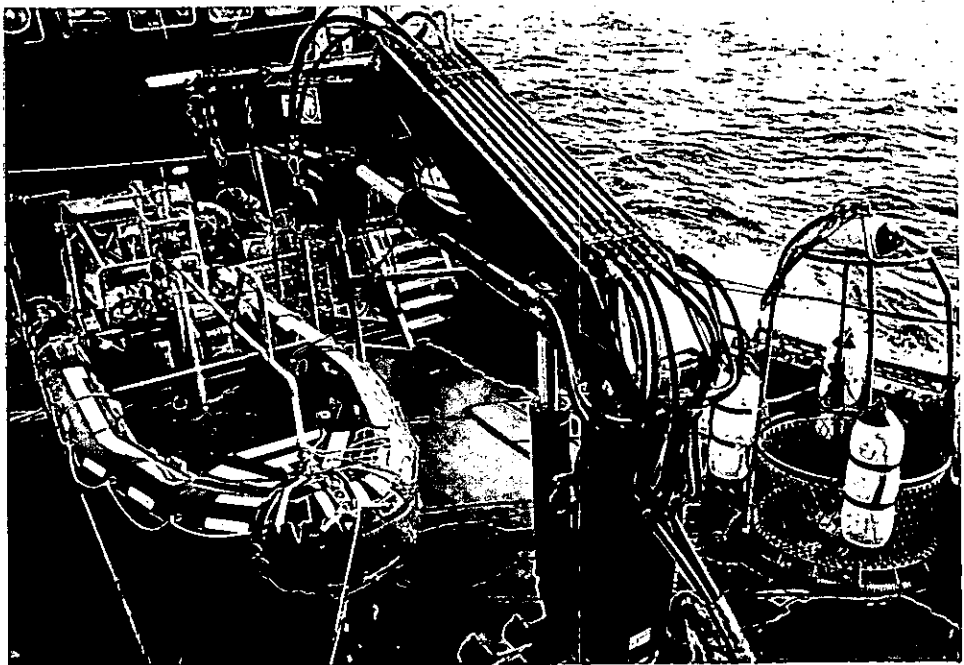
**FIG 4 FRC RECOVERY CRANE**

The ESVAGT philosophy has been to provide a vessel dedicated to rescue duties and not to compromise this capability with additional duties. The ESVAGT fleet consists of nine vessels, eight of which are converted trawlers and one a converted supply vessel. The trawlers are typically 33 metres length overall and some 250 tonnes displacement and all have been re-built to a standard layout. The level of investment in converting these vessels into an SBV was high, essentially involving a complete strip-down, new machinery and the installation of azimuth thrusters. The trawler hull was preferred as they are of a 'sea kindly' form designed to continue working in adverse sea conditions. The relatively short vessels have a less severe differential movement with the FRC than longer, hard chine hull forms. By cutting away the gunwhale it is possible to attain a very low freeboard enabling a quick recovery of the FRC with the minimum of crane wire deployed.

All the ESVAGT vessels showed a high level of maintenance even though many of them had remained at sea for a considerable period, eg 12 months.

lifted the craft but laboured during the lift. ESVAGT subsequently increased the power of their knuckle crane from 18 tonne/metre to 36 tonne/metre and increased the strength of the FRC lifting components.

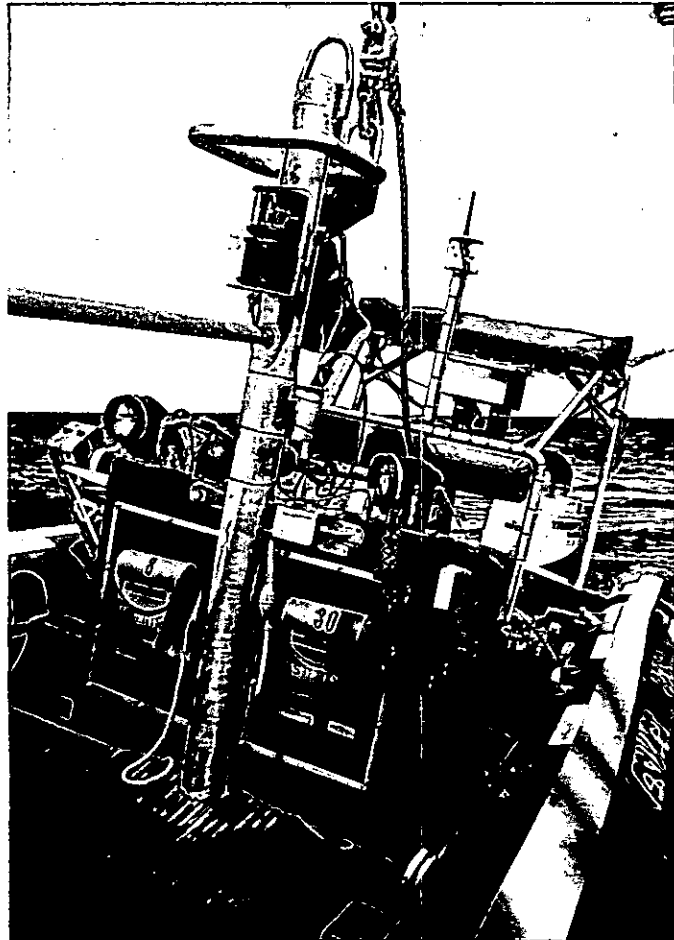
**FIG 8 FRC LIFTING POST**

The essence of the ESVAGT FRC recovery system is to have the FRC lifting point at the top of a fixed post located at the centre of gravity of the craft. With the aid of a quick connect crane hook and tag-line, the FRC crewman is not involved in lifting any equipment and can retain a grip on a hand-hold to maintain his balance. The FRC cox brings his craft under the crane hook, the crewman grasps the tagline and draws the quick connect onto the fastening at the top of the FRC lifting post. Once the connection has been made the crane operator quickly brings the FRC up to the SBV deck level and the FRC is bowsed in hard against the SBV hull, establishing stability and allowing the FRC occupants to transfer onto the SBV.

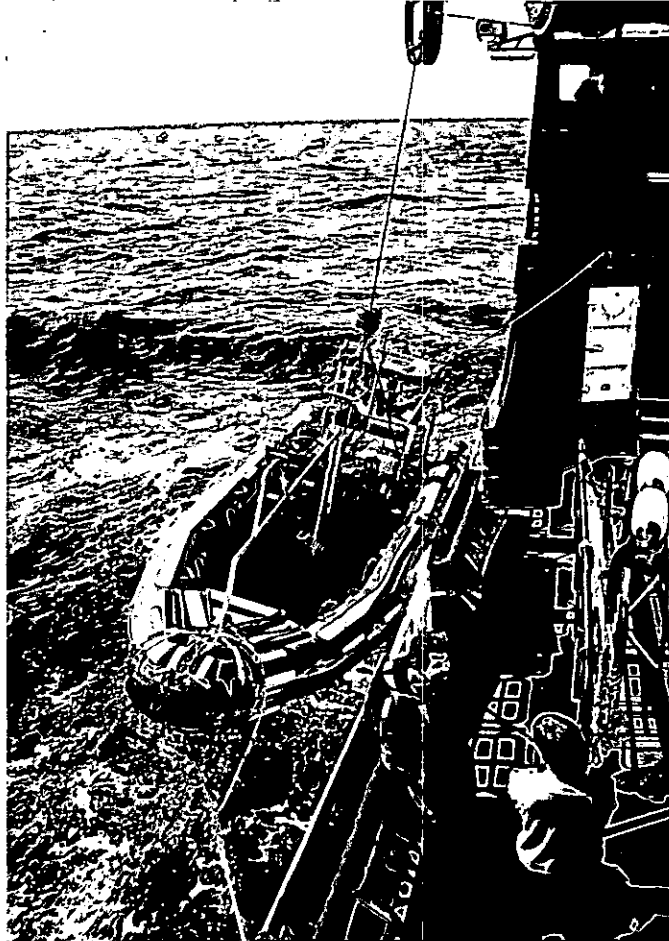
**FIG 10 FRC BOWSED AGAINST GUNWHALE**

The FRC recovery procedure adopted by ESVAGT is to have the SBV steam downwind with the wind on the port quarter with some 2 to 3 degrees of starboard rudder. This creates a lee on the starboard side for the FRC and the following seas tend to reduce the violent motion between the two vessels.

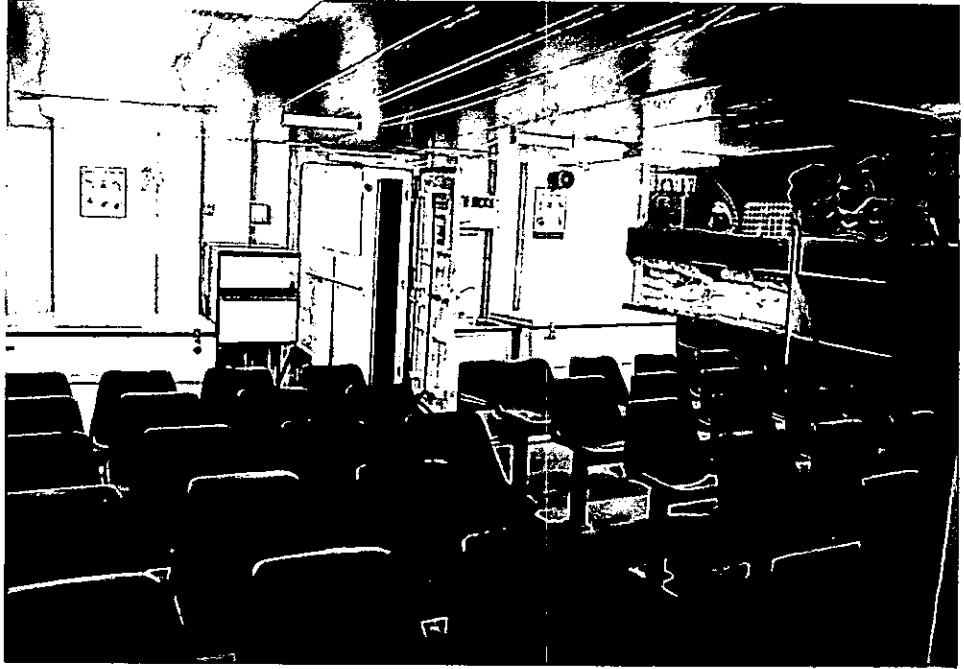
**FIG 11 SURVIVOR ACCOMMODATION**

The ESVAGT vessels had generally taken account of most of the above requirements. The survivor areas were deep in the vessel but were bright and warm with easily cleaned surfaces, though they had a somewhat stark and clinical atmosphere. A significant amount of bunk space had been provided, a further item was the provision of dry towels, 'woolly bear' suits and footwear for all survivors after they had showered. Wet clothing was put into the ship's tumble driers and returned to the survivors.

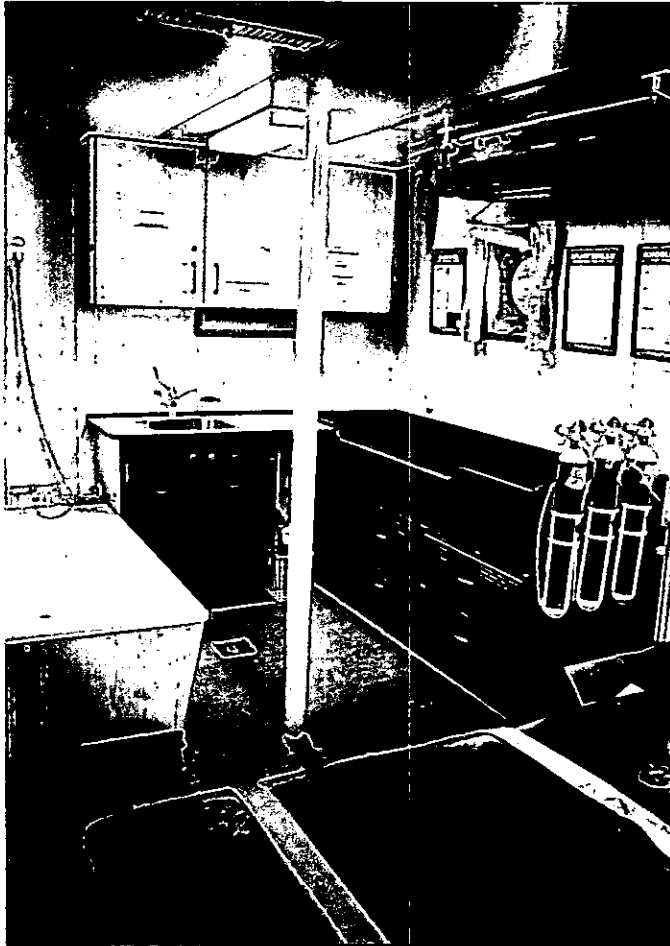
**FIG 12 TREATMENT ROOM**

ESVAGT have addressed some of the usual shortcomings by locating their treatment room near the entrance to the superstructure and providing a significant amount of bunk space in the survivor area. Nevertheless, transfer from the rescue zone to the treatment area generally follows a tortuous route when their vessels are secured for heavy weather. The re-warming bath in the treatment room is well situated; but only one survivor can be re-warmed at a time. Hot showers are available both adjacent to the treatment room and on the lower deck near the survival area. Showers, however, have been shown to be ineffective for safely re-warming hypothermic survivors.

There are clearly limitations in what can be achieved in terms of re-warming severely chilled survivors in a vessel at sea. However, some further thought could be given to transferring incapacitated survivors to an effective treatment facility in heavy weather. It is unlikely that a multiple re-warming facility using waterbaths can be provided on a SBV. Some thought should be given to alternative techniques, eg the use of hot water or electrically heated suits and survival bags similar to those used in the diving industry.
