**Summary of fibre concentrations
In CLASP construction schools containing asbestos.**

HSL/2007/22

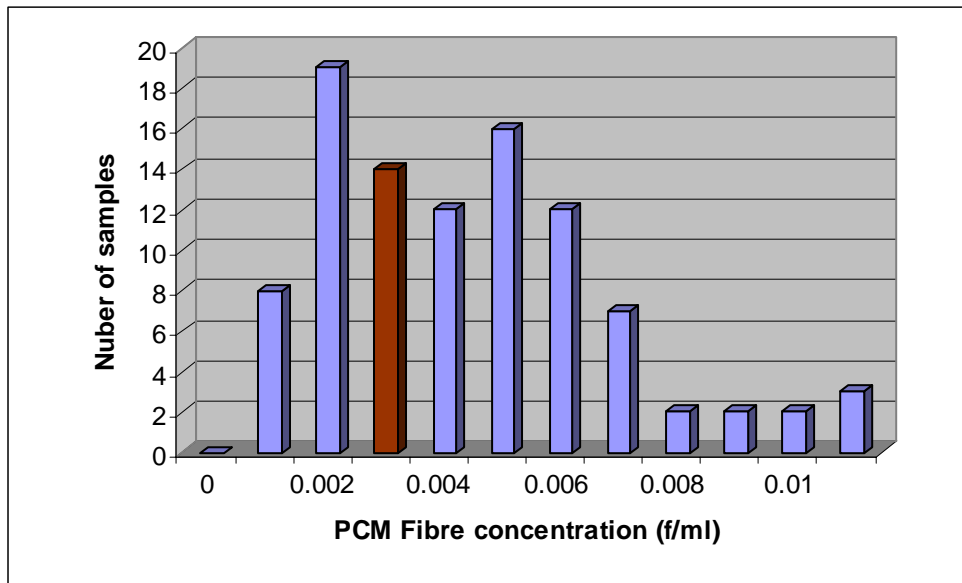
Figure 2: PCM fibre concentrations in reoccupied classrooms during normal use after remediation. (Nearly all volumes sampled were ≥ 480 l and 200 graticules counted, the different coloured column at 0.003 f/ml represents the upper 95% value expected for blank counts).

Figure 2 summarises 96 samples of PCM fibre concentrations measured after the classrooms were reoccupied and in normal use. Clearly there are some additional releases of airborne fibres but there are a number of sources of non-asbestos fibres (e.g. paper fibres, fine organic fibres) from the presence and activities of the occupants. These are compared in figure 3.

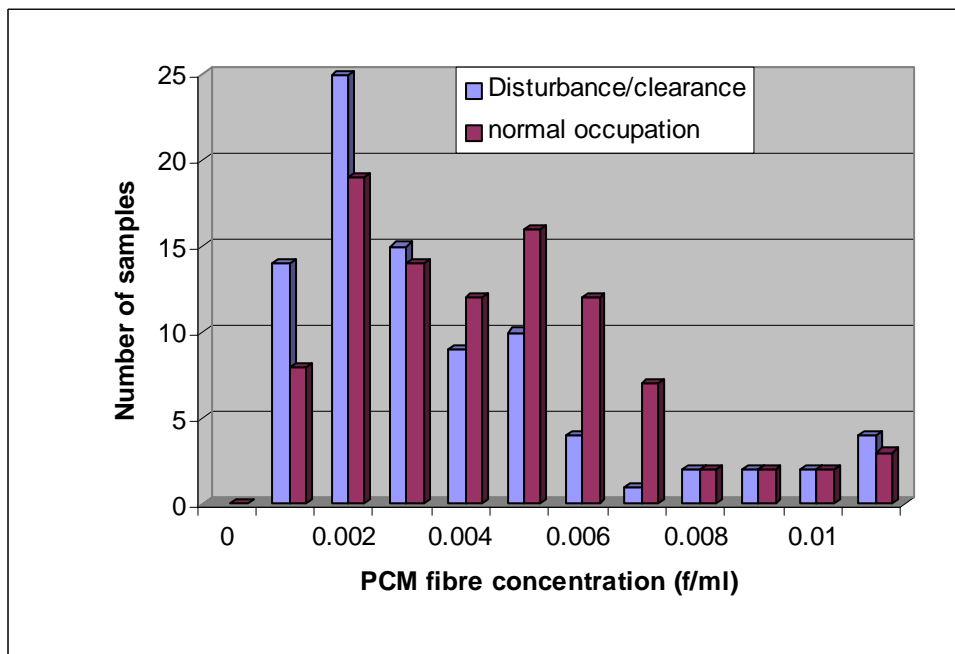
Figure 3: Comparison of PCM fibre concentrations between disturbance testing and reoccupied rooms after remediation.

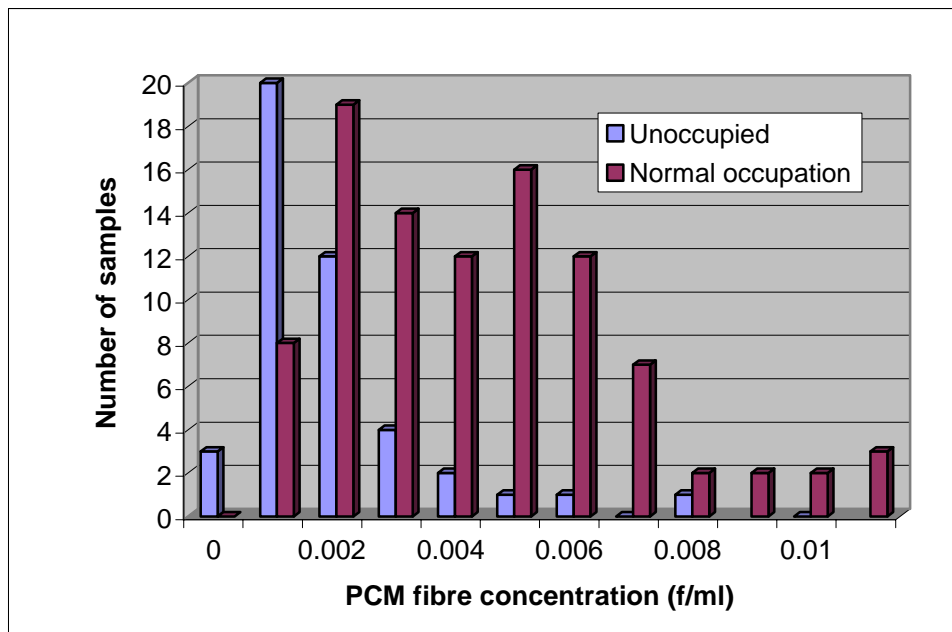
Figure 5: Comparison of PCM fibre concentrations between unoccupied and reoccupied rooms after remediation.

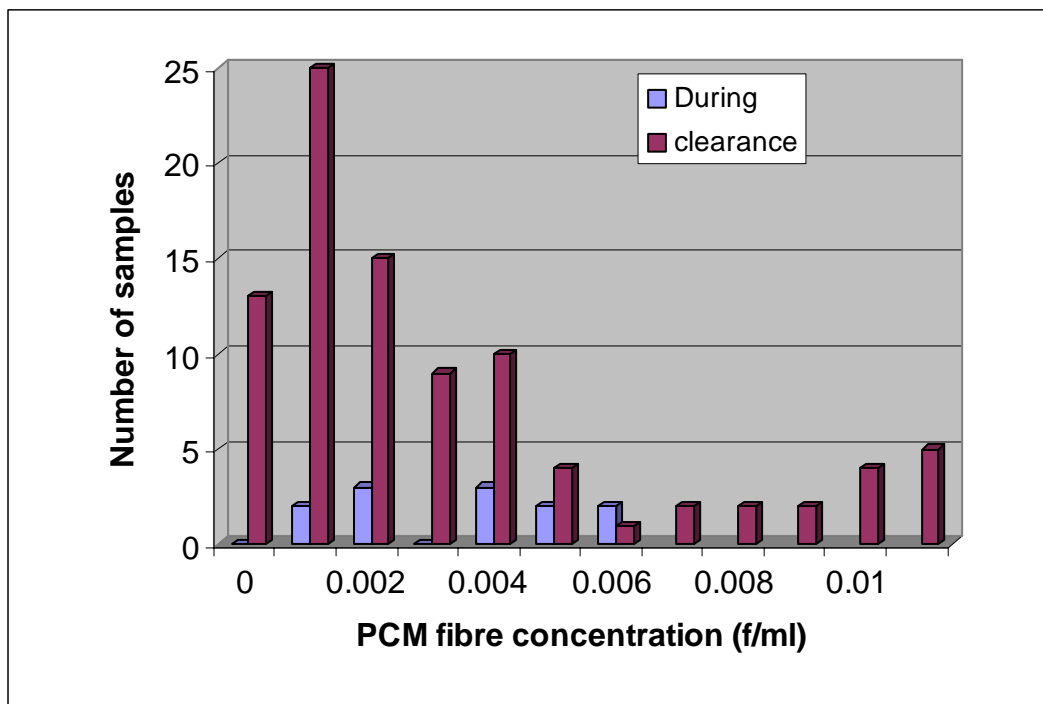
Figure 6: Comparison of PCM fibre concentrations during full remediation and sealing of the columns with disturbance/clearance testing.

Only a limited amount of data was available during the full remediation of columns and is compared with the results during the disturbance/ clearance testing in figure 6. However, HSE's interim advice was to seal the vertical seams of the column and to leave the sealing of the tops and bottoms to a later date. Although this advice was given for pragmatic reasons (e.g. speed and minimal disturbance) PCM results during this partial sealing are available and are summarised in figure 7.

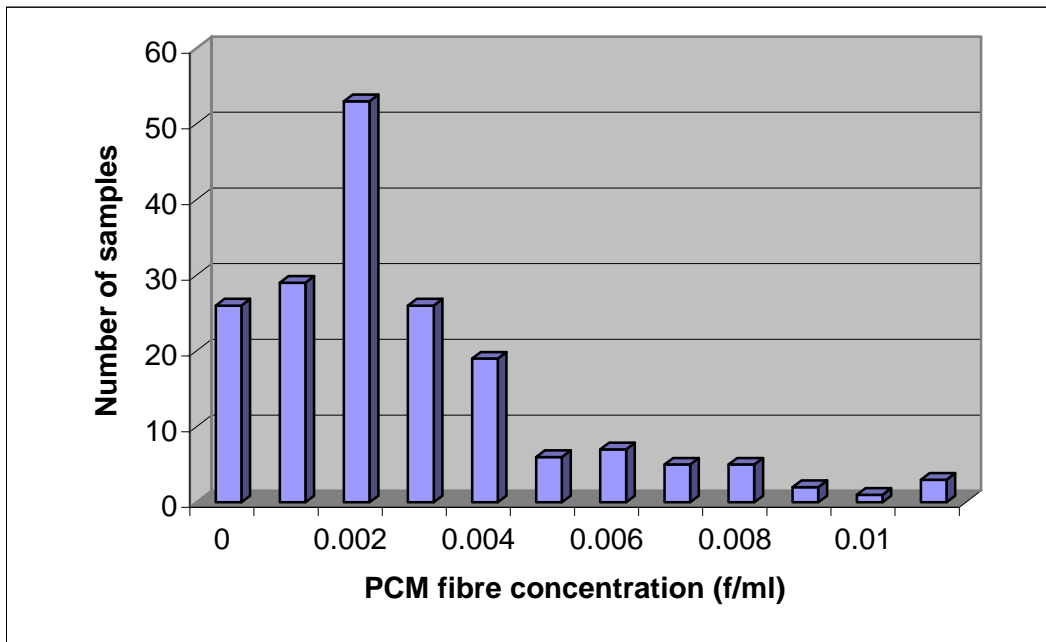
Figure 7: PCM air monitoring results from 188 samples taken during the taping of the vertical seams of the columns and surrounding joints.

The partial sealing involved taping of the seams only, so the column casing was being firmly pressed against, as the tape was unwound. This flexing of the casing would represent moderate normal contact with the columns such as leaning against them. The results in figure 7 are based on 188 individual PCM samples.

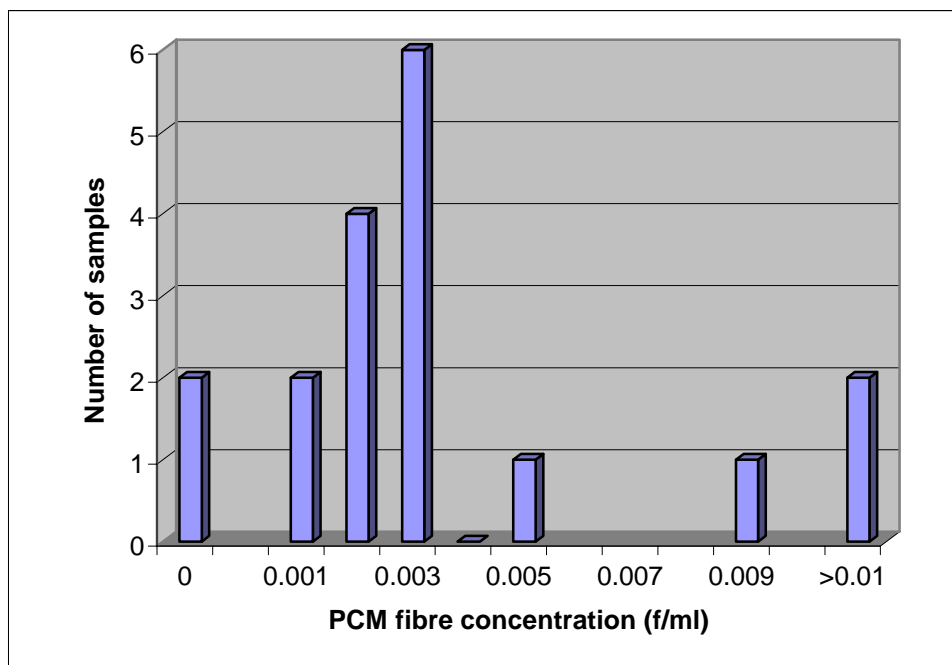
Figure 9: Distribution of PCM fibre concentrations from inspection of the site and ceiling voids.

Figure 9 gives the PCM results from 20 inspections of the site and ceiling area; two samples exceeded 0.01 f/ml showing that there are raised levels of fibres in some. Only two samples for simulated maintenance work above the ceiling are available to date (0.04 and 0.05 f/ml) and showed that there were measurable releases of PCM fibres.

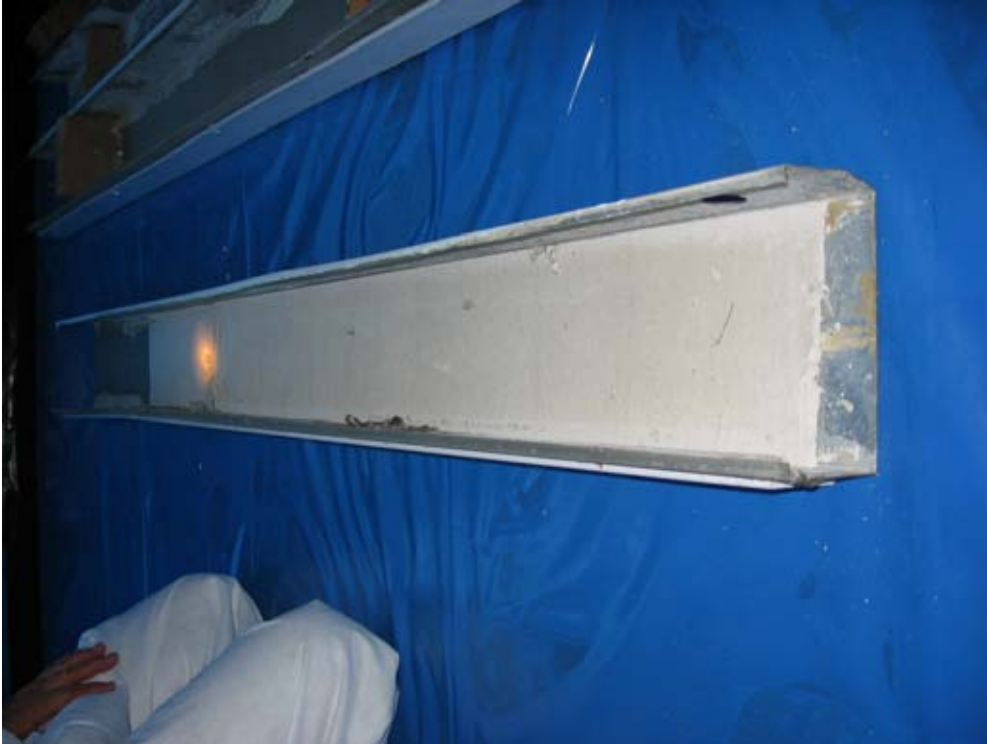
Figure 10: Example of a column casing with AIB attached to one side of the casing. The torch beam shows where the AIB has fractured due to a screw being placed into the casing. A hole is visible in the side of the casing and visible debris shows that friable material was present.

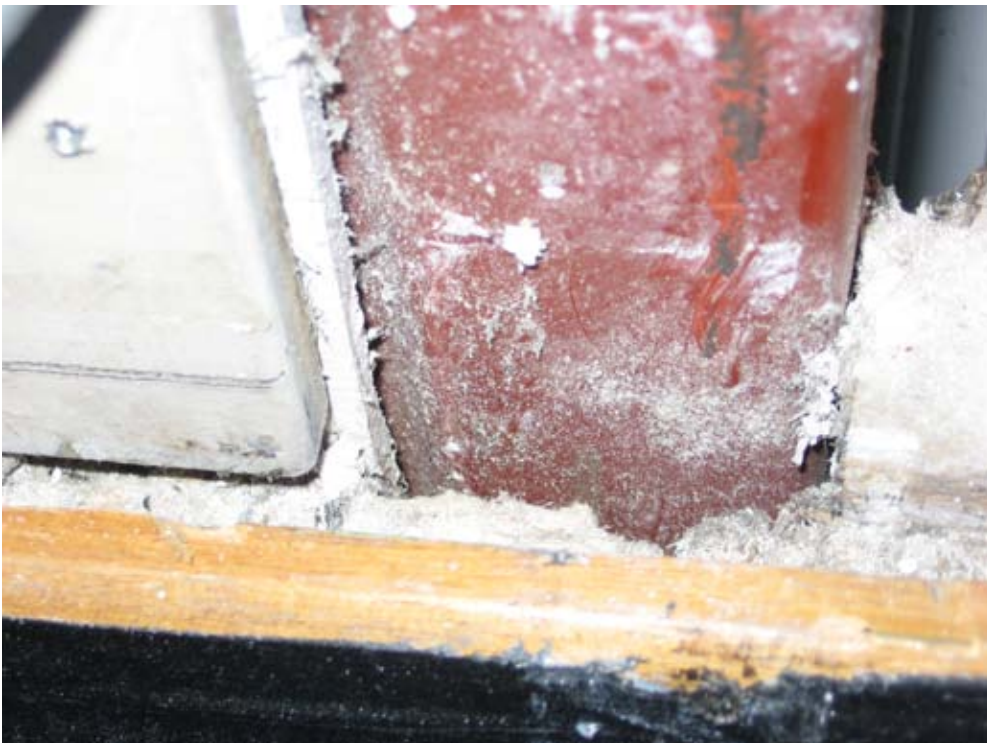
Figure 11: View of base of column from which the casing in figure 10 was removed. A large amount of friable AIB debris can be seen.

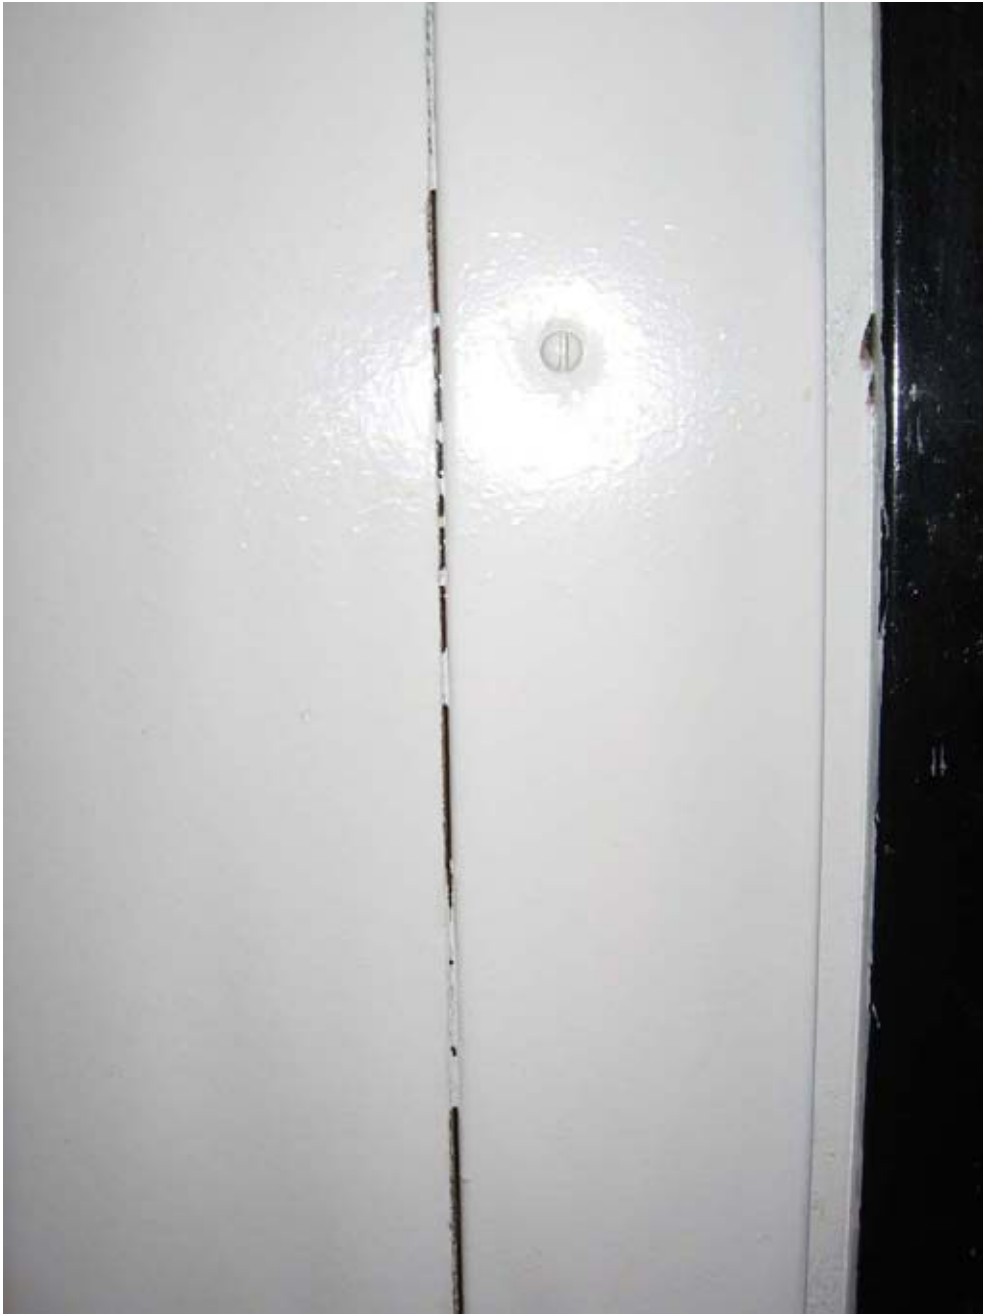
Figure 12: Example of a gap in the casing.

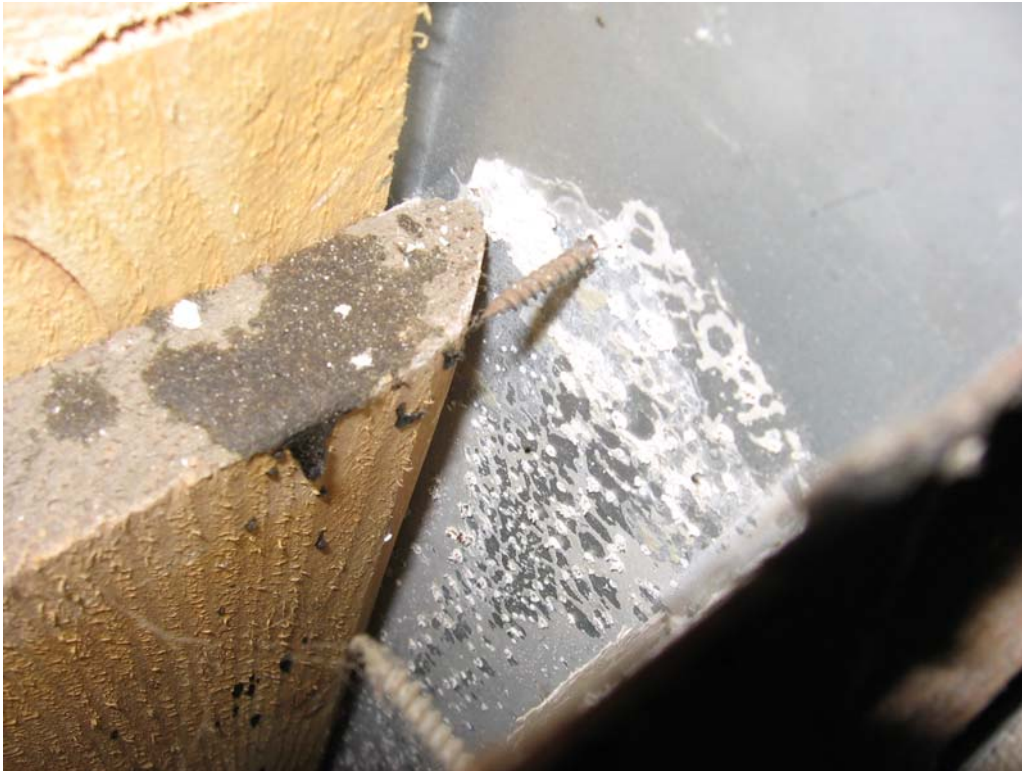
Figure 13: Example of asbestos debris from pieces of AIB that was glued onto the casing but had been torn off at some time. View down the column from above the suspended ceiling.

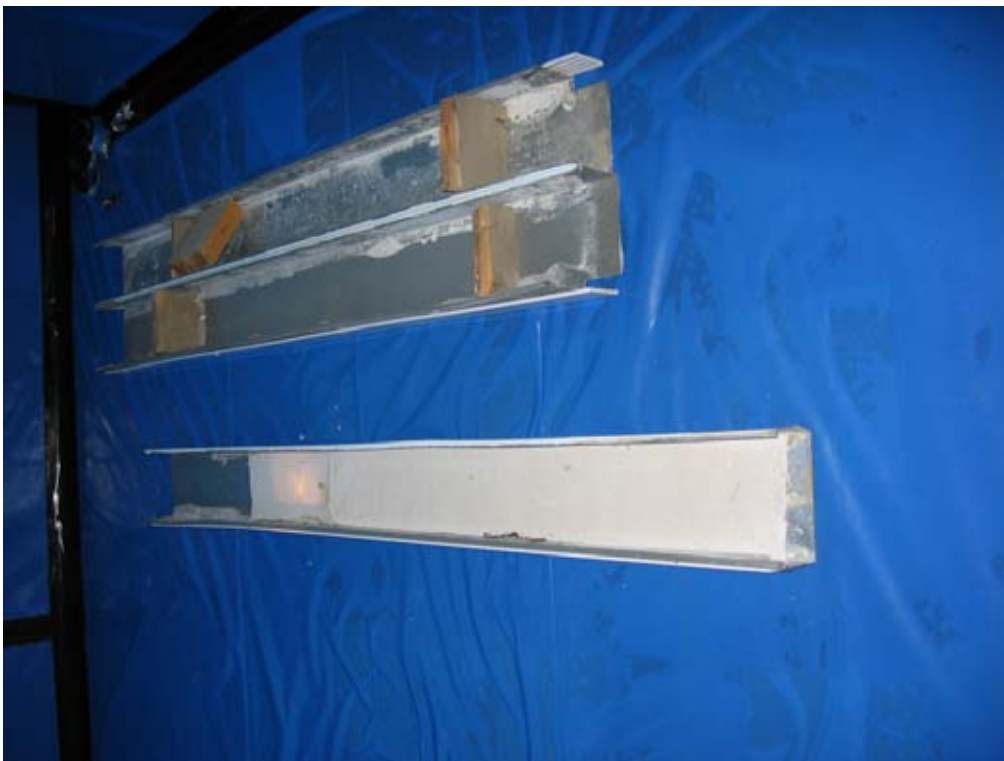
Figure 14: Example of casings removed from columns showing where AIB had been removed or left in place.
