TULLIS RUSSELL PAPERMAKERS

Removal v's Encapsulation

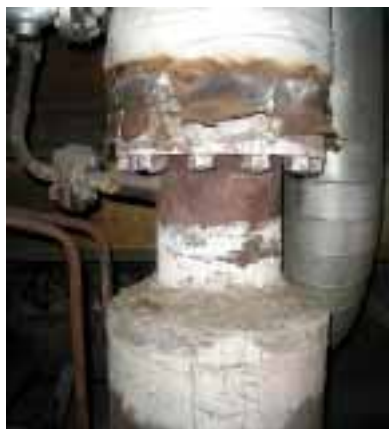
Photo: heat damage to recent asbestos encapsulation

- Asbestos in particularly poor condition.
- Major renovation of area or modification/renewal of equipment.
- Levels of heat/vibration that can damage asbestos encapsulation creating a safety hazard and incurring frequent repeat encapsulation costs.

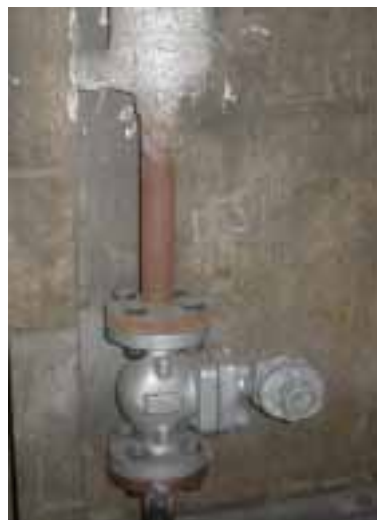
Photo: access is required to maintain the valve, therefore asbestos lagging has been removed from working area.

- Used where a particular section within a wider area is problematic. Typically where asbestos is likely to be damaged by access or maintenance requirements.

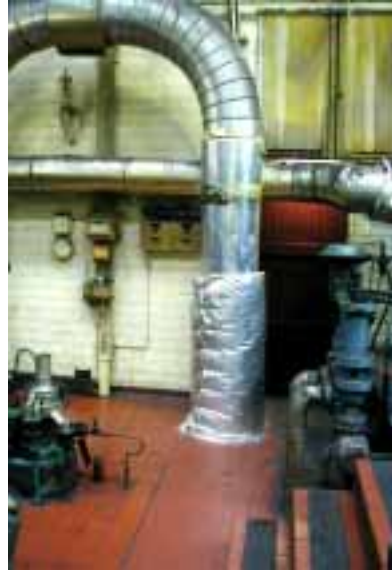
Photo: Aluminium cladding above and to the side of a pedestrian access route where there is a higher likelihood of impact damage.

- Aluminium cladding is commonly fitted over encapsulated asbestos to provide additional protection in areas where there is a likelihood of impact damage. These areas tend to be the populated working areas. The disadvantage of this option is that it is difficult to monitor the condition of the asbestos within the cladding.
