When Isolations go WRONG

Andrew Hall HID CI 1G

HM Specialist Inspector (Mechanical)

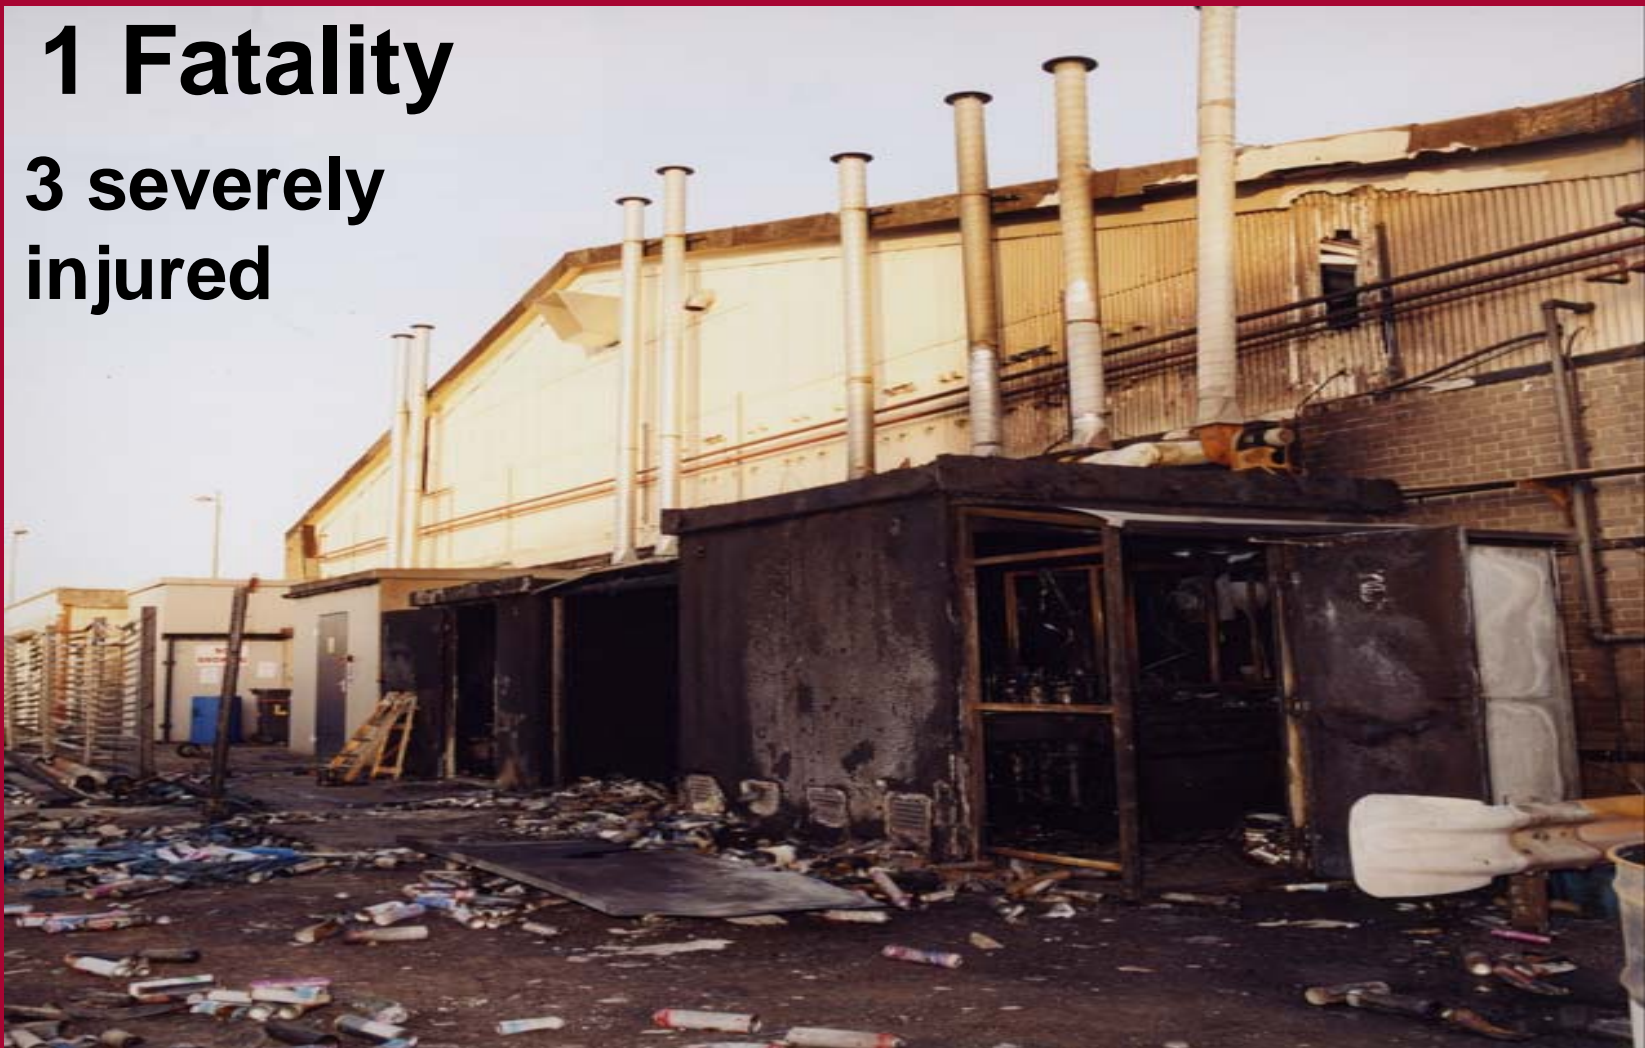
Fire at North West Aerosols Ltd, Liverpool

1 Fatality

**3 severely
injured**

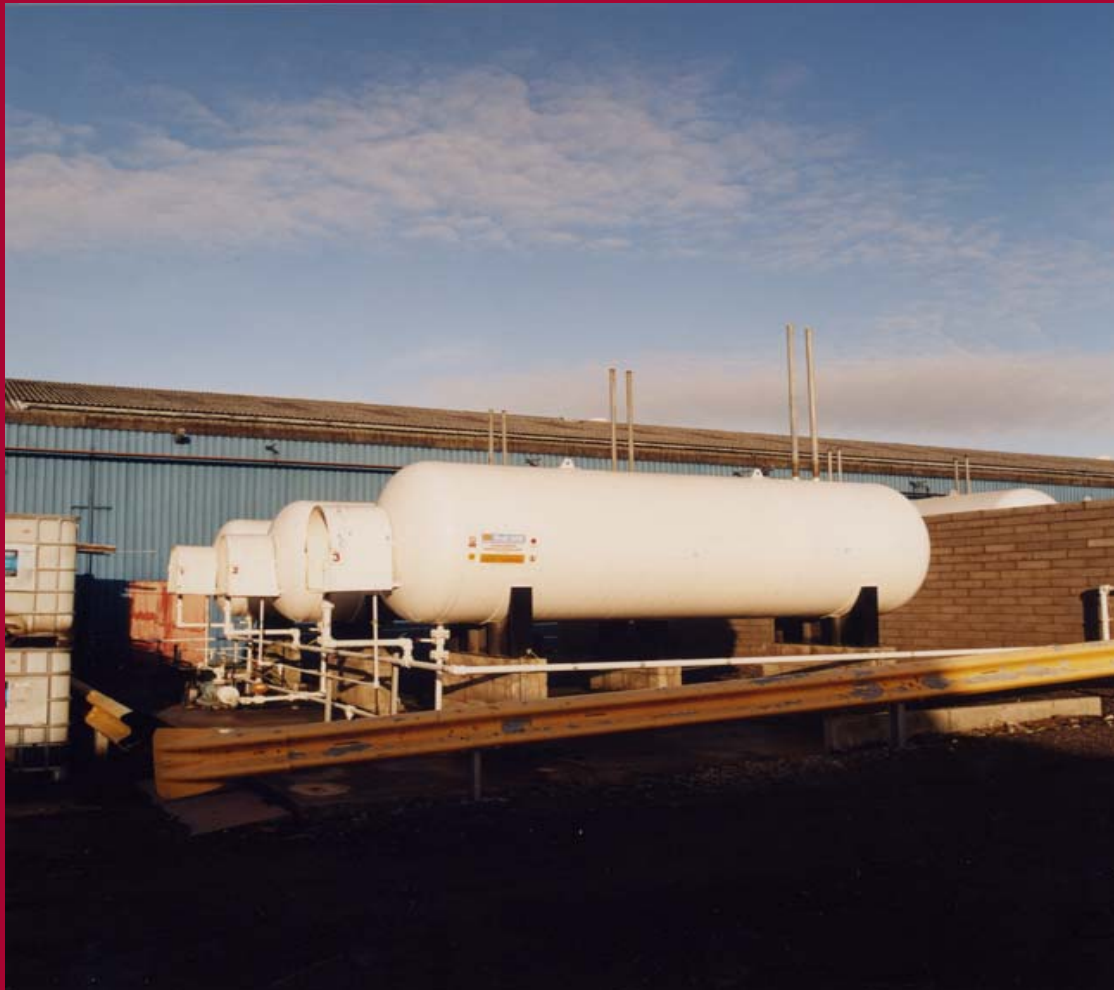
The site had 5 x 9000 litre LPG bullets feeding any 1 of 4 gas houses used to fill aerosols with LPG propellant

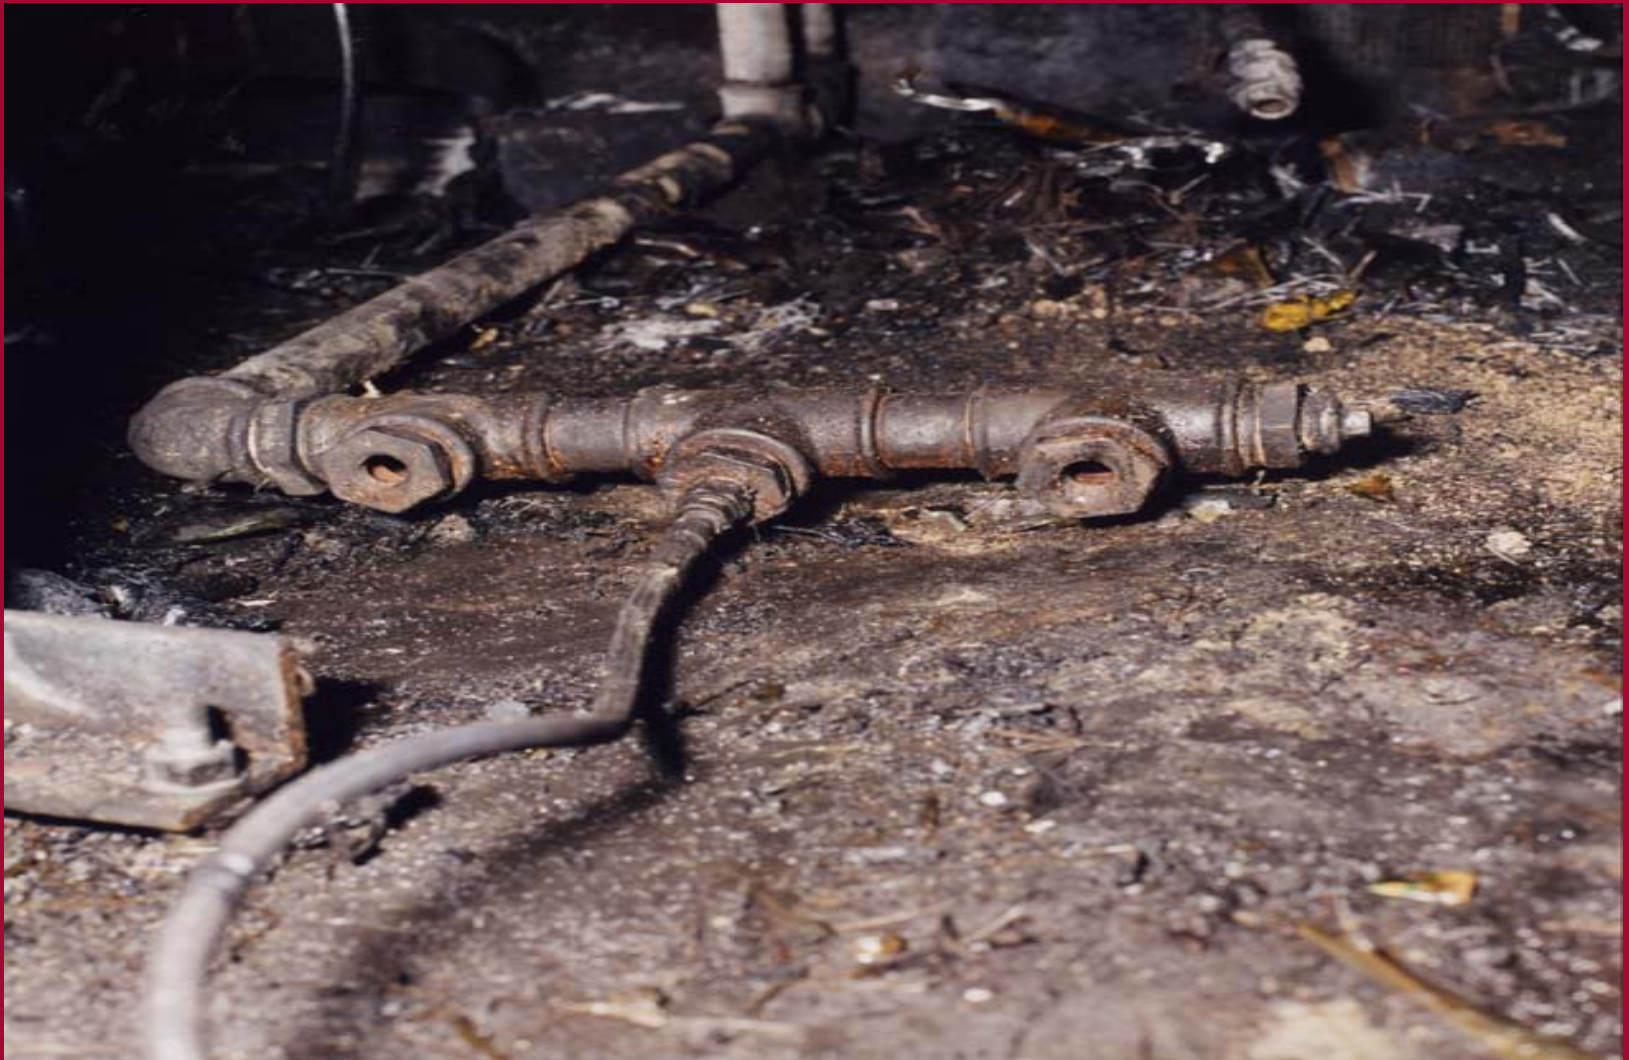
Unblanked LPG Supply Manifold

- Gas house 1 had been isolated from the LPG supply to use compressed air for filling aerosols
- The LPG manifold connections used to supply LPG to the filling lines were only isolated by a pneumatically operated control valve
- The only other valve on the line was a manually operated ball valve that had been left open
- The LPG supply manifold pipe work had not been blanked off as per BAMA recommendations (self seal, quick release couplings) representing good practice

- Overriding the safety interlocks on the control panel to access internal wiring
- Tripping control circuits at their own discretion
- They shorted and activated the pneumatic valve on the LPG supply line thereby supplying LPG at 250 kg/hr to gas house 1 via the two unblanked manifold ports.
- The LPG entered the plant, found an ignition source, ignited and caused a flash fire that then spread throughout most of the plant.

- MAH's are prevented by layers of protection - Some were in place but others were not:
- Gas detection was thought to be non-functional
- Control valves were defeated - (HS(G) 253 recommends that control valves are not generally suitable for isolations)
- No end caps on manifold
- Manually operated valve left open
- Line change-over procedures were not followed
- No specific isolation procedure

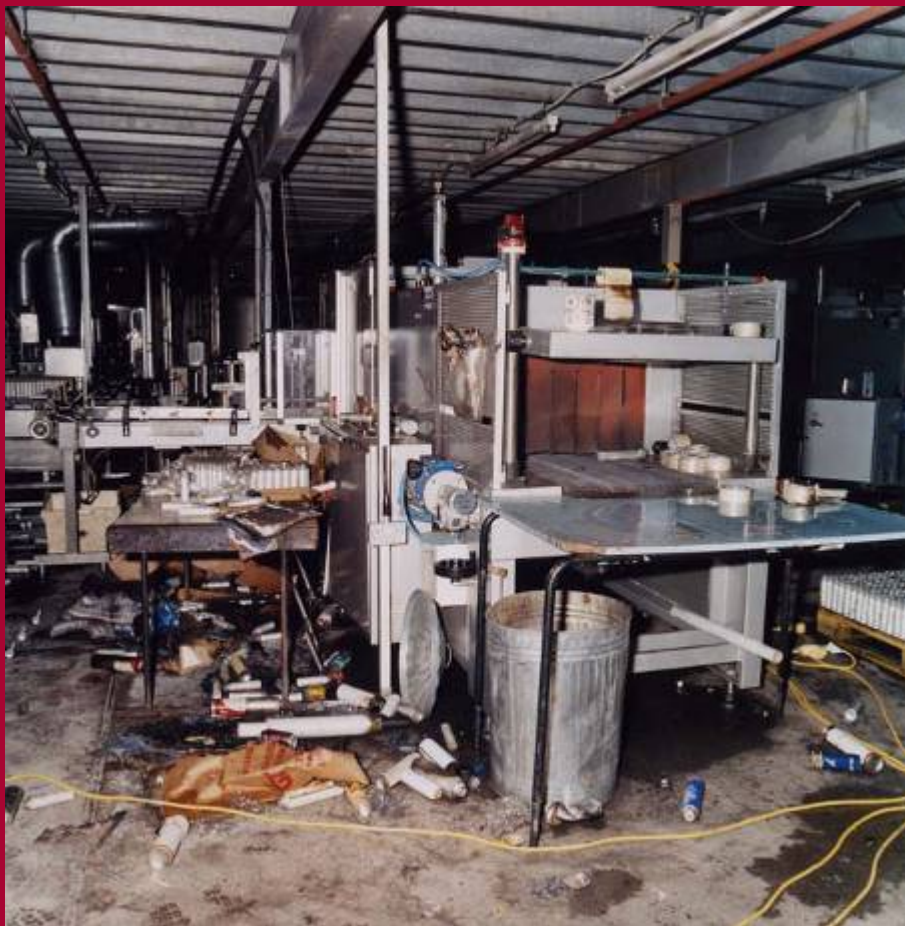
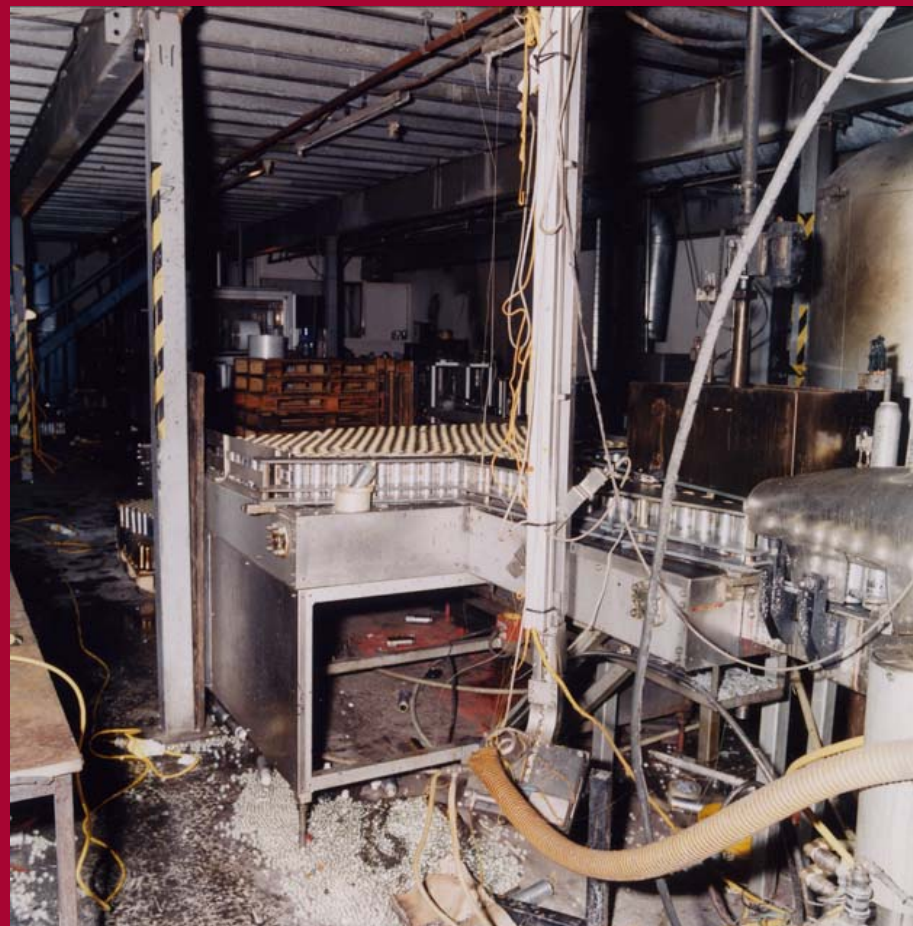
Internal Plant Fire Damage

- The fire destroyed two of four gas houses associated with their aerosol filling lines
- The factory production area was also fire damaged
- 1 FATALITY
- 3 other employees severely injured
- **It is thought the external location of the gas house prevented further fatalities**

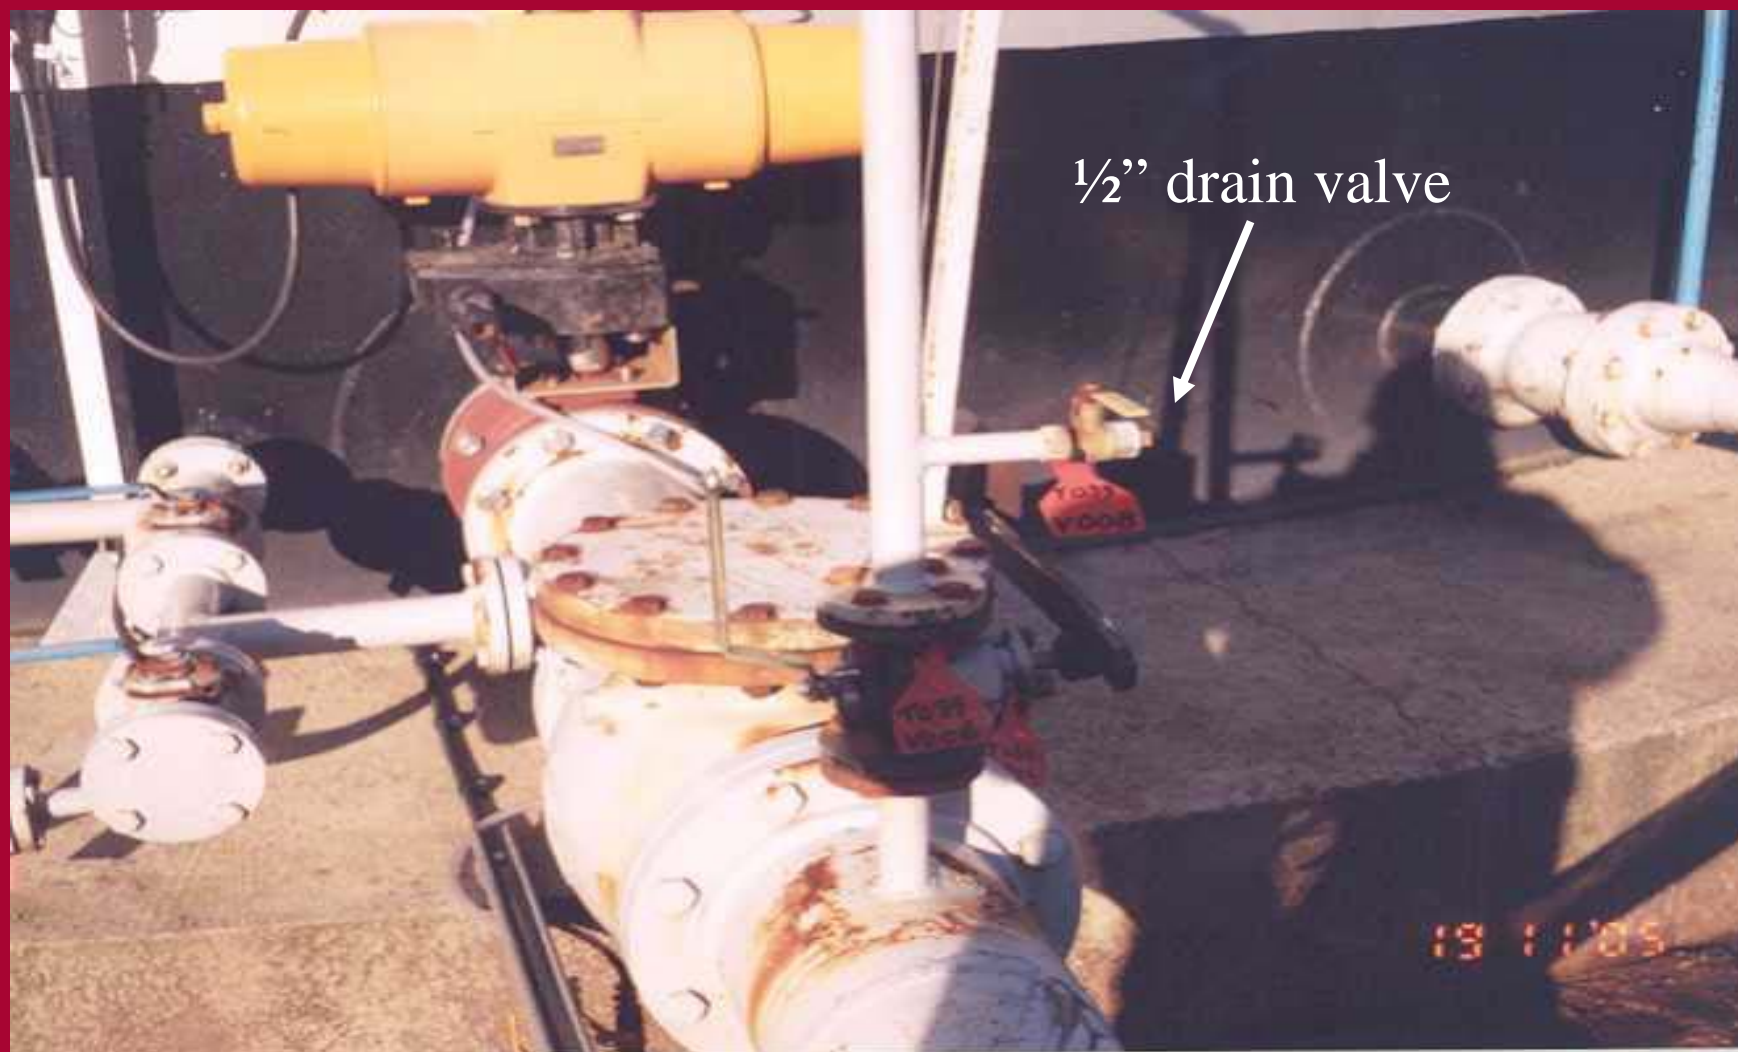
Open 1/2 " Drain Valve

- Loss of Containment of 20 to 35 te of Methanol when filling tank - ship to shore
- This incident had the potential to be a COMAH major accident
- 1/2" drain valve had been left open and unplugged after maintenance work to fit a ROSOV and new valve on a thermal relief line

- Human error, inadequate management systems and inadequate safe system of work
- Work authorisation was poorly completed, with no details of valves to be replaced, tank isolations, reference to drawings P&ID's
- Method statement for work raised without training - It did not identify the isolation of valves or checks to return the system to a safe condition
- The completed permit was not signed off as being completed. Despite the permit remaining open for work to be carried out on the tank, the site permitted the filling of the tank from the ship

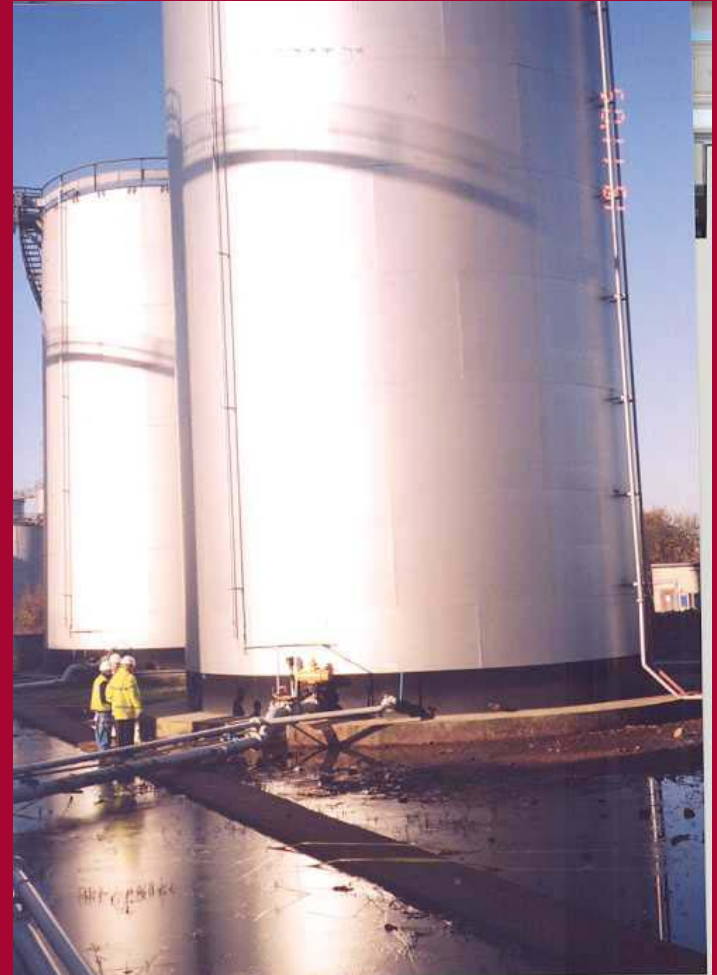
Methanol Storage Tank

The site failed to identify that the methanol was pouring into the bund for approximately 25 hours

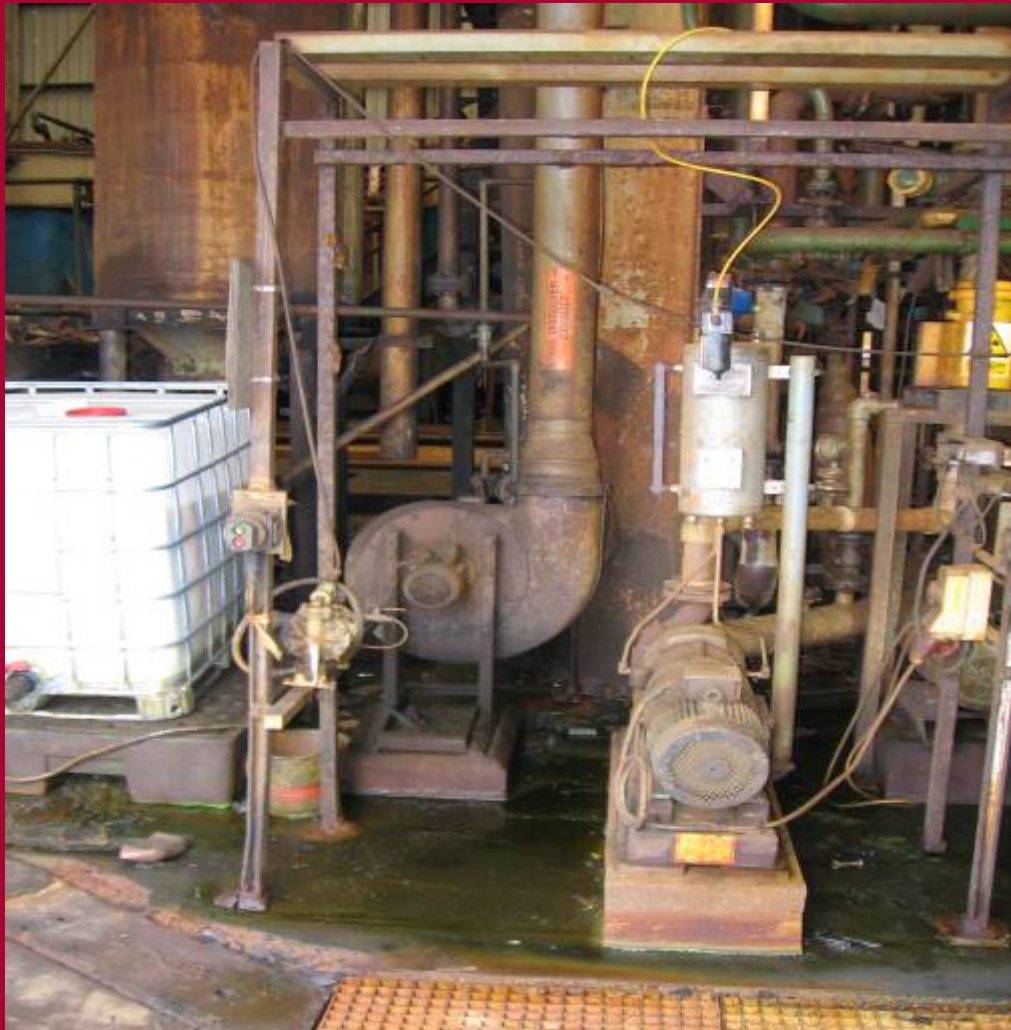
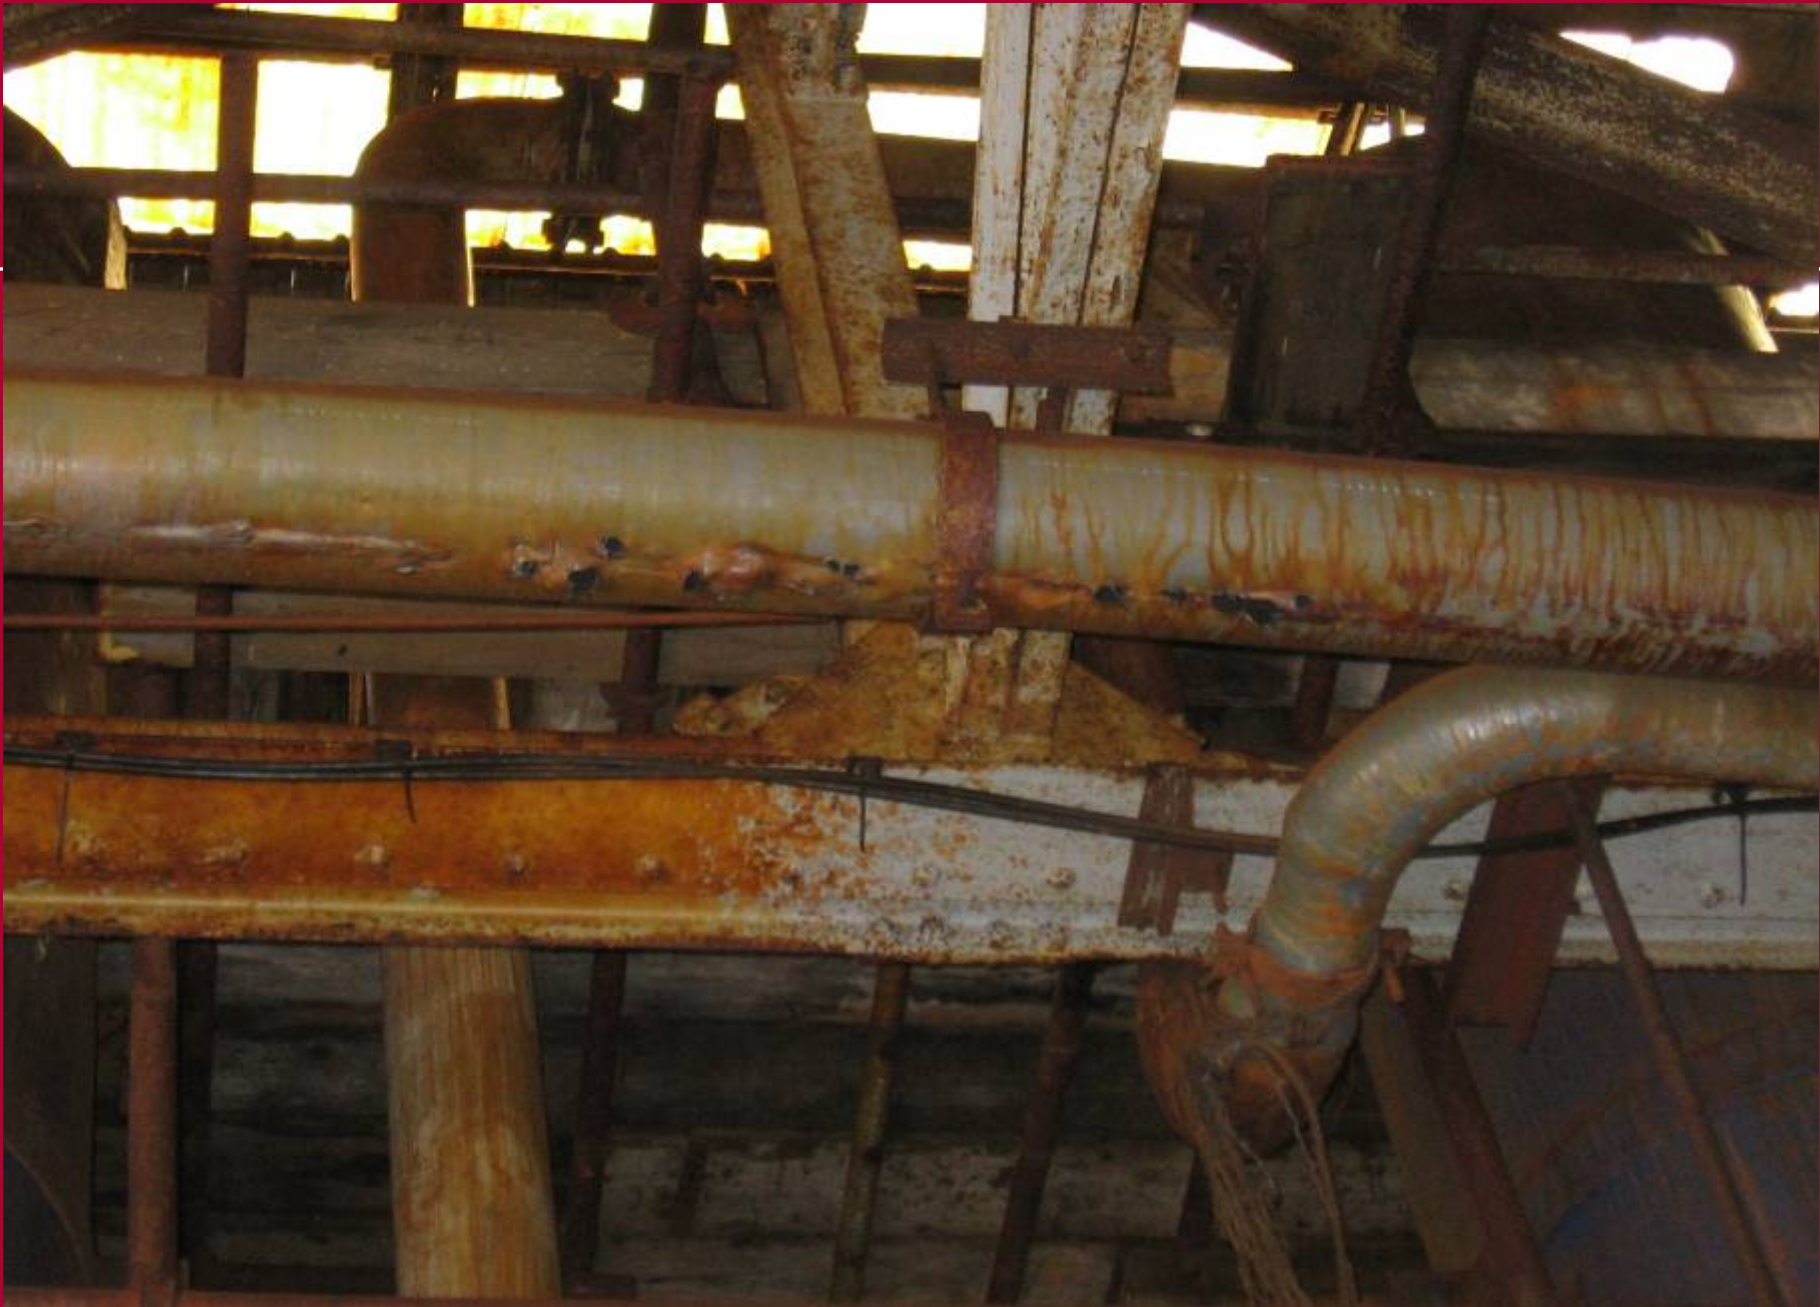
Fan Housing

- The gas vented into the plant from the fan housing

- The gas exothermically reacted with hydrocarbon deposits in the ducting causing a small fire
- Estimated LoC was 50kg/hr Chlorine Gas over a 21 minute period

- The manually operated isolation valve should have been closed
- The power operated shutoff valve was confirmed faulty after the incident and was passing
- Vent system had only been designed for hydrogen and air

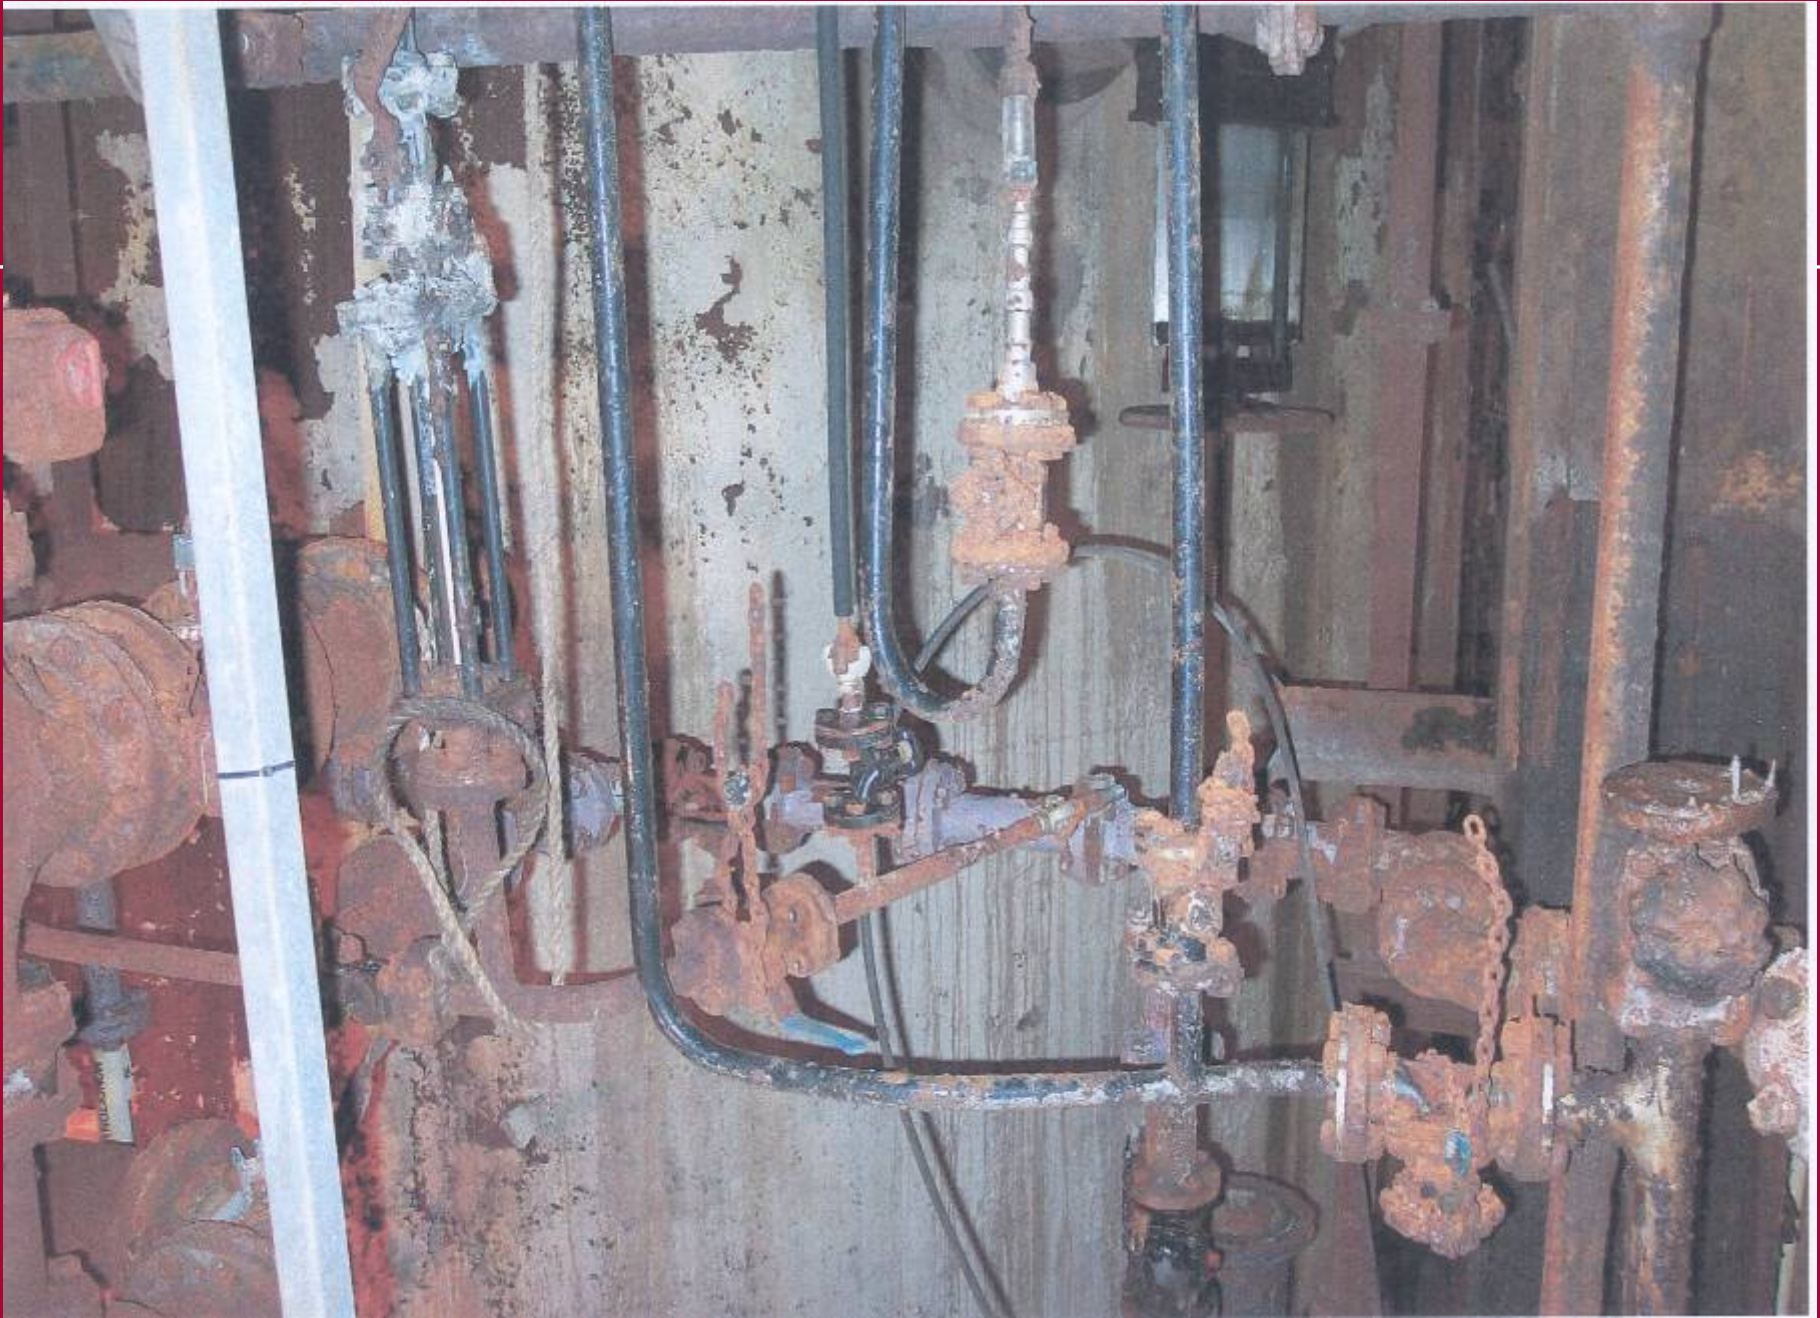
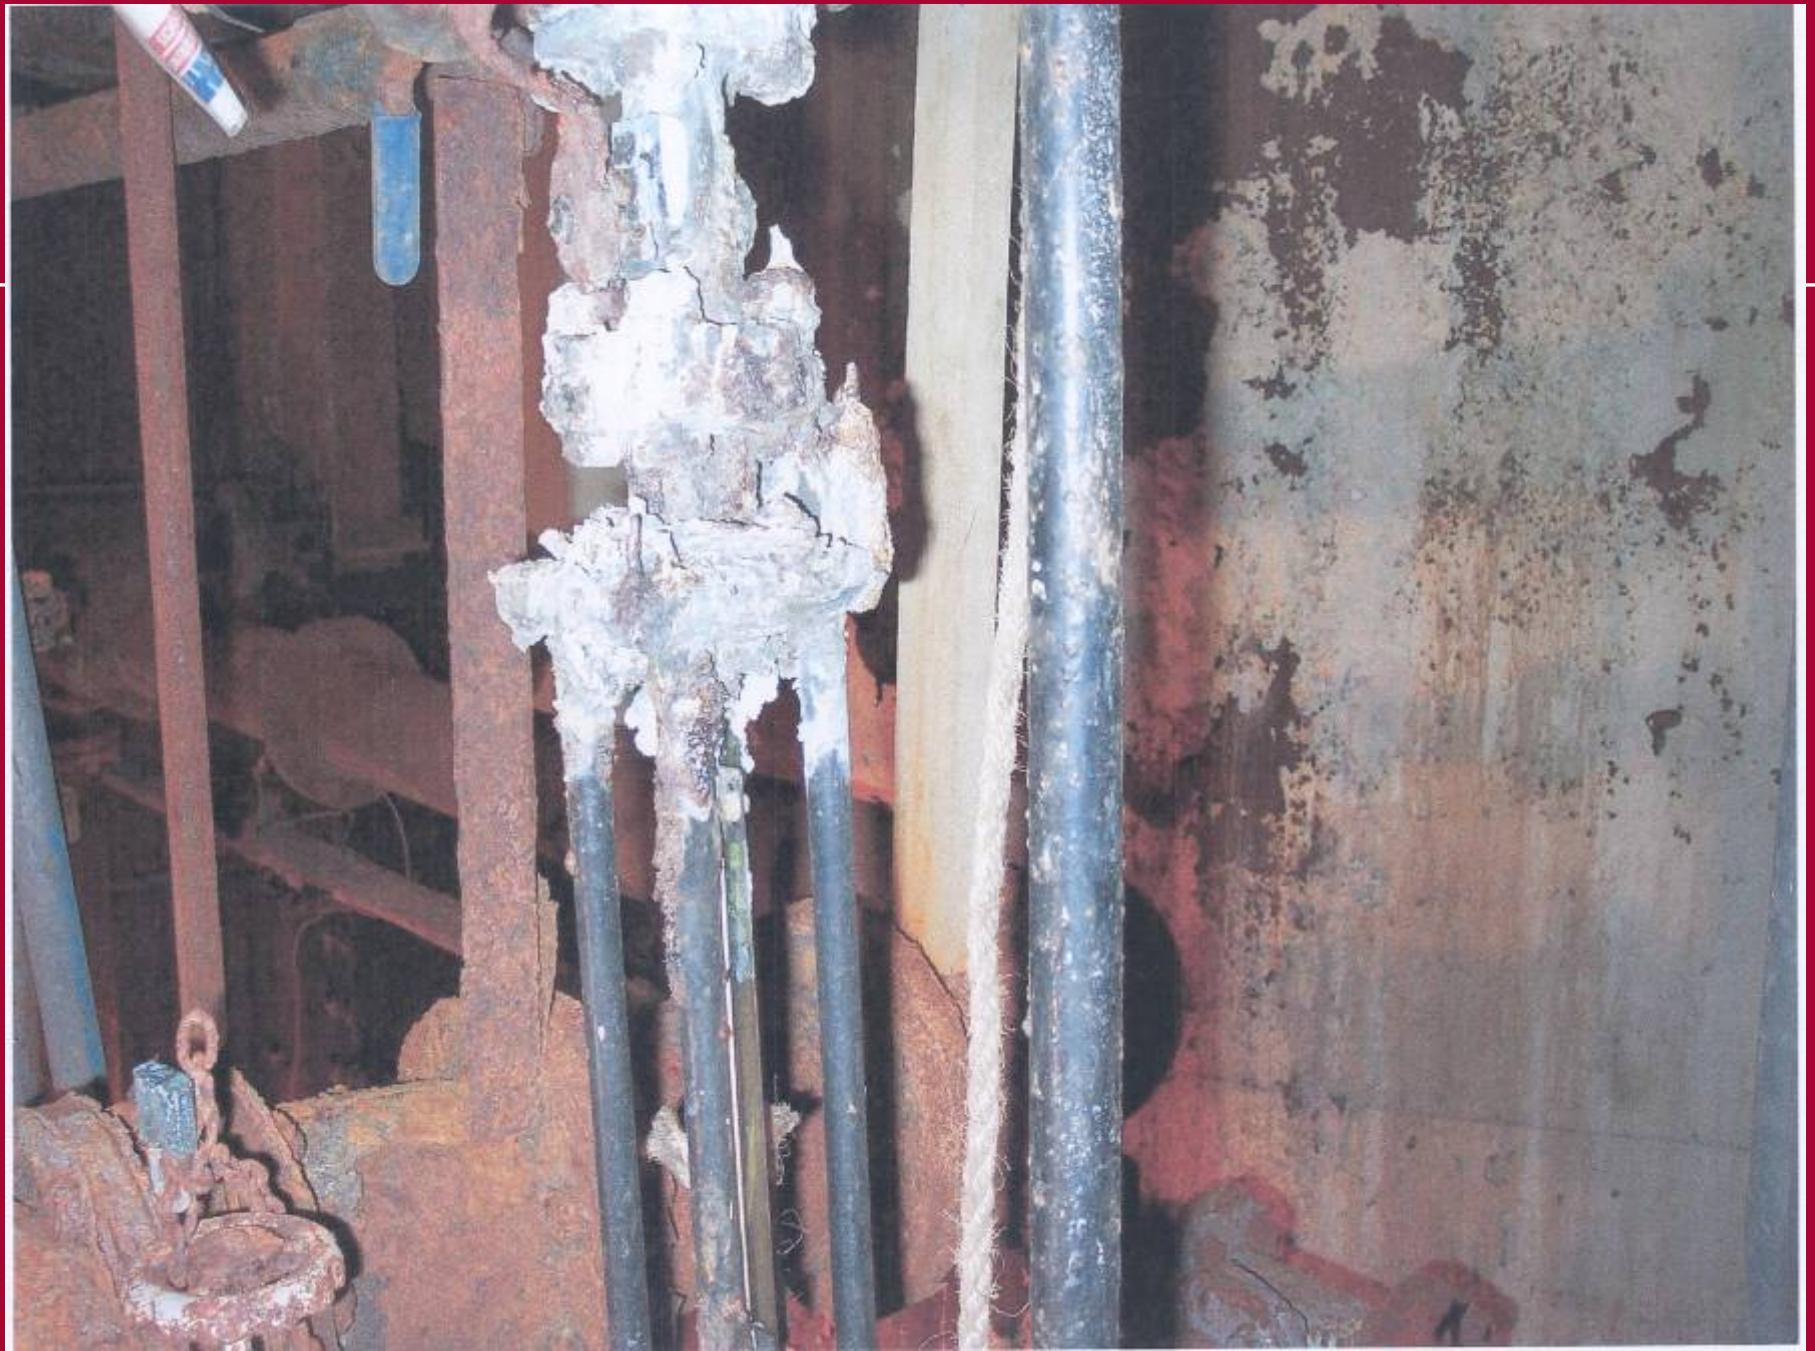
- This incident related to a failure to isolate redundant pipework
- The incident started with a pipe blockage resulting in a loss of additive to a crude liquor system
- A hot water line was connected to back-flush the system
- As the hot water was turned on a jet of ammonia liquor hit the operator in the face from a redundant rotometer when the gauge glass failed from thermal shock

- The rotometer had been redundant for over 6 years but the unit and redundant pipework had not been effectively isolated or removed
- The rotometer was not designed to withstand hot product / water
- MoC relating to a modification had not considered this scenario
- Redundant pipework was capable of reconnection
- Inadequate PPE (no safety goggles)

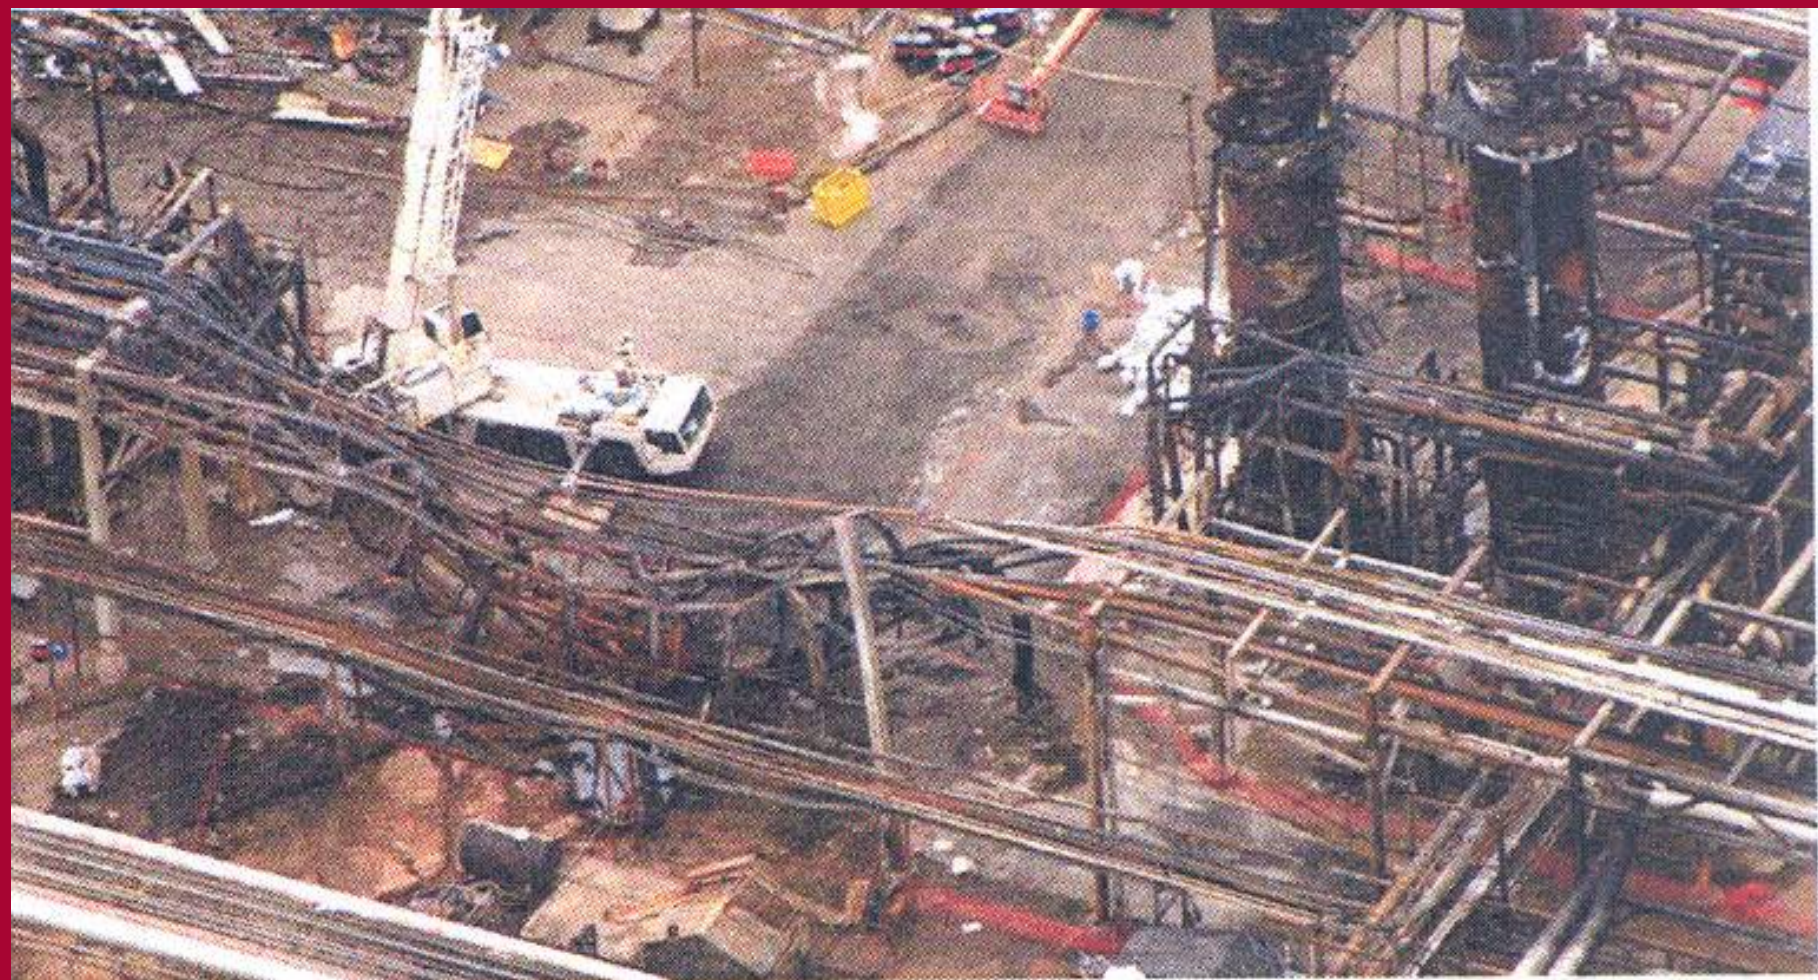
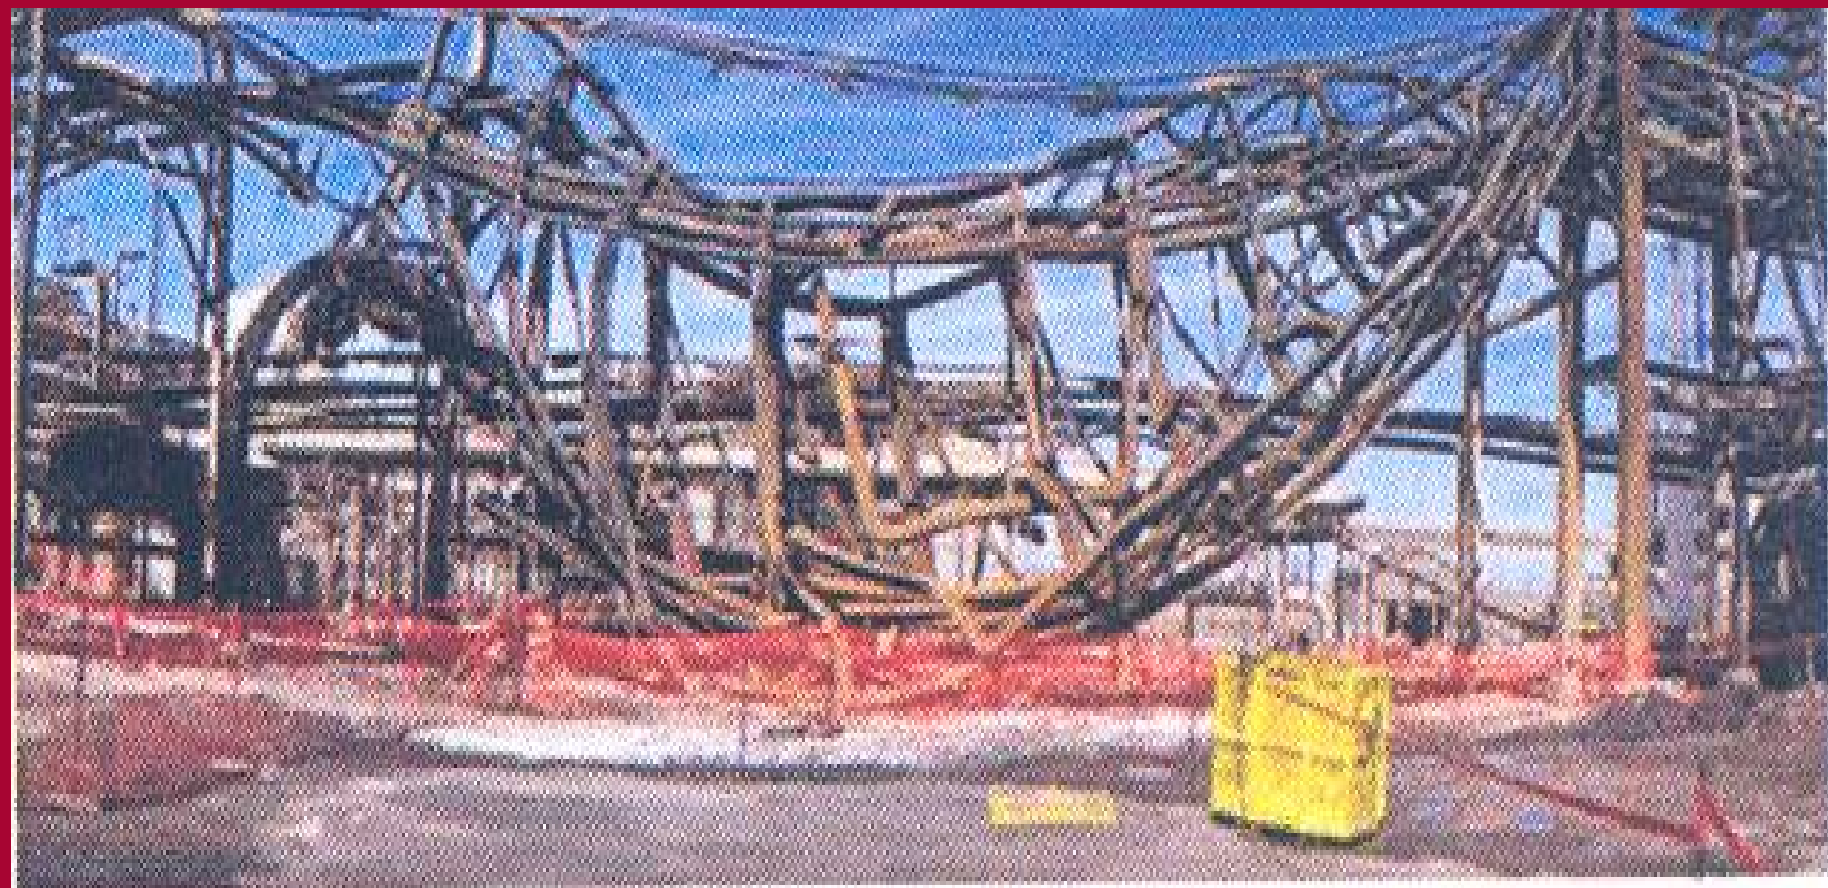
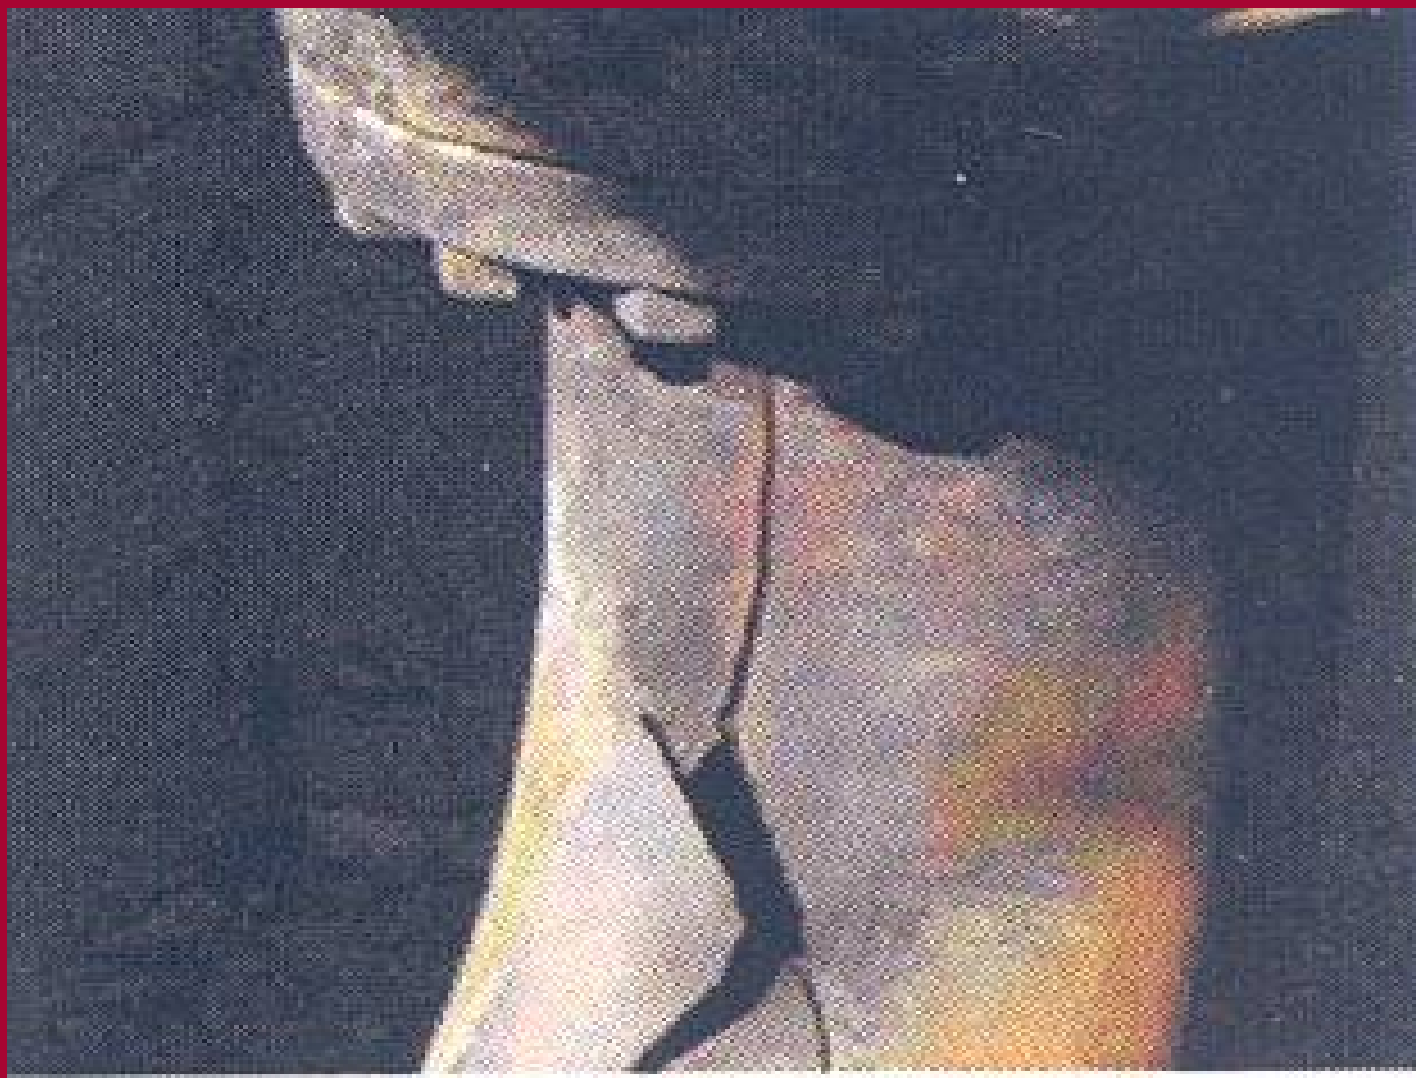
- A large flammable vapour cloud formed, found an ignition source and ignited

- Four persons injured
- Refinery was evacuated
- Refinery shut for 2 months
- Major fire damage to that plant
- Major fire damage to other plant releasing other flammable materials
- 2 te of chlorine was also released to atmosphere from fire damaged containers

- Make sure all process modifications including removal of piping from service undergo a MoC review
- Make sure all equipment in your plant is either physically disconnected from active equipment and piping
- OR
- By using spades or other reliable isolation methods
