When Isolations go WRONG

Andrew Hall HID CI 1G

HM Specialist Inspector (Mechanical)

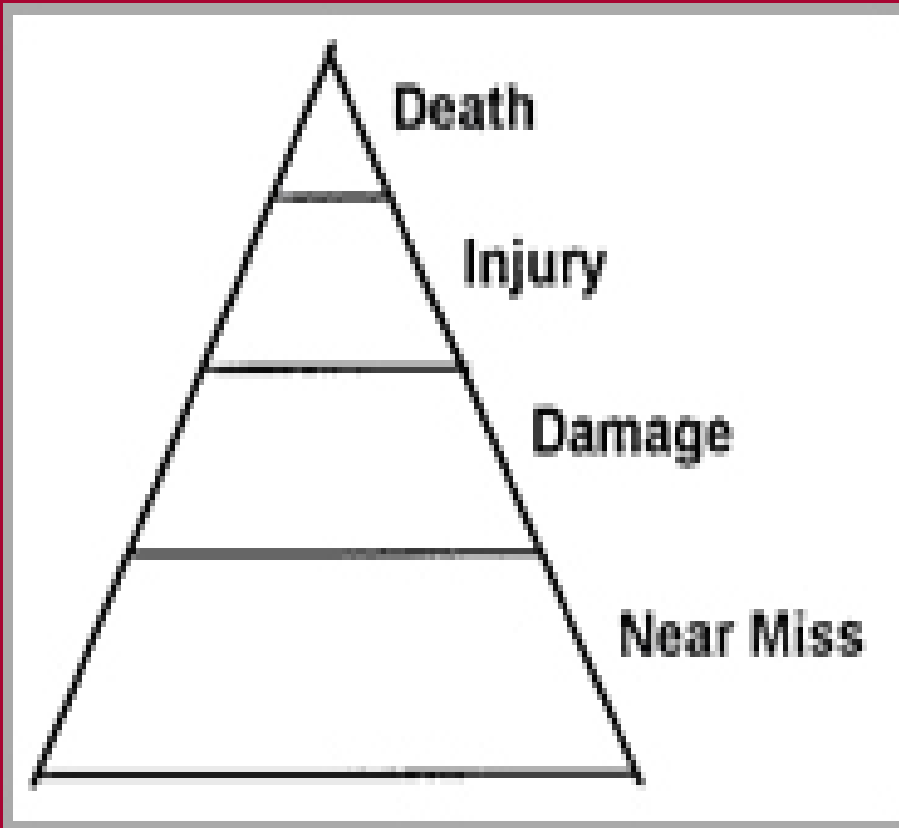
Accident Triangle

The greater the incidents in the bottom half of the triangle the greater the likelihood of an accident in the top half of the triangle, e.g. Injury or Death
