3663 First for Foodservice

Reduction in accidents thanks to vehicle changes

Reducing falls from vehicles case study 3

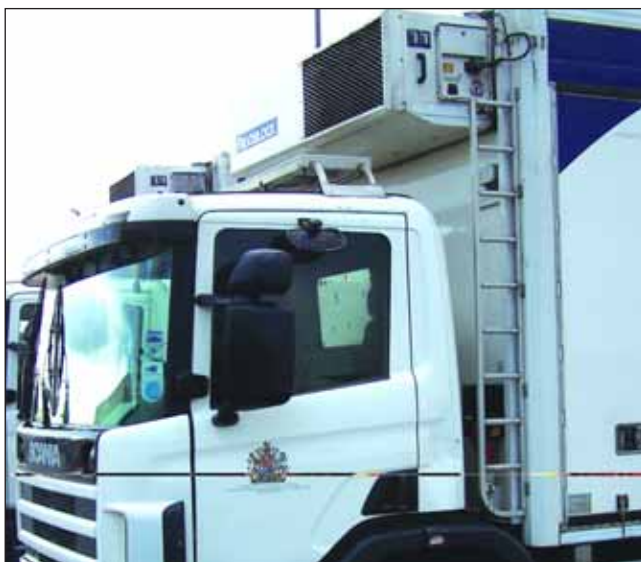
Figure 1 Access ladder to refrigeration equipment on old vehicles

- Employees were accessing refrigeration units above the driver's cab to adjust settings for the refrigerated box van on a daily basis. By specifying ground level controls on new vehicles employees no longer have to climb on the wheel and up a narrow ladder to gain access to them. Access equipment such as mobile work platforms or gantries can then be provided at site or at the repair depot for routine servicing or repairs on the equipment by engineers.

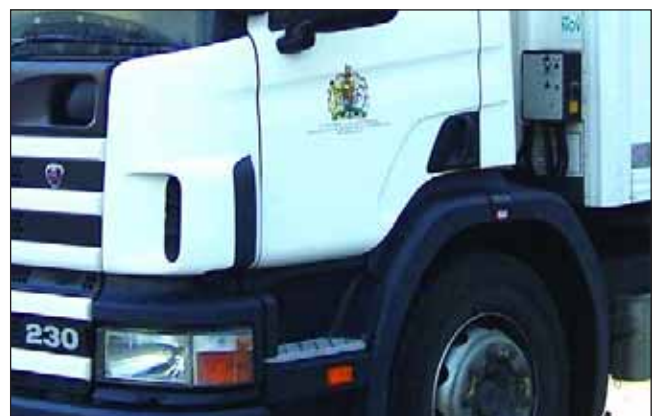
Figure 2 New controls at ground level eliminating the need for a ladder.

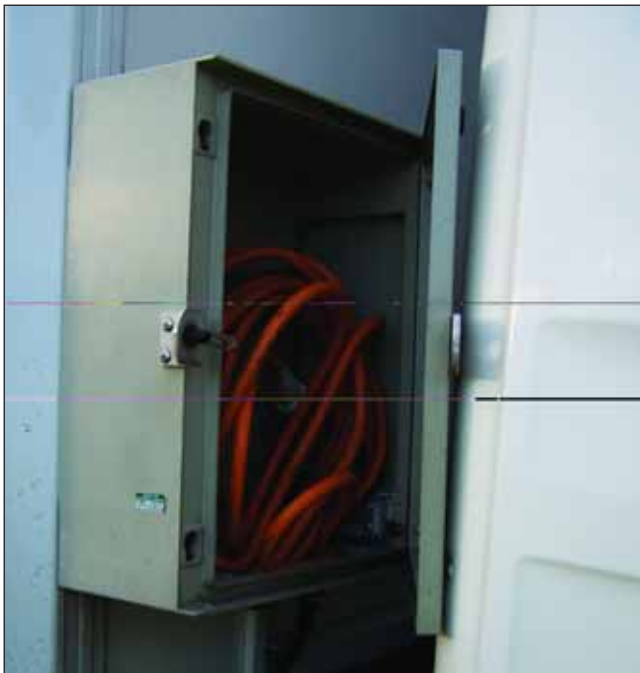
Figure 3 New interlocked trailing leads

- Trailing electrical cables, used to provide power to the refrigeration equipment while vehicles were at the depot, were problematic. New trailing socket outlets are now installed, which are interlocked to the ignition circuit to prevent the vehicles being driven away with the power cable still connected.

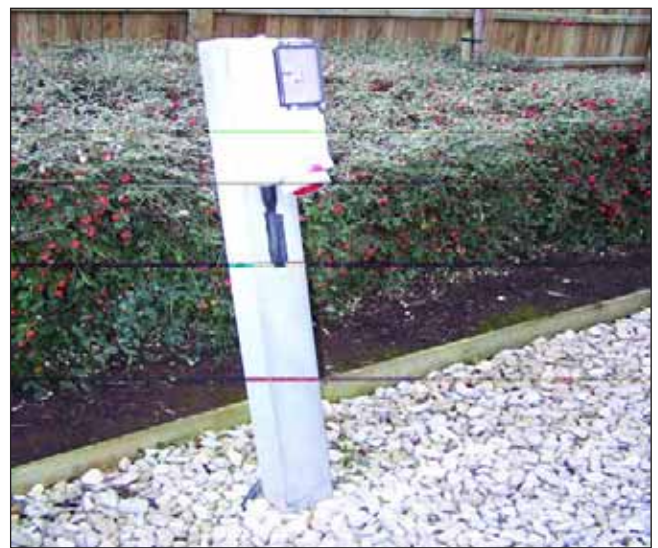
Figure 4 New socket outlets for refrigerated vehicles while parked

New power points are in place to avoid damage from vehicles and to reduce slip and trip hazards from trailing cables.
