**THE DEVELOPMENT AND TESTING
OF A METHODOLOGY FOR USING
FLUE GAS ANALYSER
MEASUREMENTS TO ASSESS
DOMESTIC GAS APPLIANCE
COMBUSTION PERFORMANCE**

Advantica report designation: R6635

Transco, HSE, British Gas
Services and CoGDEM

Advantica Ltd

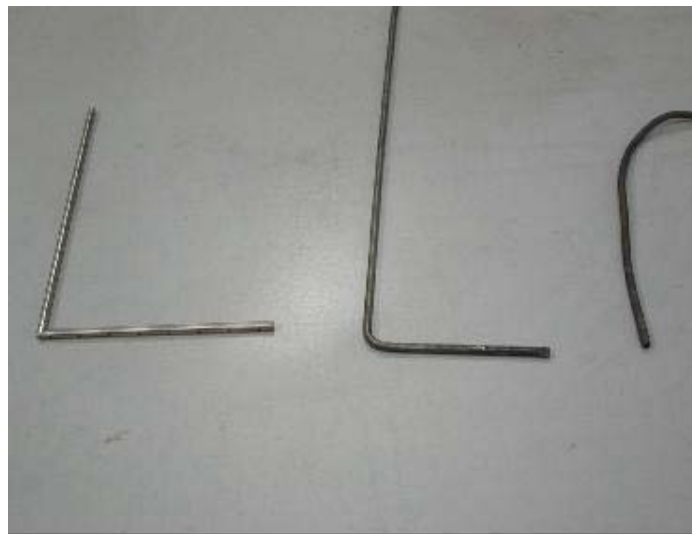
Figure 2: Probes used in the combustion tests

The sampling probes used during the work will enable practical information to be offered to the BS7967 panel that supports the drafting of the standard. The range of probes is shown in Figure 2. The draft standard recommended testing and validation of new probe designs and this is being covered in the current test programme.

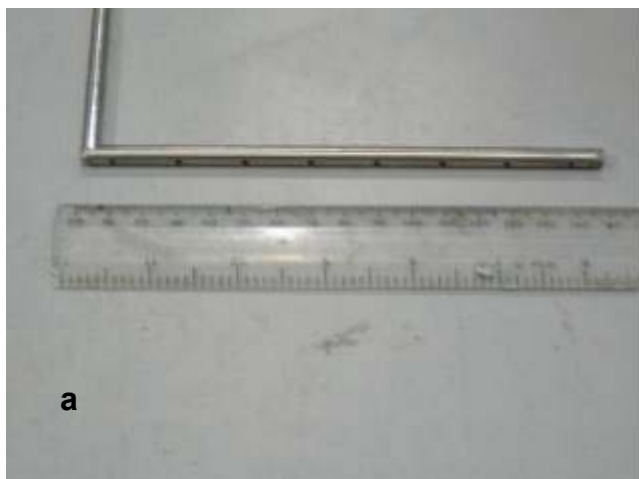
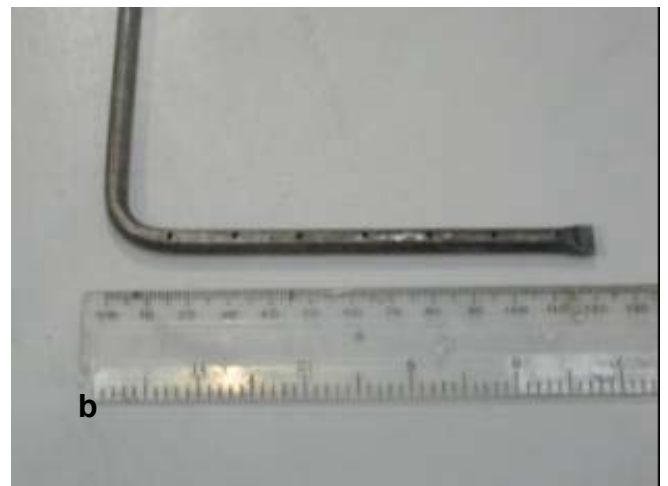
Figure 3: Detail of two multi-point sample probes

The multi-point probes are shown in more detail in Figure 3 (a and b).

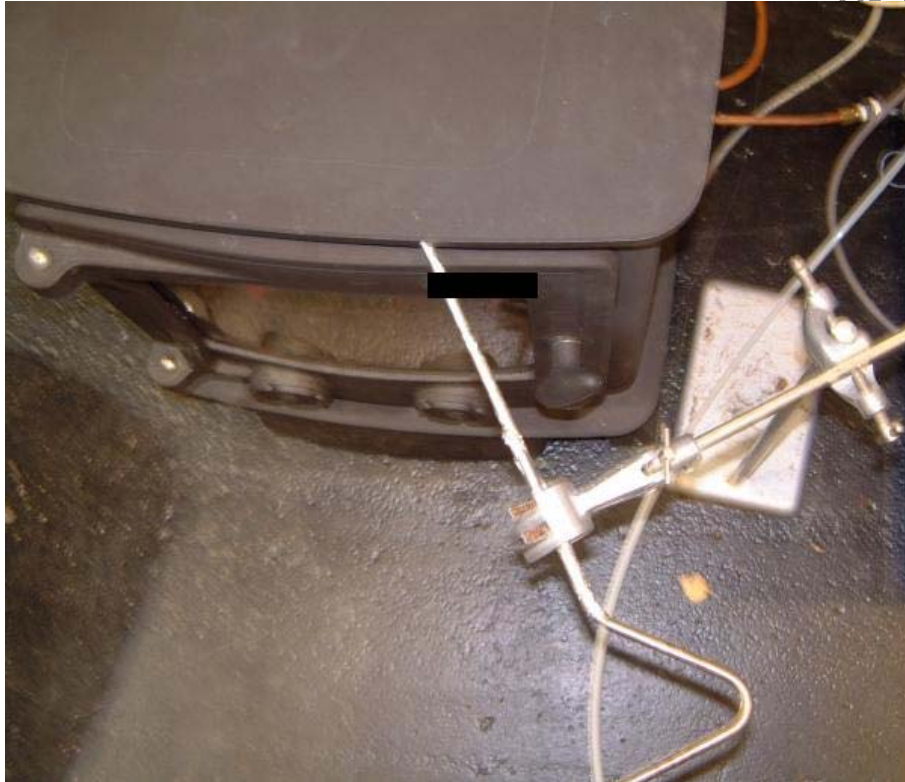
Figure 4: Position of external sample probe from above

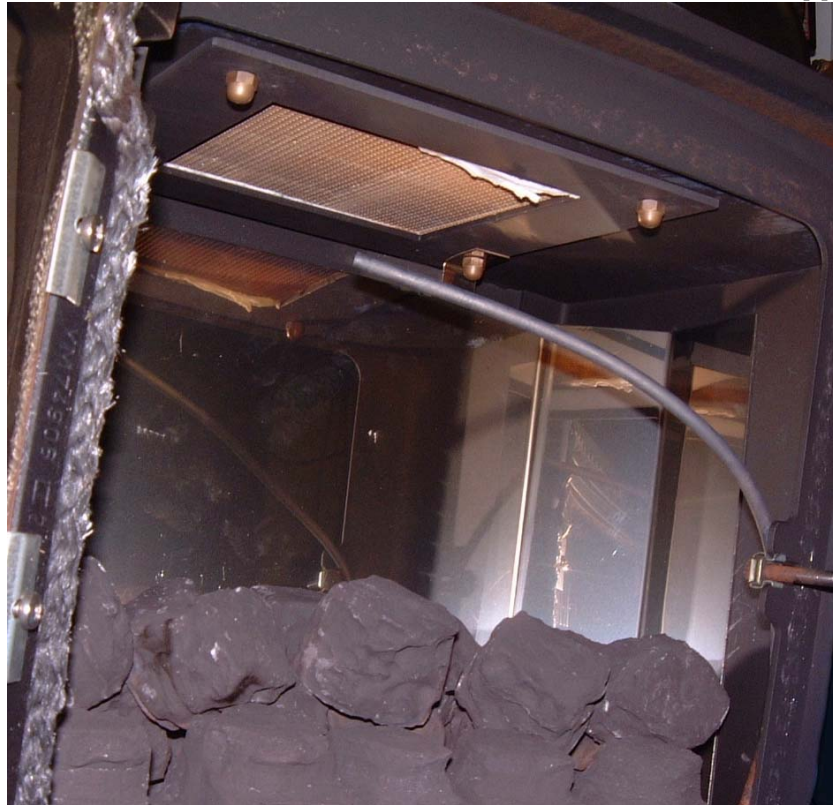
Figure 6: Position of internal sample probe (1)

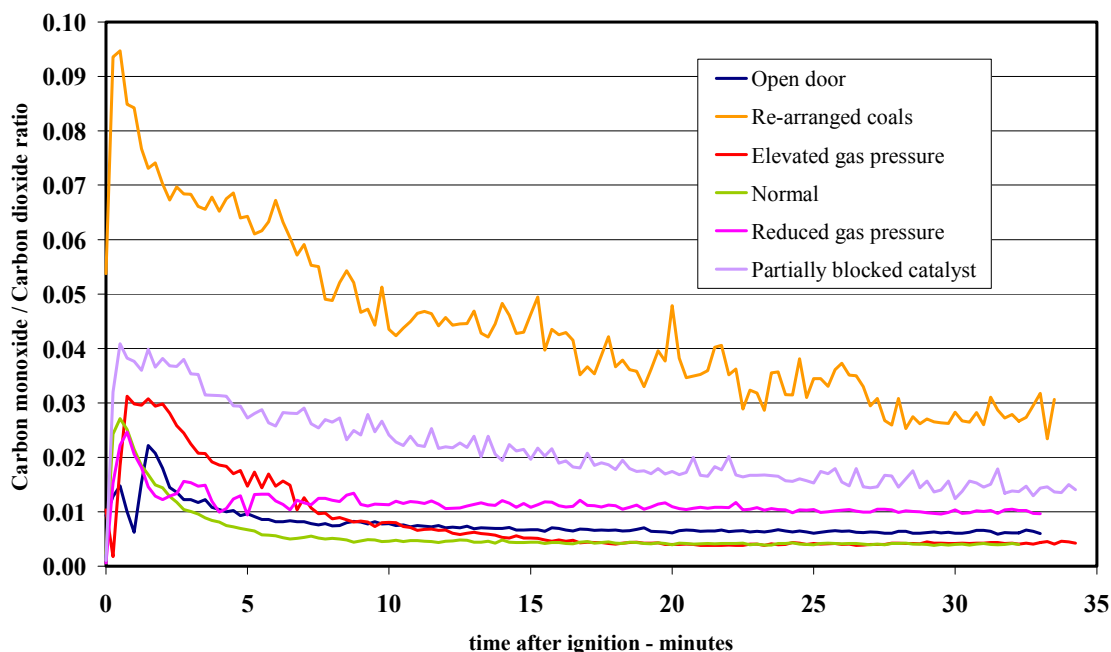
Figure 8: Flueless fire data inside firebox

In contrast, the measurements made inside the firebox, under fault conditions, took at least twice the time to stabilise than for standard operation. The probe sampling location is clearly an important feature of these tests and can influence the results and their interpretation. The probes were located adjacent to the catalyst and centrally within the operating area of the catalyst, as can be seen in Figure 6 and Figure 7. In this way the probes will sample the “bulk-flow” of combustion product gas. If the probes were located close to the edge then emission values changed.

For normal operation, the CO level peaks at over 400 ppm immediately following ignition but rapidly drops to a steady level near zero, with a CO₂ emission of about 4.5%. This shows the effectiveness of the catalyst at oxidising carbon monoxide.

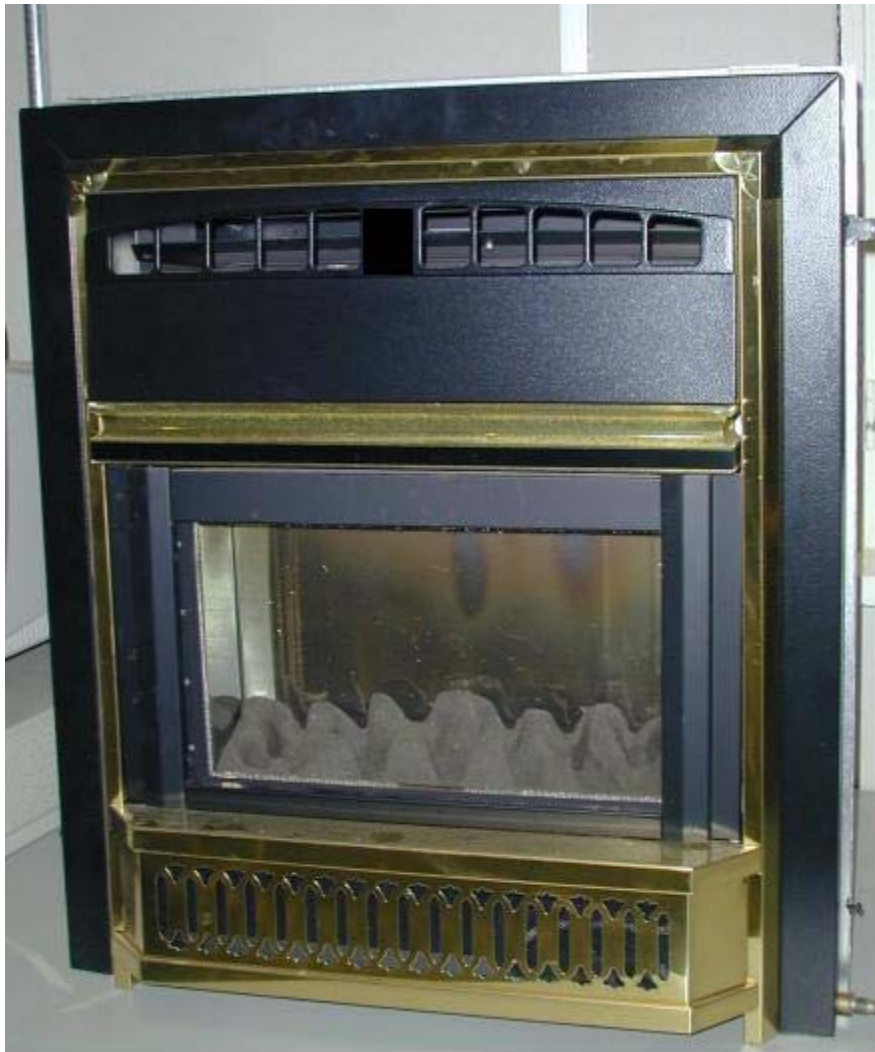
Figure 10: Balanced Flue fire

A room sealed inset live fuel effect gas fire representative of the natural draught, balanced flue type was used. Figure 10 shows the appliance.

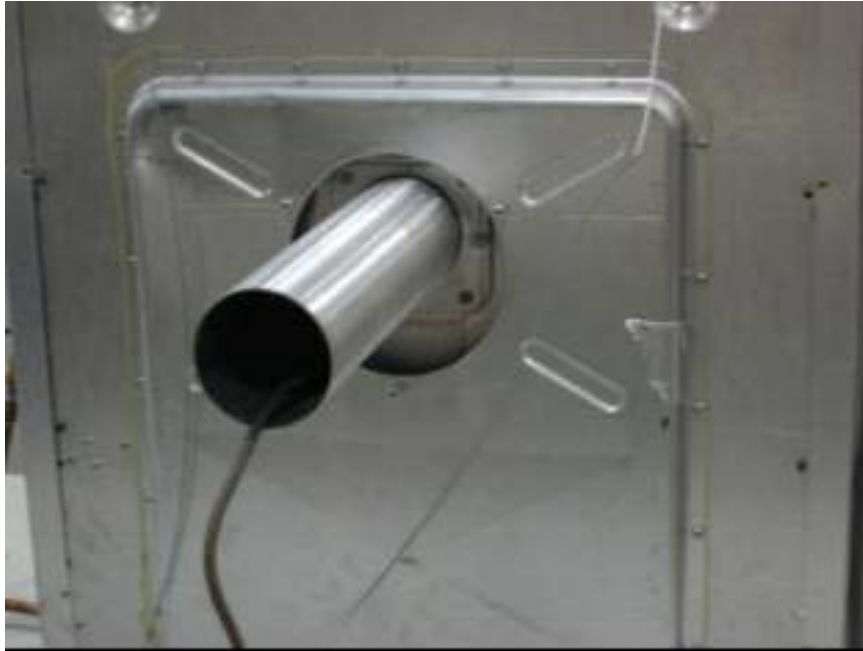
Figure 11: Location of the sampling probe in balanced flue fire

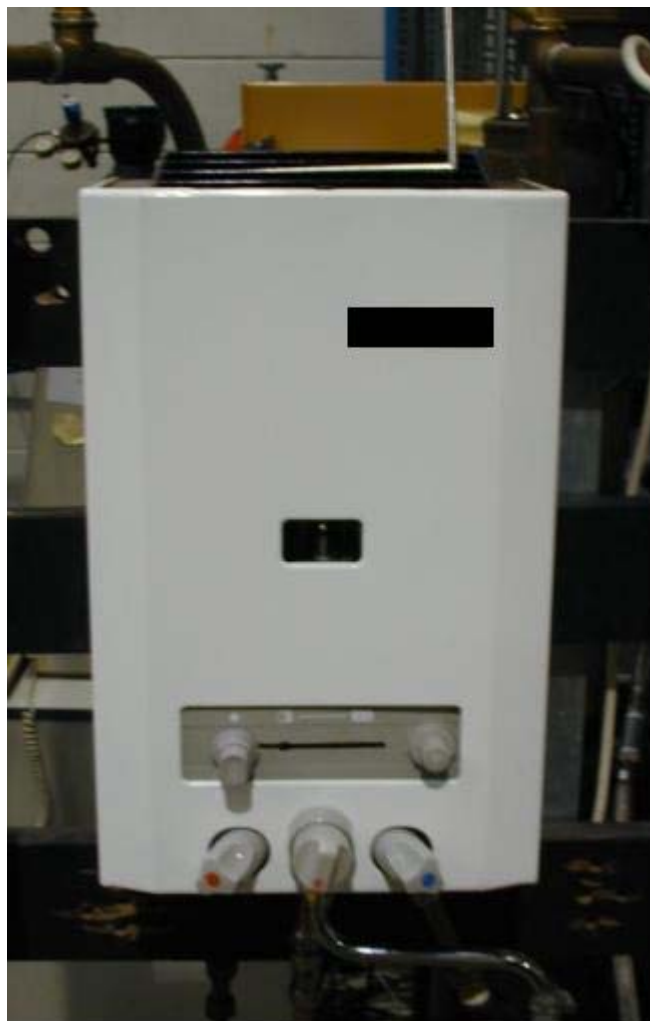
Figure 13: Water heater and probe

A flueless single-point water heater with atmosphere-sensing device representative of this type was used. The appliance is shown in Figure 13 together with a multi-point sampling probe. Measurements of carbon monoxide, carbon dioxide and oxygen were taken over the grille of the vent from the appliance as can be seen in the figure. The probe position was initially varied to obtain a maximum CO value and then fixed in position to measure the time dependence of the concentration values together with the steady-state values obtained after about three minutes constant operation. Figure 14 shows a photograph of the burner under normal operating conditions. The flames are of moderate height, do not impinge on the heat exchanger and show the characteristic blue colour.

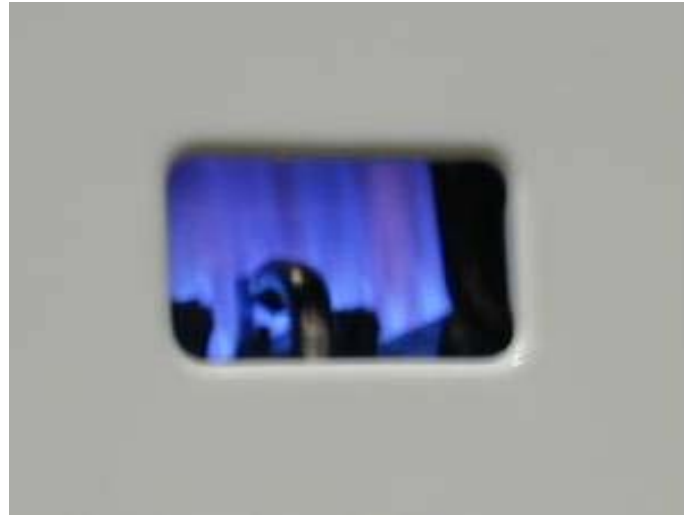
Figure 14: Burner under normal operating conditions

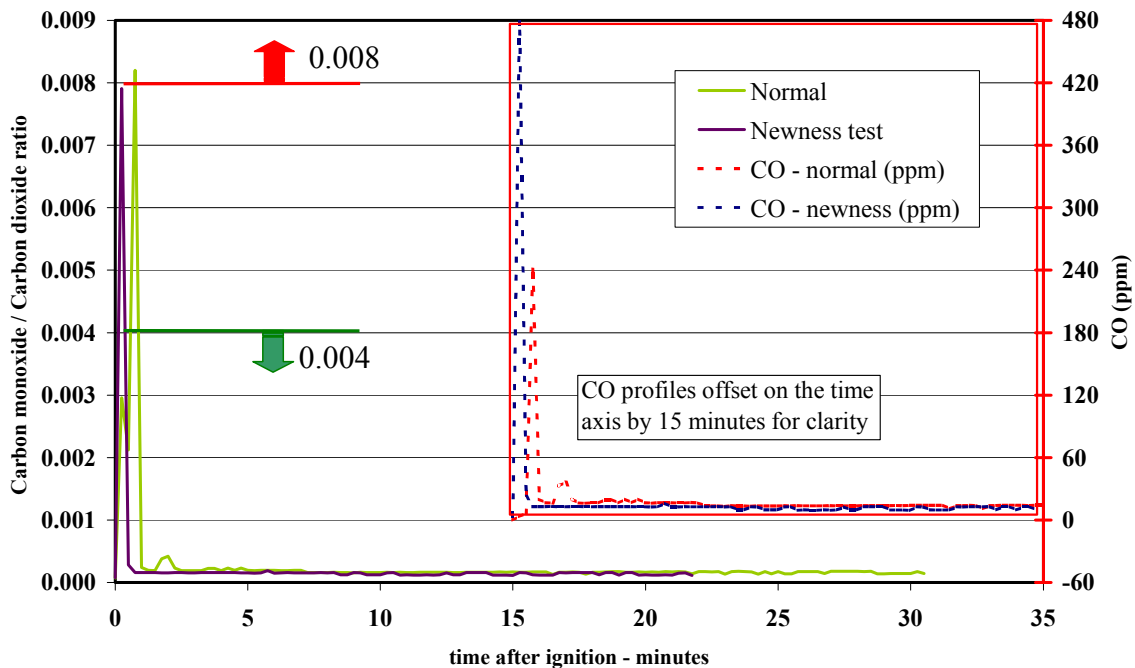
Figure 15: Comparison of “Newness” and “Normal” emissions tests from the water heater

was repeated to determine if the emissions from the appliance were dependent on the time and use after installation, although such appliances are not normally operated for more than 5 minutes. These results are shown in Figure 15.

As can be seen (Figure 15), the emissions from new and those from a normal test are in close agreement, including the initial peak in CO/CO₂ ratio. (There is a slight difference in start-up of the appliance caused by the inability to ignite the pilot burner at the first attempt on the “normal” test.)

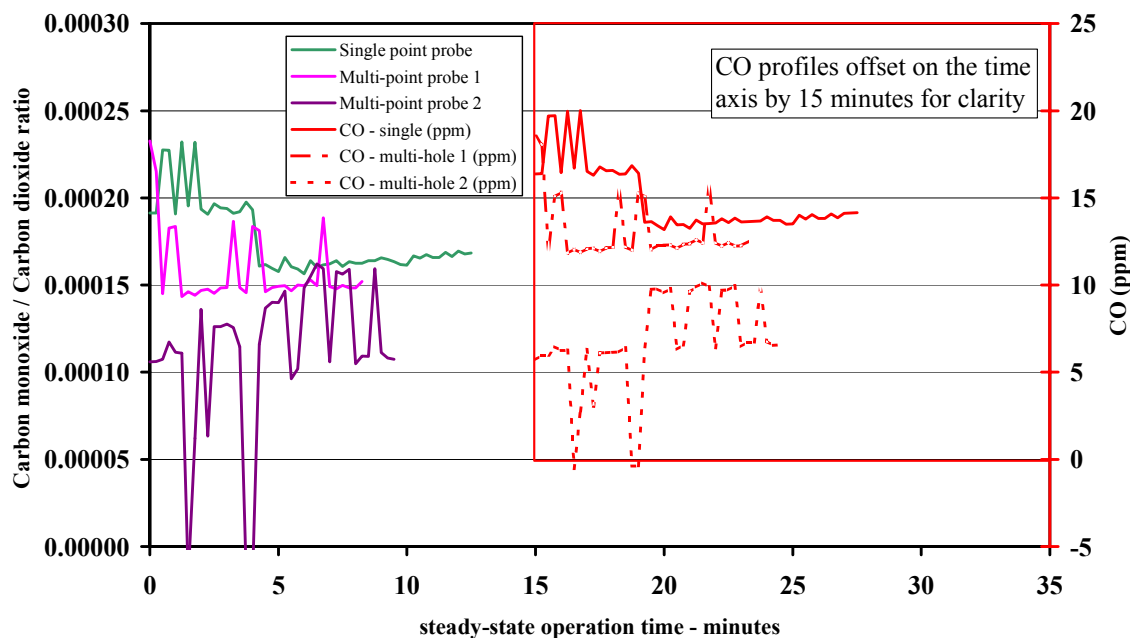
Figure 16: CO/CO₂ ratio from “normal” tests using different probes

Emissions from the appliance were monitored using three probes at separate times. The single point probe was used for most tests. Both multi-point probes were used to monitor emissions under normal operation and the results from the three probes can be seen in Figure 16. Although the agreement in the CO/CO₂ ratio is quite good for the three probes it is clear that the sampling is different as the absolute levels of CO and CO₂ show that there is a significant amount of dilution with air for the longer multi-point probe.

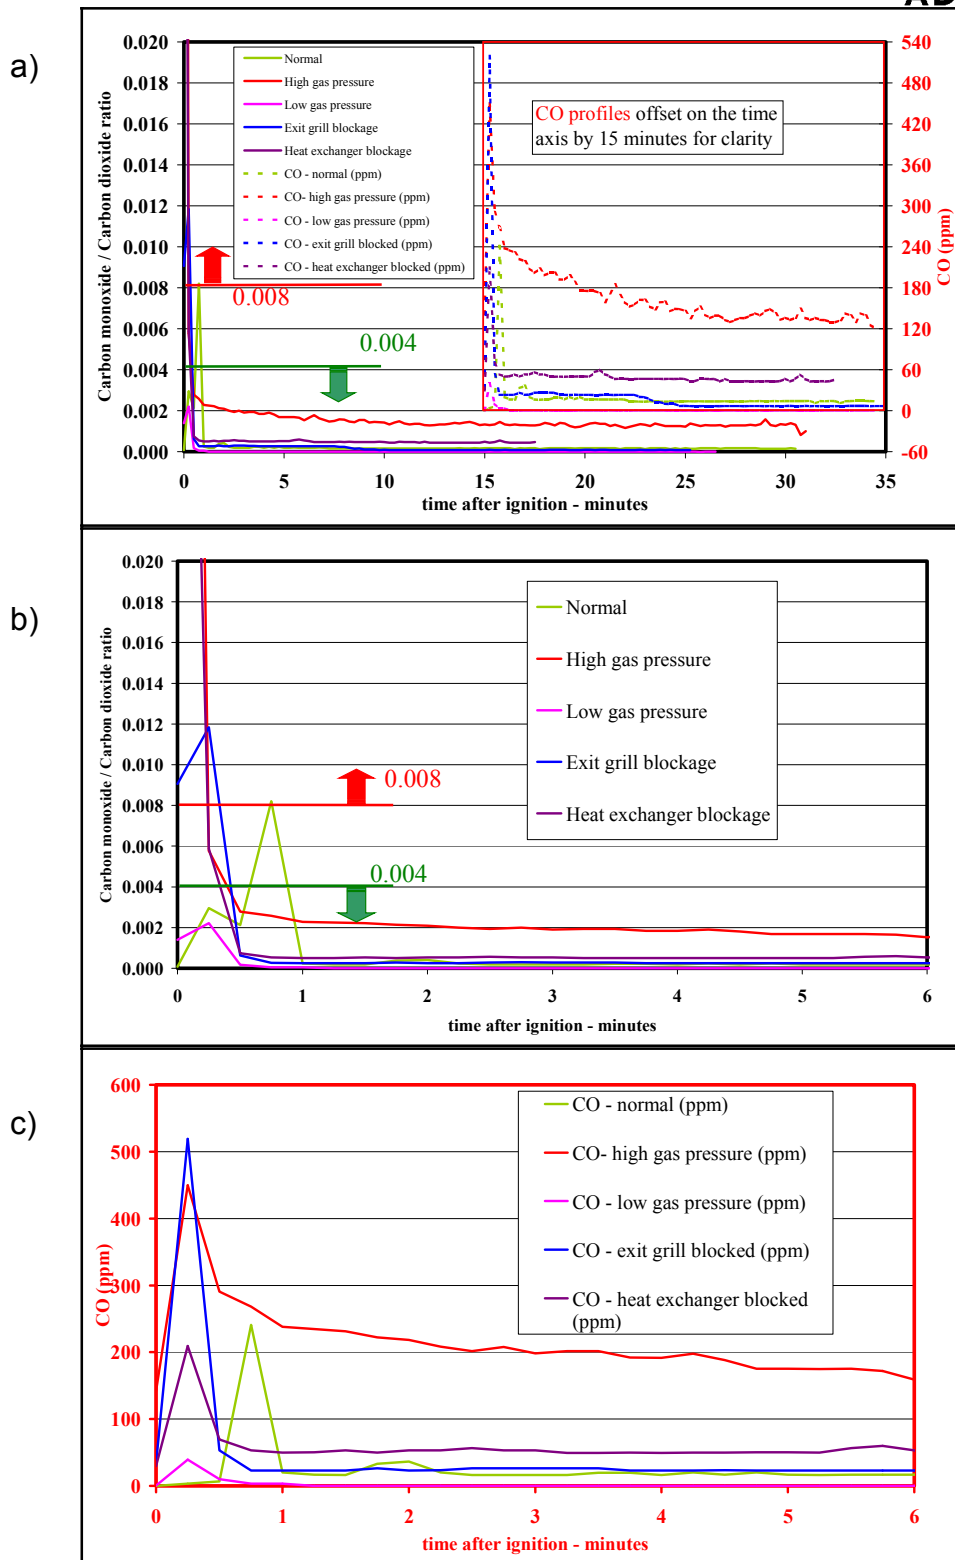
Figure 18: Water heater data for a range of test conditions

The results from the fault tests for this appliance are shown in Figure 18. The scale on the y-axis has been expanded to show the equilibrium steady-state combustion performance ratio and to give good resolution of the 0.004 and 0.008 limits. It is apparent that the steady-state CO/CO₂ ratio is lower than 0.004 for the majority of tests. Tests with high gas supply pressure and blockage of the heat exchanger resulted in very high initial values of CO. However, this subsides very quickly and the steady state levels are lower than 0.002. Of the tests undertaken, only the high gas supply pressure test resulted in higher steady-state operation values for the CO/CO₂ ratio. The rate of decline of the peak value of the combustion performance ratio provides an indication of the time an engineer could have to make measurements whilst on-site. It should be noted that for this type of appliance it may be easy to miss the peak CO value, as the duration of the peak is particularly short.

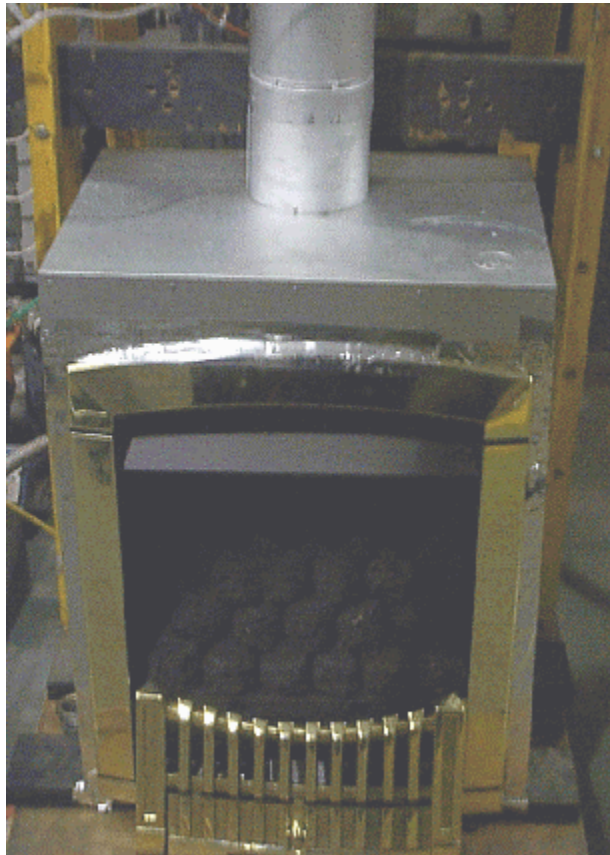
Figure 19: Open flue coal-effect inset gas fire

A coal-effect gas fire representative of this type was used to study emissions of carbon monoxide and carbon dioxide. The appliance is shown in Figure 19, and was installed in an open flue box.

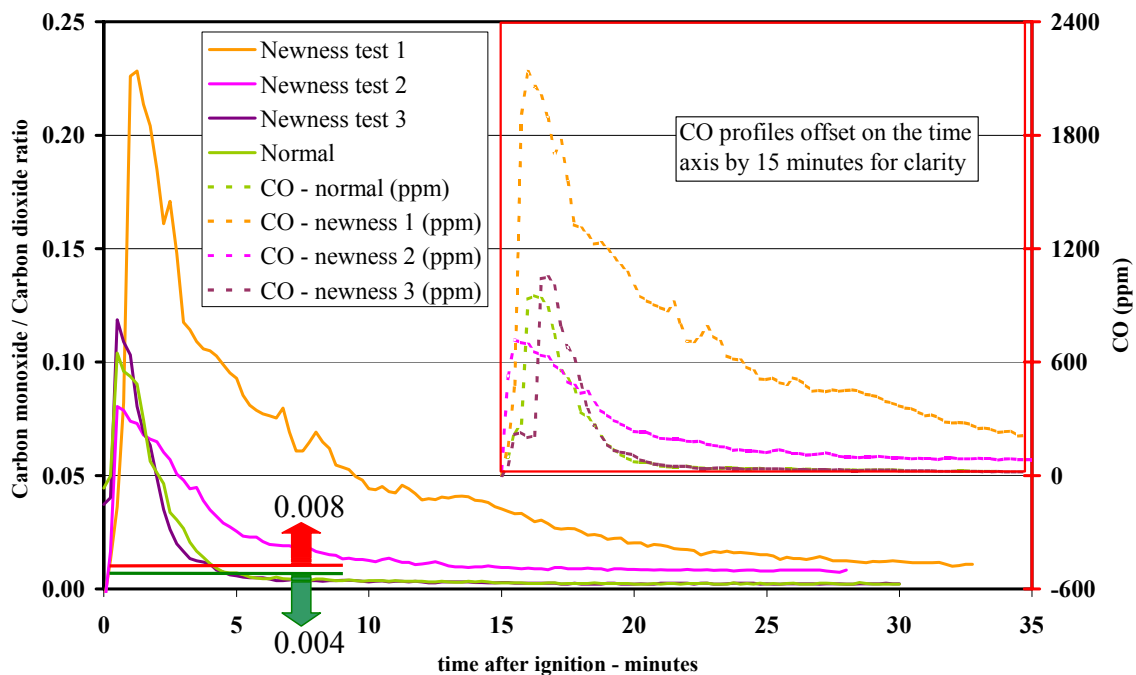
Figure 20: Open flue coal-effect gas fire CO/CO₂ ratio for “newness” and “normal” test conditions

Initial tests using this appliance showed that there were substantial CO emission levels (> 2000 ppm) and the decay in the level was slow compared to other appliances tested in this project. It was concluded that the binder on the coals was a potential source of CO and had to be “aged” by repeated heating/cooling cycles. In addition to the high CO emission levels, slight “smoking” of the coals was observed. Some of this “smoke” also spilled from the front of the fire. Repeated ageing of the appliance was undertaken until a consistent low, steady-state level of CO was established and this was then deemed to be the “normal” operation. The results from the “newness” and “normal” operation are shown in Figure 20.

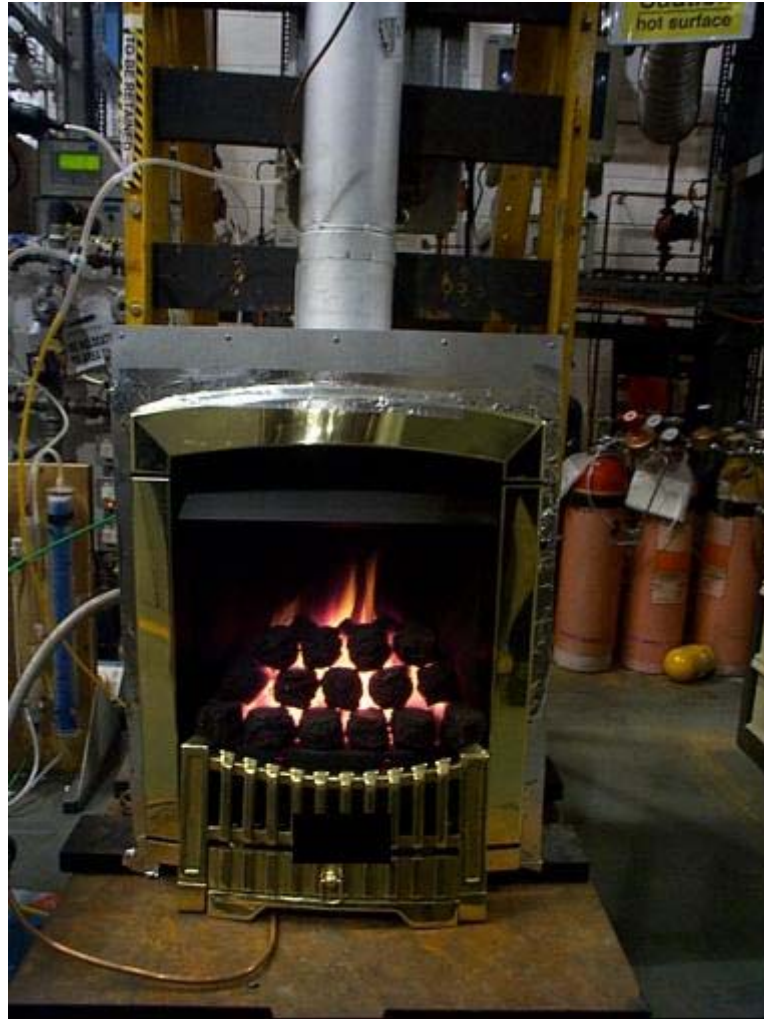
Figure 21: Open flue coal-effect fire under “normal” operation

- CO ~ 20 ppm
- CO₂ ~ 0.8%
- O₂ ~ 20.1%

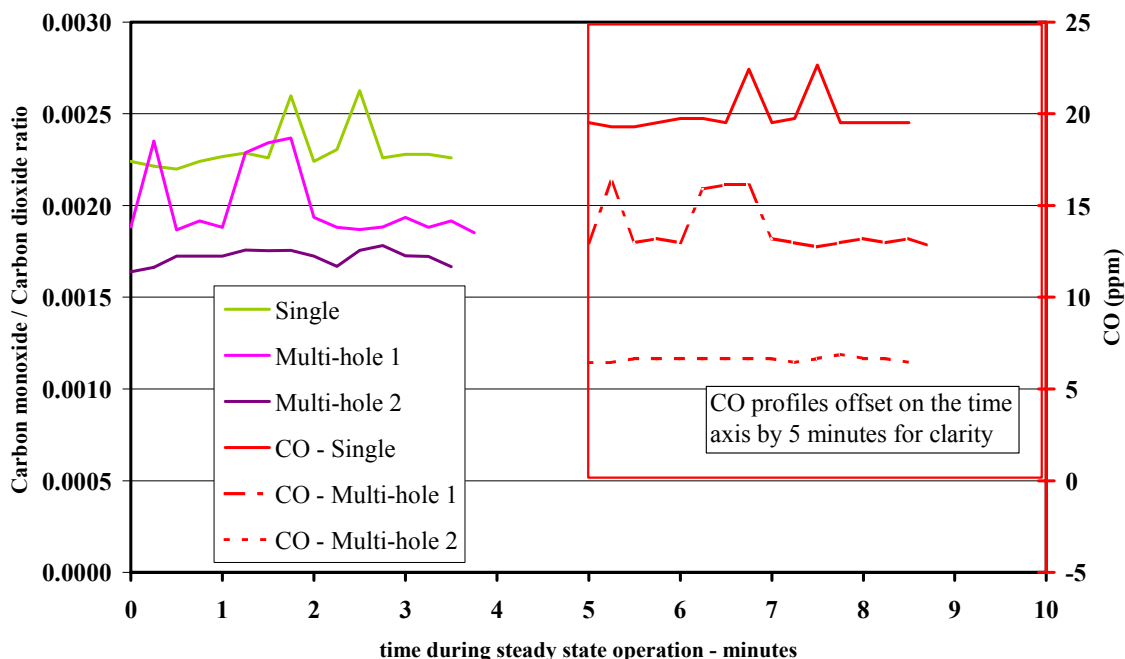
Figure 22: Comparison of emissions measurements using different probes in the flue of an open flue coal-effect gas fire operating under normal conditions

Emissions from the appliance were monitored using the three different sampling probe designs at separate times when operating under “normal” conditions. The results can be seen in Figure 22 and the steady state values for CO, CO₂ and O₂ are shown in Table 2.

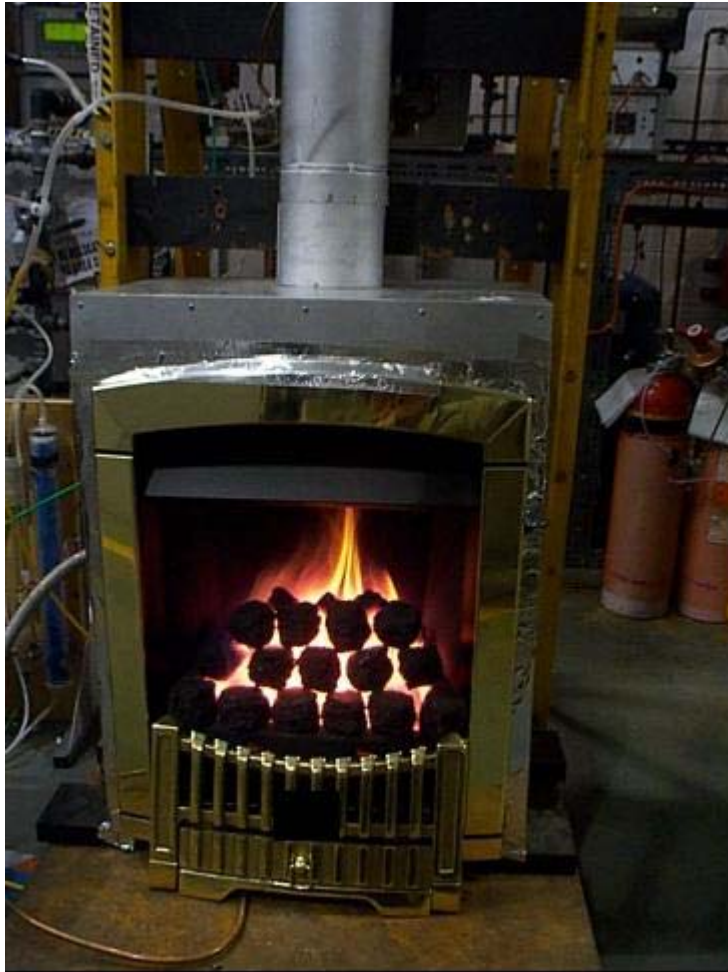
Figure 23: High gas supply pressure fault

The preliminary tests showed that the appliance would operate under low and high gas supply pressure. With low gas supply pressure, the flames shortened but remained the same colour, and the appliance reached a steady-state condition in a similar time to the normal operation. However, the measured emissions were very low and a full test was not performed.

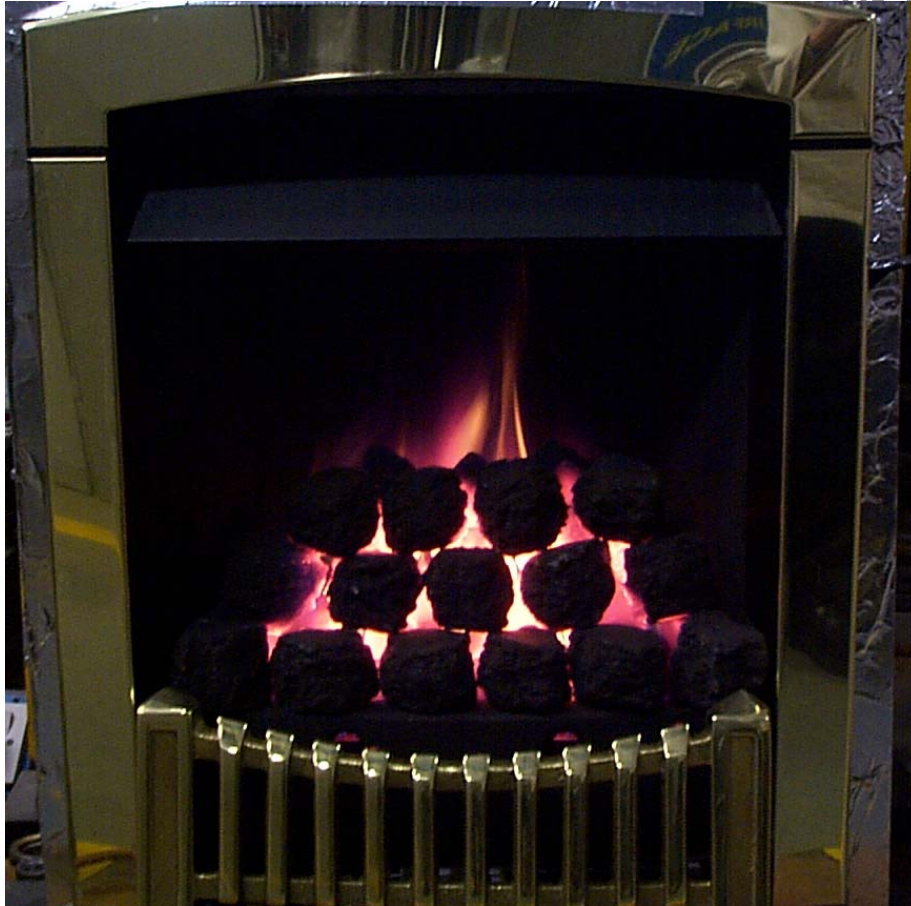
Figure 24: Partially blocked flue fault test for coal-effect fire

A series of trials were undertaken to establish the potential range of flue blockage possible that would give noticeable changes to the appliance emissions. With about 25% of the flue blocked there was no difference in the results compared to the “normal” operation. With 50% blockage there was an increase in the level of CO emission and there was also some “spillage” of combustion products from the front of the fire. The blockage was increased to about 75% of the flue and this was used for the formal test. A photograph of the fire operating under these conditions is shown in Figure 24.

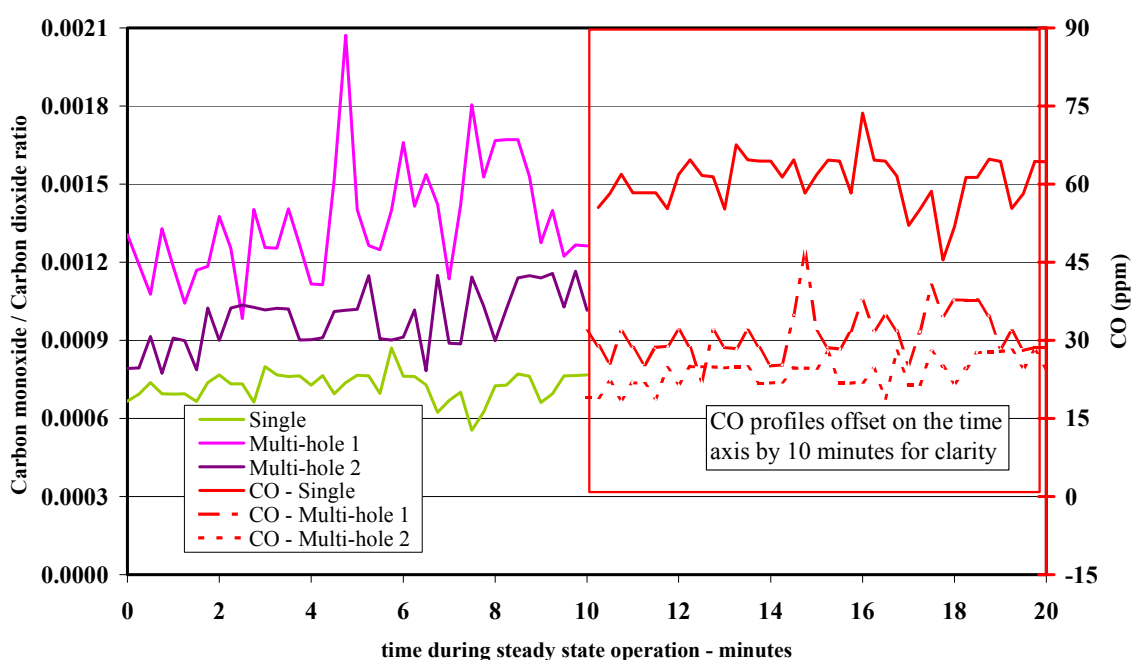
Figure 29: Comparison of emissions measurements using different probes in the flue of an open flue boiler operating under normal conditions

Emissions from the appliance were monitored using three probes at separate times when operating under “normal” conditions. The results from the three probes can be seen in Figure 29 and the steady state values are shown in Table 3.

As can be seen from information presented in Table 3 and Figure 29, there are significant differences between the measurements found using the different probes. The single-point probe is located in the centre of the flue and samples flue gas products from the main flow in the flue. The multi-hole probes sample gas from a range of locations across the flue and appear to show increased dilution of the emissions by air. Indeed the larger multi-hole probe (Multi-hole 2) could not fit completely into the flue and the hole nearest the 90° angle of the probe was completely outside the flue and had to be sealed by adhesive aluminium tape to prevent it from sampling the ambient air in the laboratory.

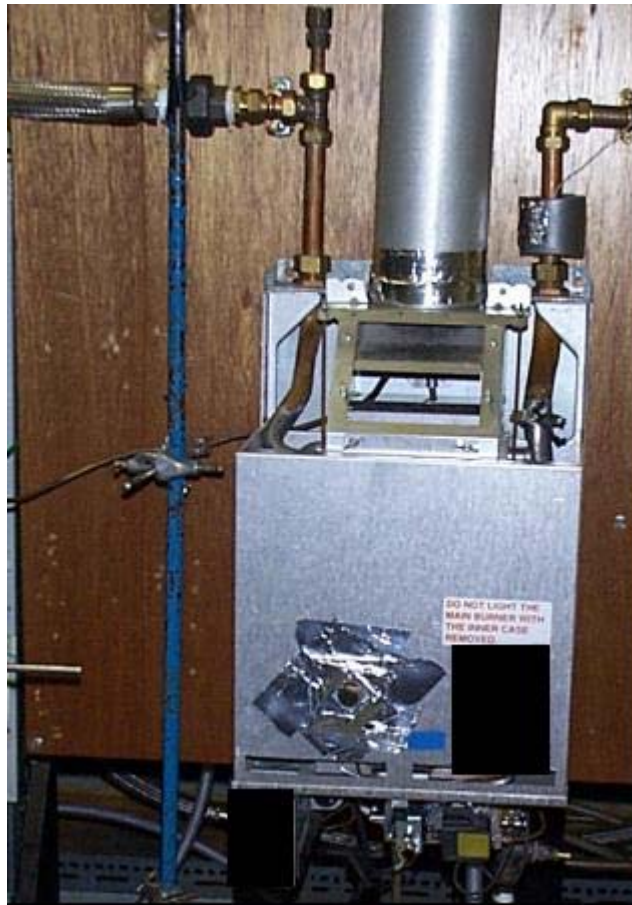
Figure 30: Blocked boiler heat exchanger

Details of the results are shown in Figure 28. A photograph of the blocked heat exchanger is shown in Figure 30. A close-up photograph of the blocked heat exchanger is shown in Figure 31.

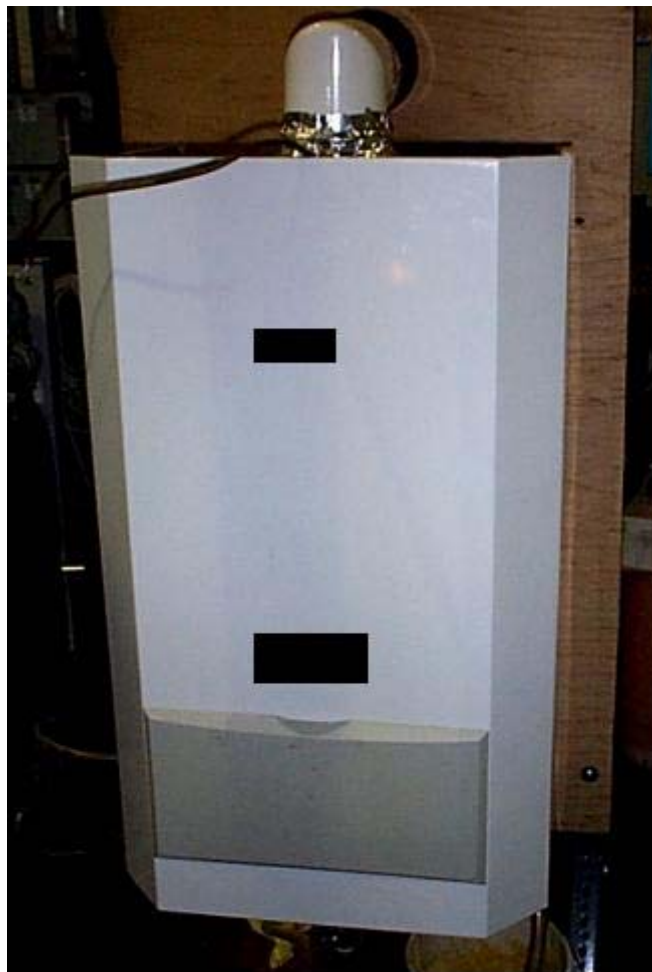
Figure 32: Fan-flued combi-boiler

A wall-hung, room-sealed, fan-flued condensing combination boiler representative of this type of boiler was used and installed in the laboratory test bay according to the manufacturers instructions. The installation was similar to that for the open flue boiler except for certain additional features present on the combi-boiler that needed to be catered for. A photograph of the boiler is shown in Figure 32.

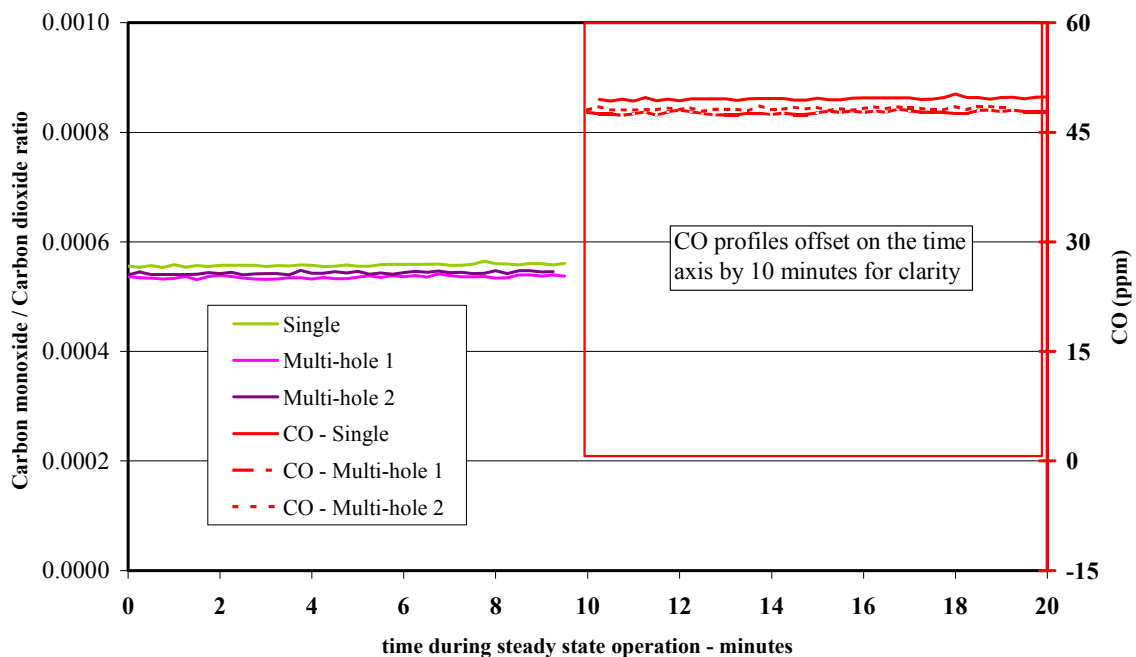
Figure 34: Comparison of CO emissions and combustion performance ratio for the fan-flued, condensing, combi-boiler

Emissions from the appliance were monitored using the three sampling probe types at separate times when operating under “normal” conditions. The results from these probes can be seen in Table 4 and Figure 34.

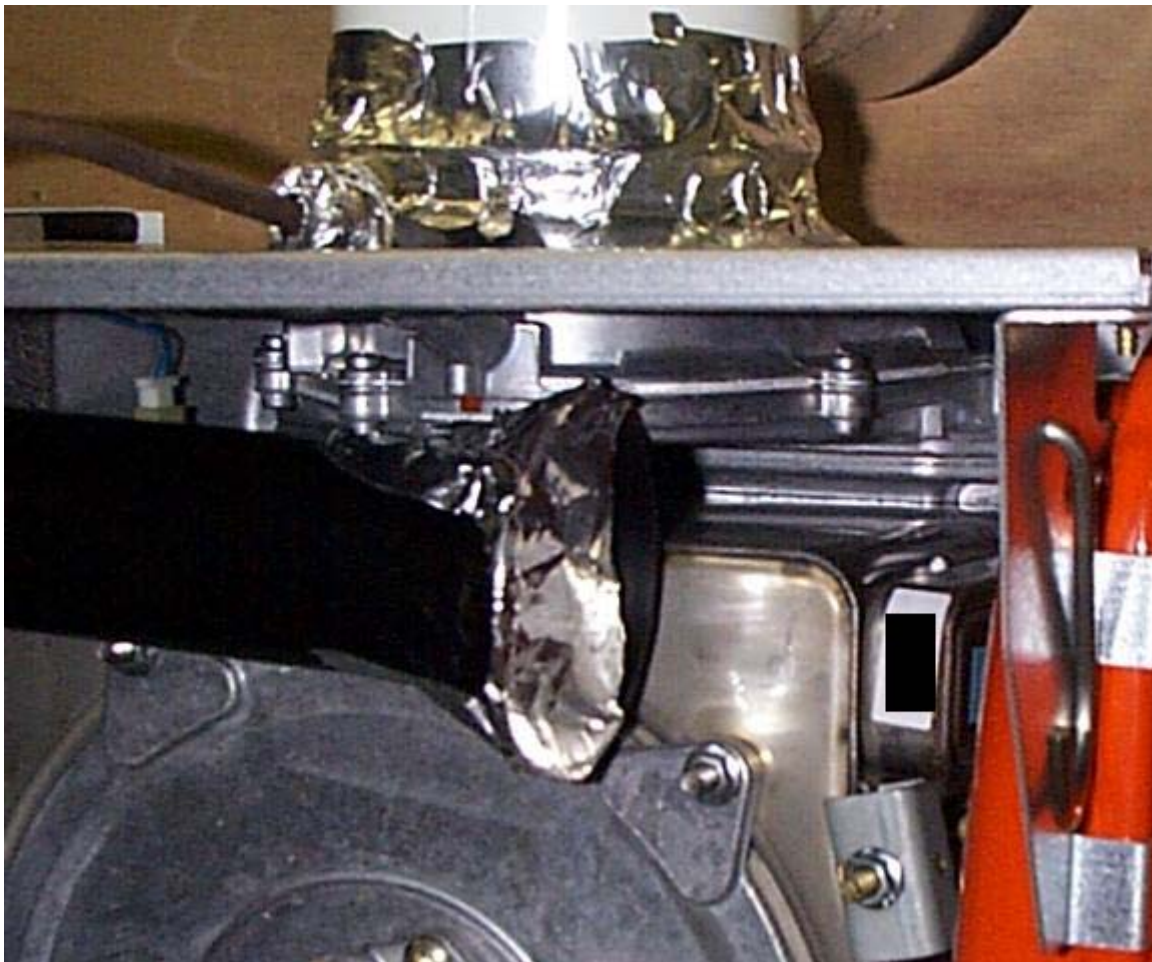
Figure 36: “Close-up” of partially blocked air intake funnel

The internal section of the boiler showing the blockage is presented in Figure 35 and a close-up photograph of the blocked air intake funnel in Figure 36. Initially the air intake funnel was blocked to about 50% of its active area and the observed changes to the emissions and boiler performance were small. CO emission level increased to 60ppm, but the CO₂ level remained constant and the boiler operating temperature remained at 72°C. when the degree of blockage was increased to 75%, CO levels rose to about 200ppm and the CO₂ level increased to 10.4%. Attempts to increase the blockage to 90% did give rise to high, transient levels of CO but the boiler only operated for a minute before the control system “shut-down” operation.

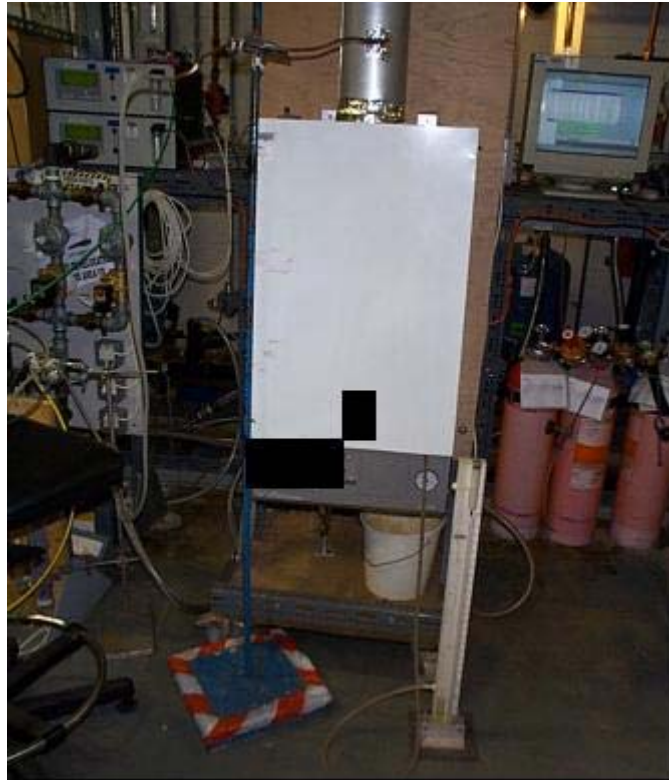
Figure 37: Open flue combi-boiler in the test bay

A boiler representative of this type was used. The boiler was installed in the test bay and fitted with a 2m flue. The boiler contains an internal pump and so the external pump was not used in this appliance test. All gas and water connections were made so that the boiler could be operated in central heating (CH) and/or direct hot water (DHW) mode. Gas supply connections were made according to the manufacturers instructions. A photograph of the boiler as installed is shown in Figure 37.

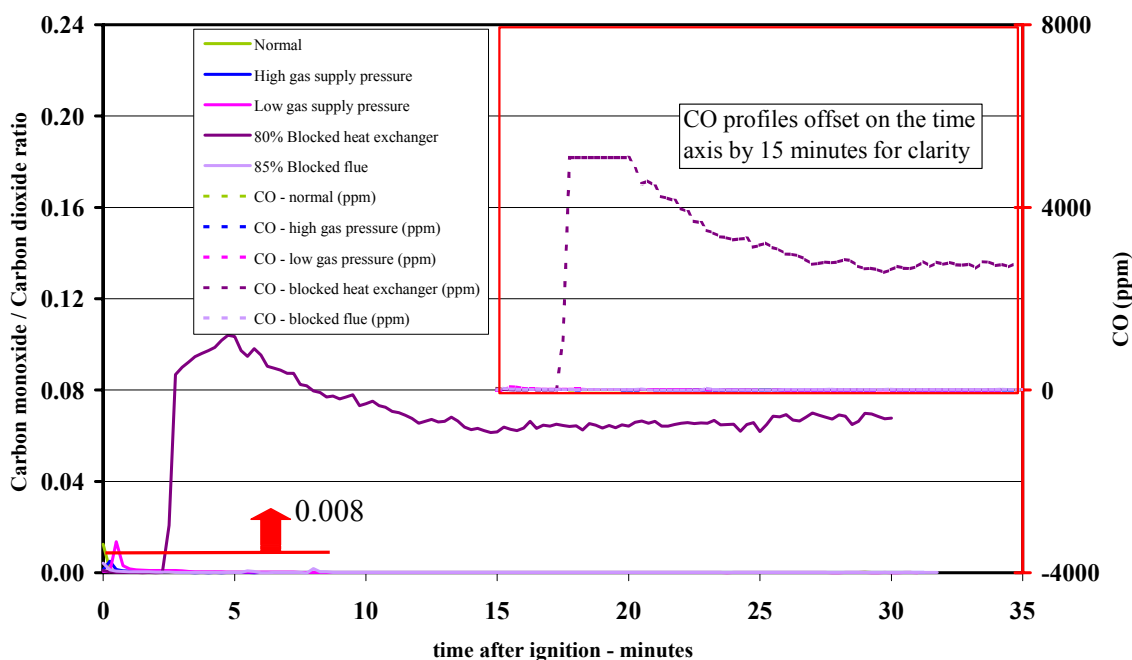
Figure 39: Expanded scale comparison of “normal” and fault combustion product gas emissions for the combi-boiler

Typical CO and combustion performance ratio variation with time are shown in Figure 38 and Figure 39. The format of the emissions profiles is typical of this type of appliance. On ignition at the low burner gas pressure there is an initial peak in the CO emission level (typically of the order of 50ppm), as the appliance is cold. This peak emission rapidly subsides during the low gas pressure operation and CO emission drops to under 5ppm.

As the operation at 2mbar burner gas pressure stabilises, the CO emission levels-off at about 6ppm. When the burner gas pressure increases from 2mbar to 13mbar the CO emission increases to about 10ppm. Although there is an increase in CO emission when the burner gas pressure increases there is a substantial increase in the CO₂ emission and consequently the combustion performance ratio decreases. Under “normal” operation there is no spillage of combustion products from the appliance.

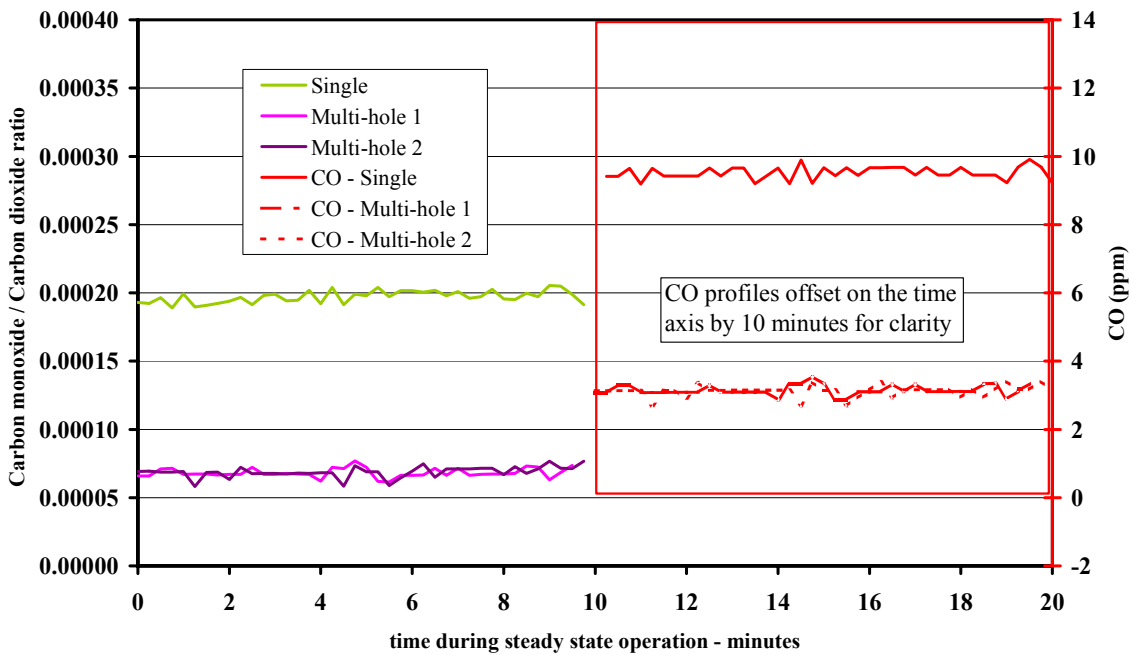
Figure 40: Comparison of CO emissions and combustion performance ratio for different sample probes for the combi-boiler

Emissions from the appliance were monitored using the three different sampling probe types at separate times when operating under “normal” conditions. The results from these probes are shown in Table 5 and Figure 40.

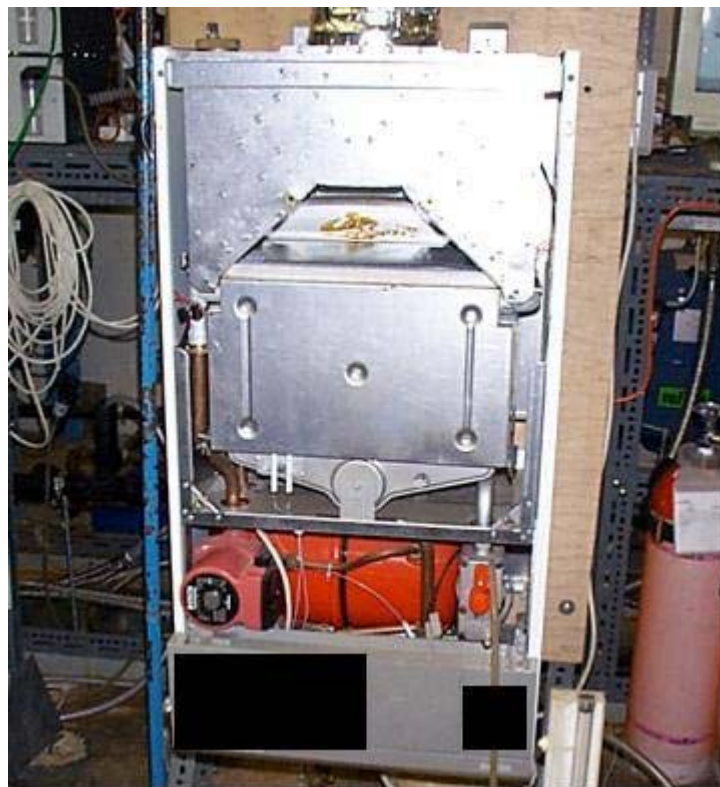
Figure 41: Blocked heat exchanger and internal structure of the combi-boiler

With the blocked flue tests, the boiler thermal performance did not appear to be adversely affected but there was a significant rise in the CO emissions. With the heat exchanger blocked to about 80% of its active area the CO emissions increased to over 3000ppm resulting in a very high combustion performance ratio. Photographs of the heat exchanger blockage are shown in Figure 41 and Figure 42.
