**THE DEVELOPMENT AND TESTING
OF A METHODOLOGY FOR USING
FLUE GAS ANALYSER
MEASUREMENTS TO ASSESS
DOMESTIC GAS APPLIANCE
COMBUSTION PERFORMANCE**

Advantica report designation: R6635

Transco, HSE, British Gas
Services and CoGDEM

Advantica Ltd

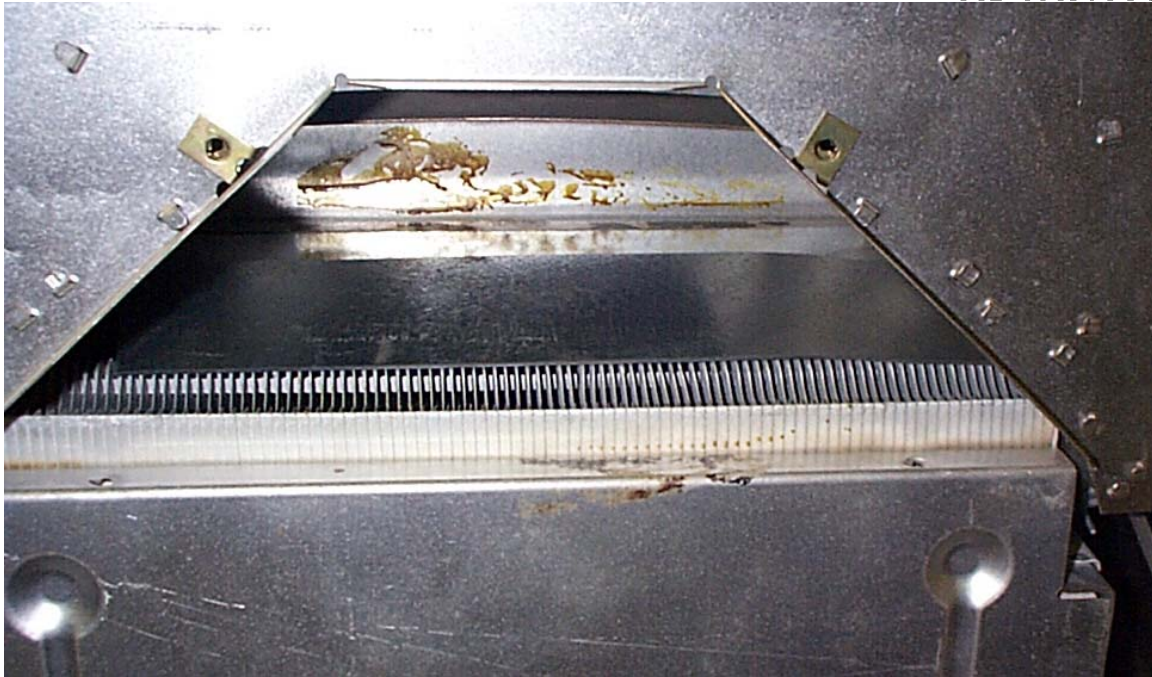
Figure 42: “Close-up” of the blocked heat exchanger

With the blocked flue tests, the boiler thermal performance did not appear to be adversely affected but there was a significant rise in the CO emissions. With the heat exchanger blocked to about 80% of its active area the CO emissions increased to over 3000ppm resulting in a very high combustion performance ratio. Photographs of the heat exchanger blockage are shown in Figure 41 and Figure 42.

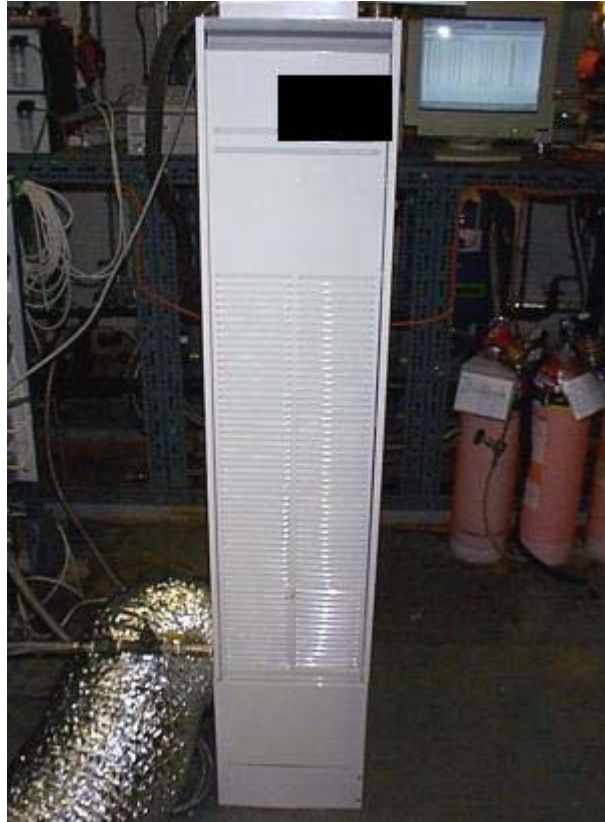
Figure 43: Combined warm air heater/water circulator

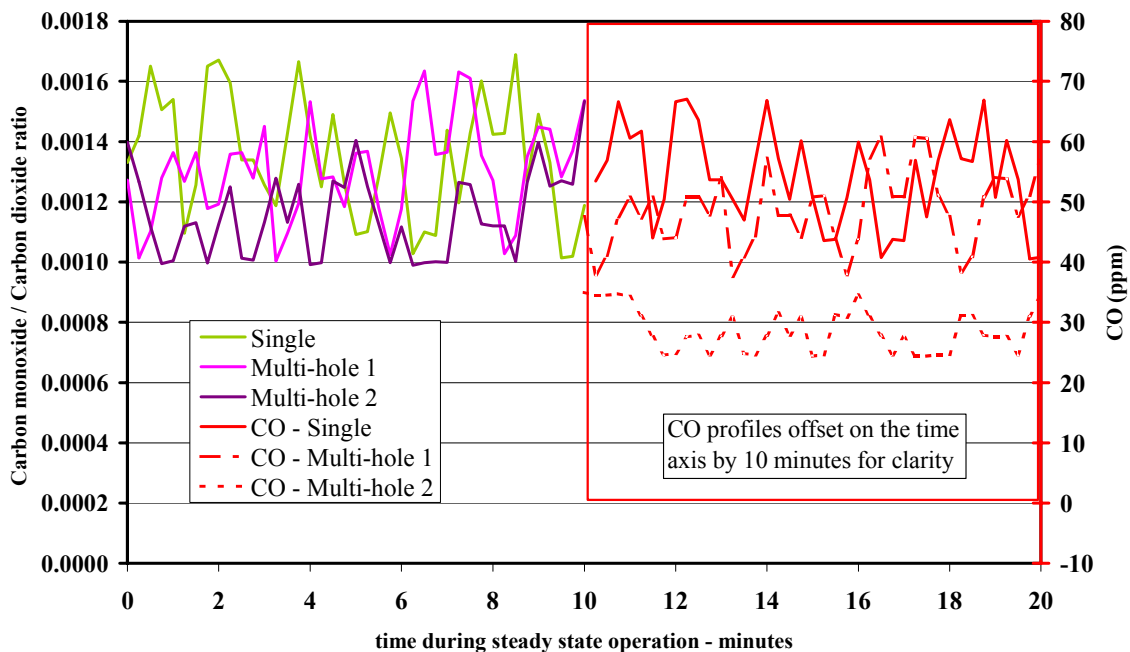
Figure 44: Comparison of CO emissions and combustion performance gas ratio for different sample probes for the combined air heater and water circulator

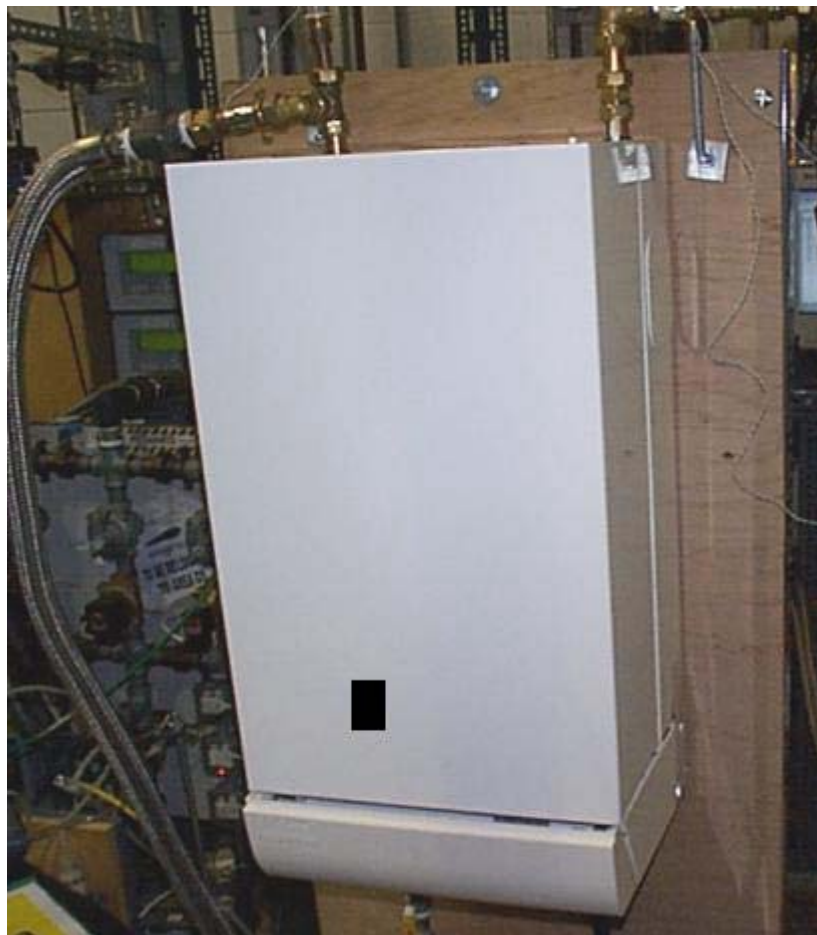
Figure 46: Fan-flued boiler

All tests on the boiler were performed with at the maximum rating of 10.8kW heat input and 8.8kW boiler output.

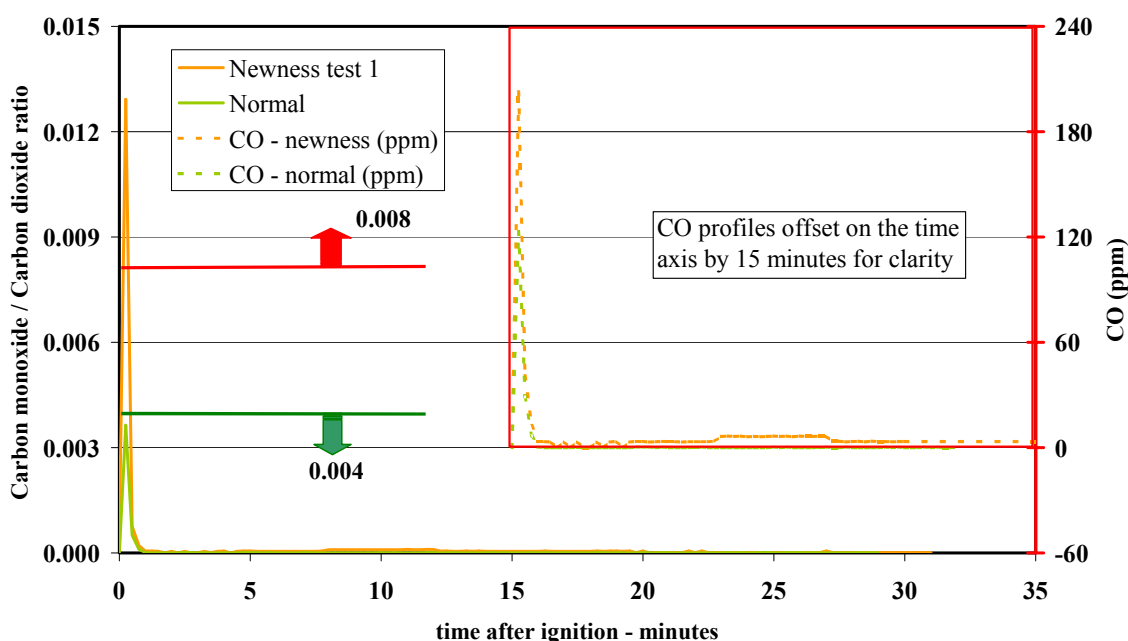
Figure 47: Comparison of “Newness” and “Normal” emissions tests from the fan-flued boiler

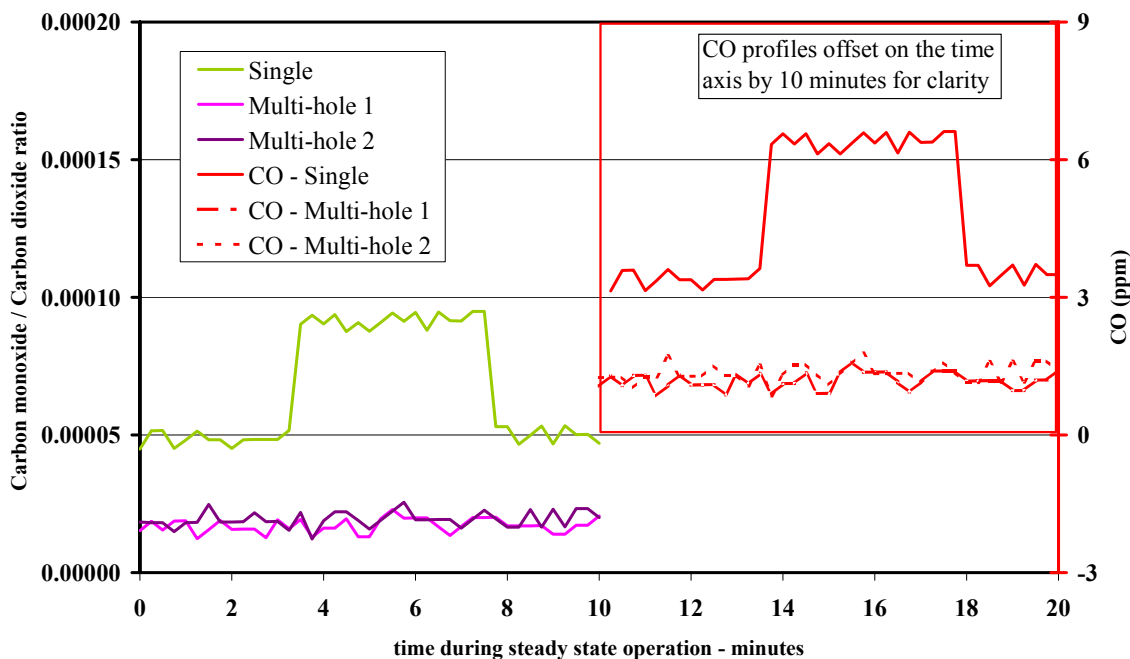
Figure 48: Comparison of CO emissions and combustion performance ratio for different sample probes for the fan-flued boiler

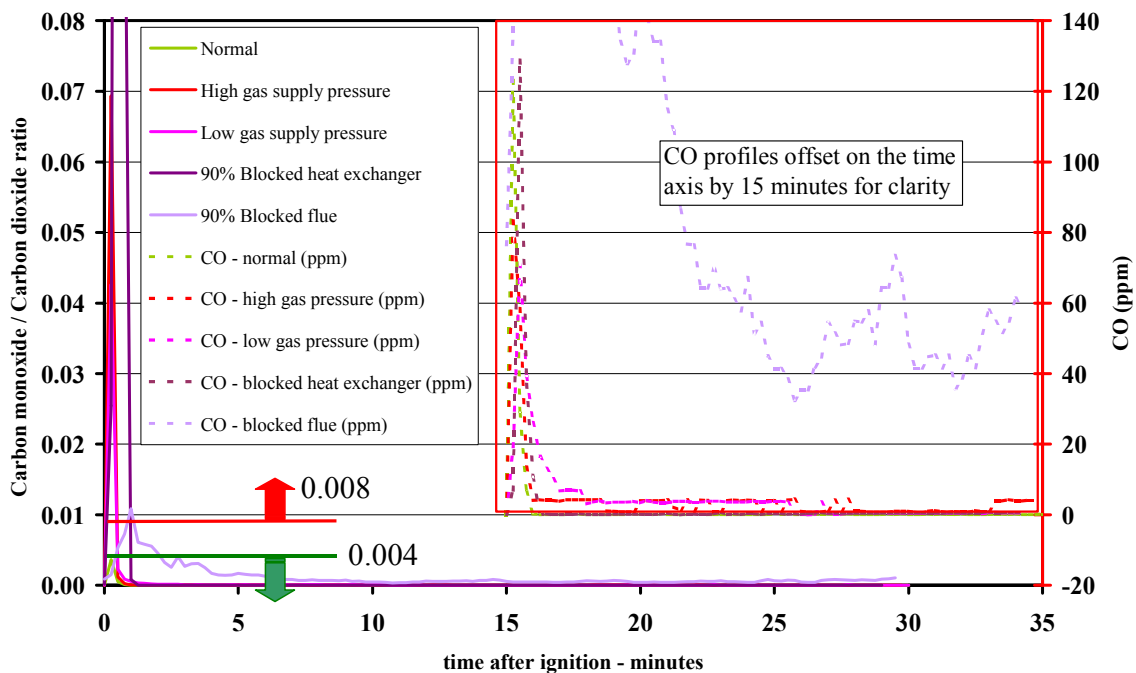
Figure 50: Comparison of “normal” and fault combustion product gas emissions for the fan-flued boiler (expanded scale)

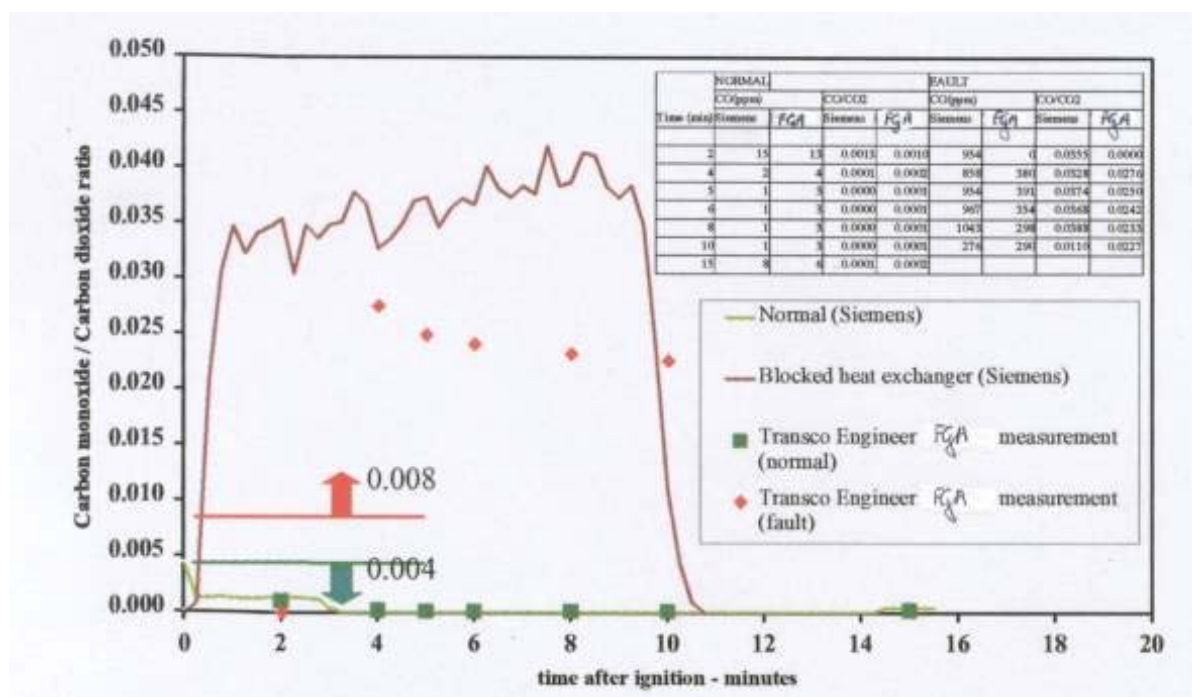
Figure 51: Comparison of engineer tests with logged data for an open flued combi boiler

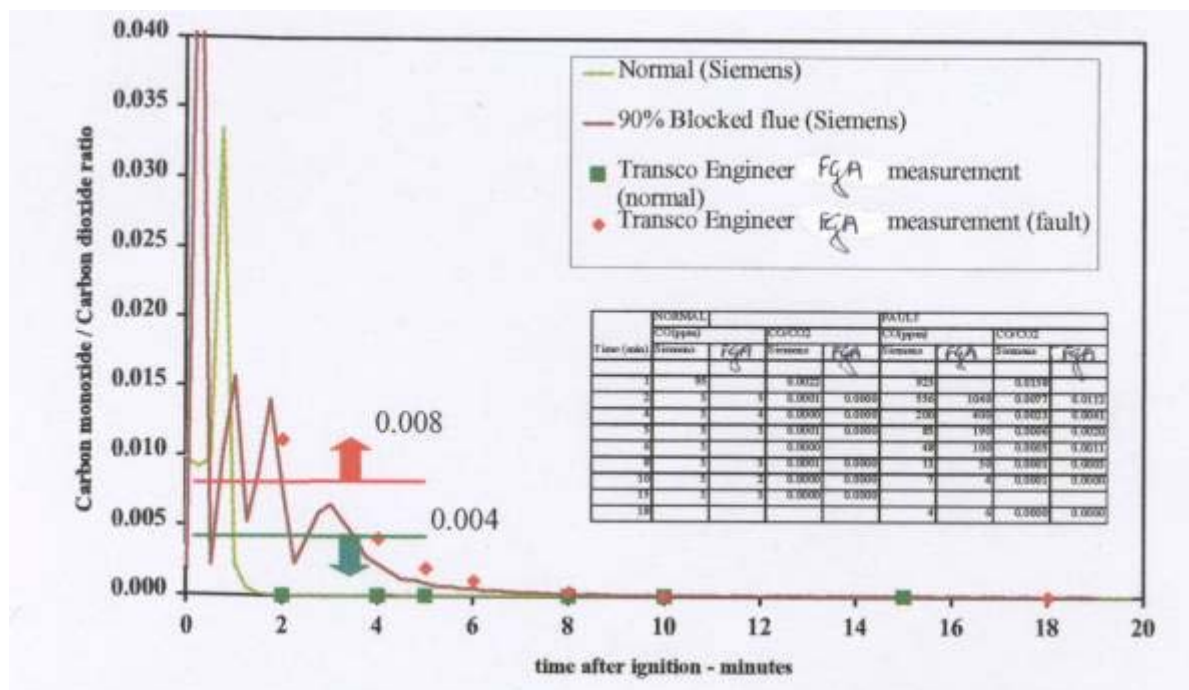
Figure 52: Comparison of engineer tests with logged data for a fan-flued boiler

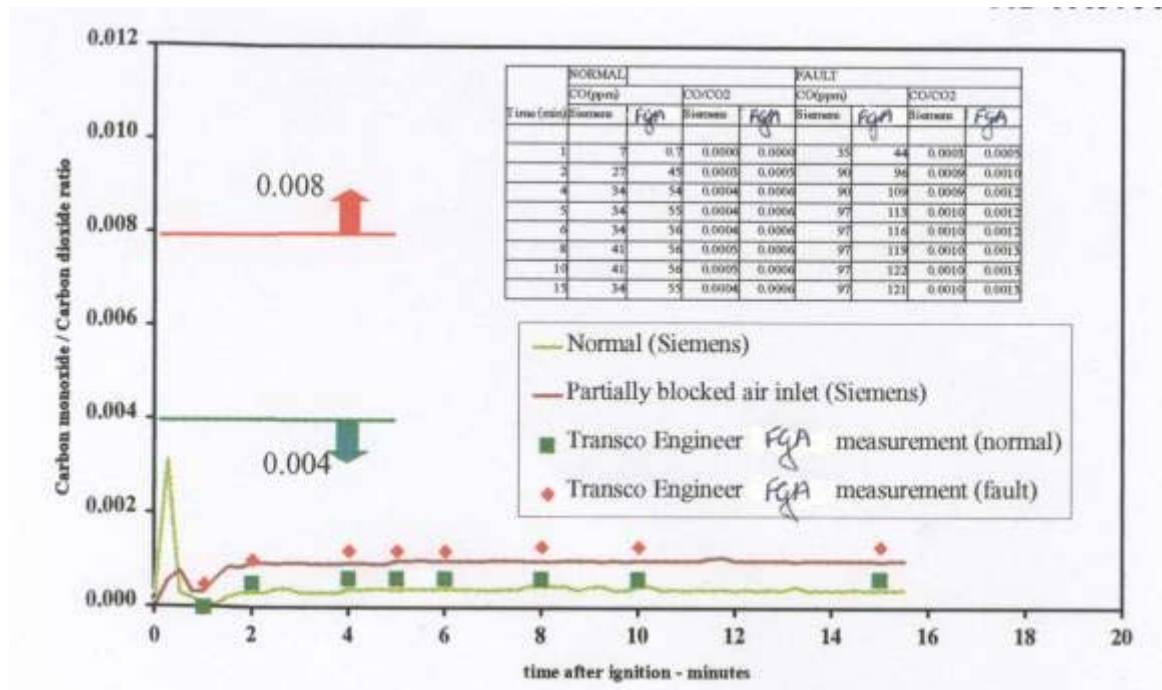
Figure 53: Comparison of engineer tests with logged data for a fan-flued combi boiler

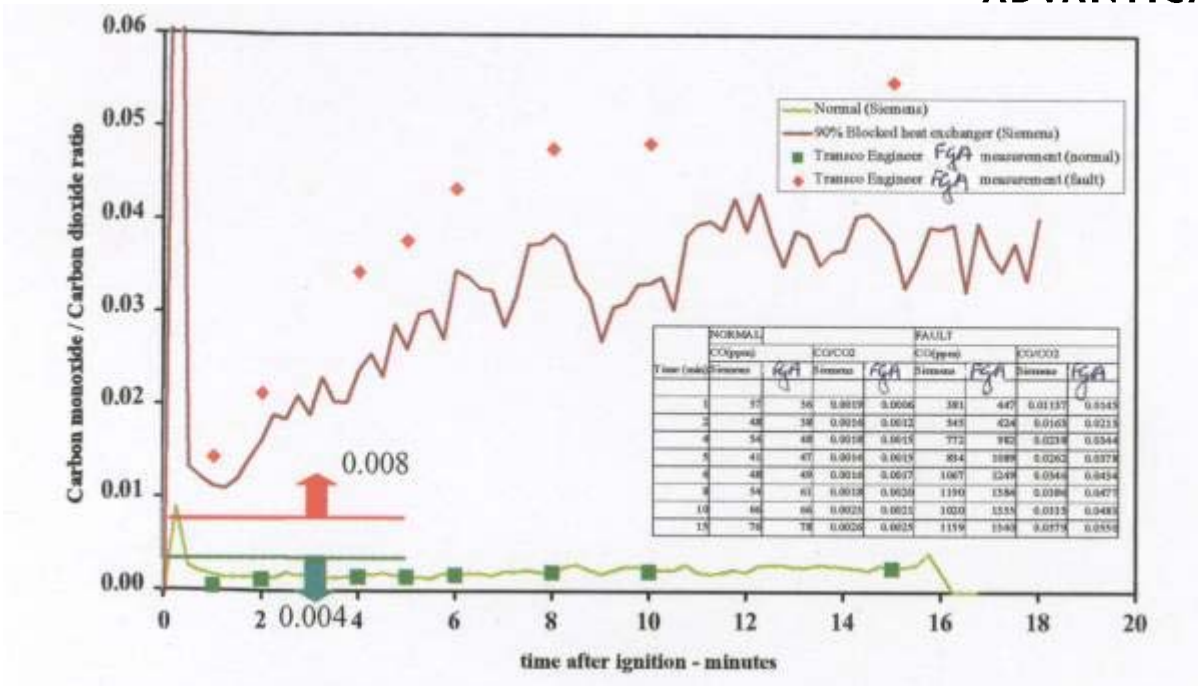
Figure 54: Comparison of engineer tests with logged data for an open flued boiler

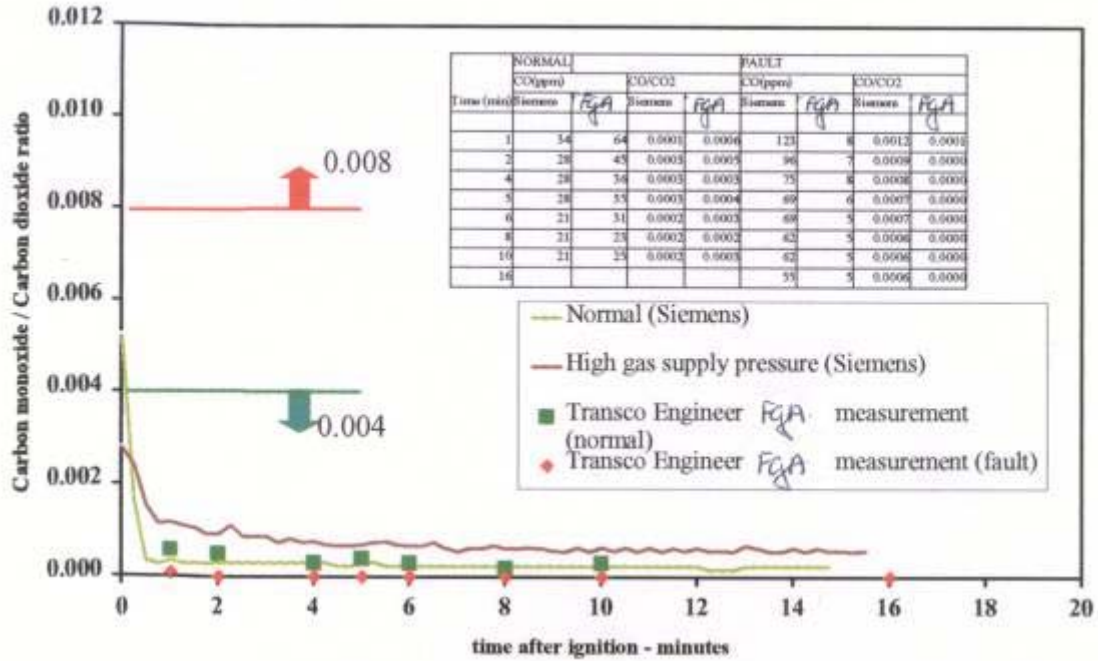
Figure 56: Comparison of engineer tests with logged data for a flueless water heater

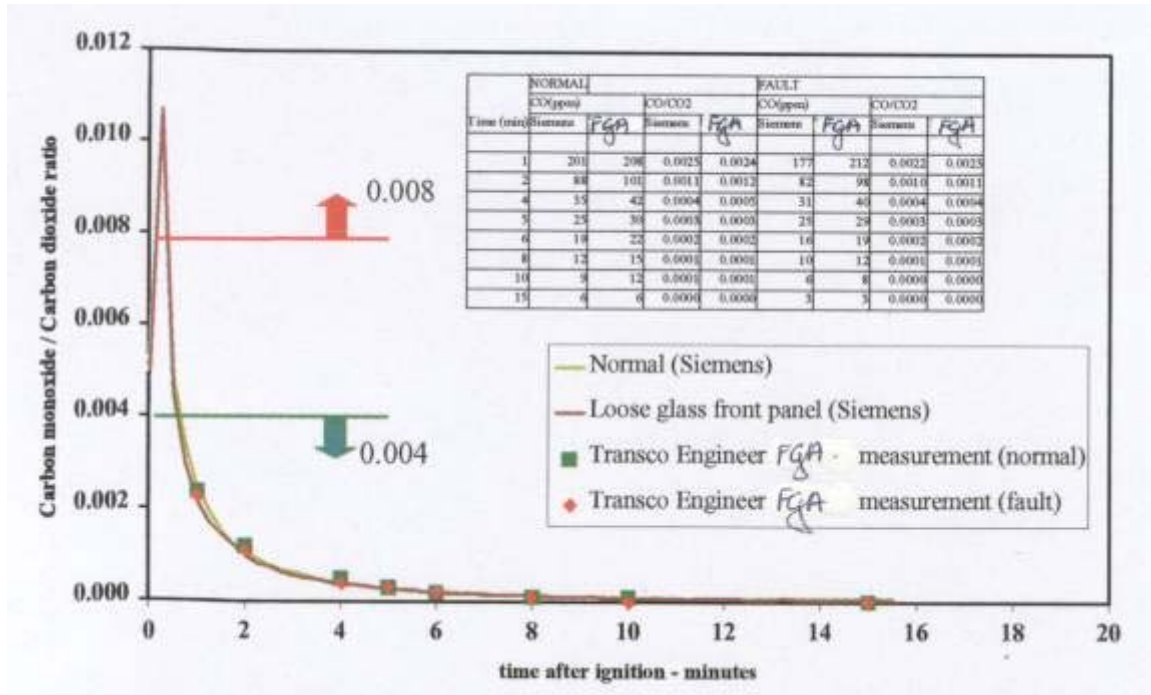
Figure 57: Comparison of engineer tests with logged data for a balanced flue fire

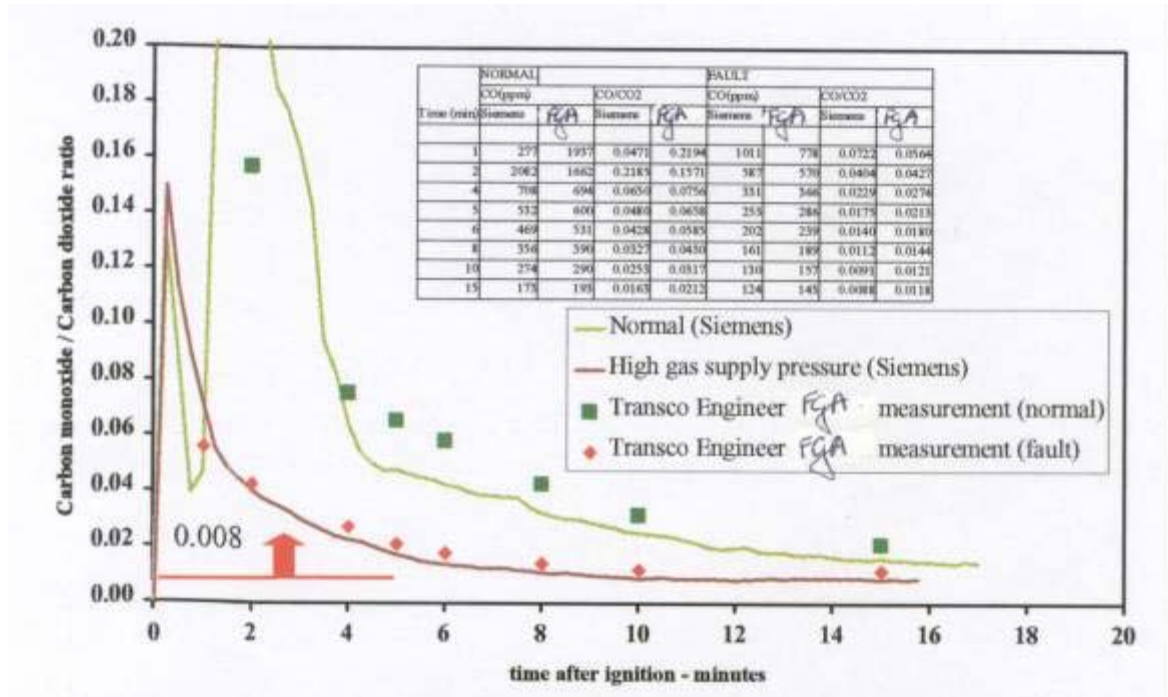
Figure 58: Comparison of engineer tests with logged data for an open flue inset live fuel effect fire
