**An Observational Study of  
Motor Vehicle Repair Paint Sprayers**

**HSL/2006/44**

Project Leader: **Vikki Sanders**  
Authors: **Vikki Sanders and Tim Davies**  
Science Group: **Human Factors**

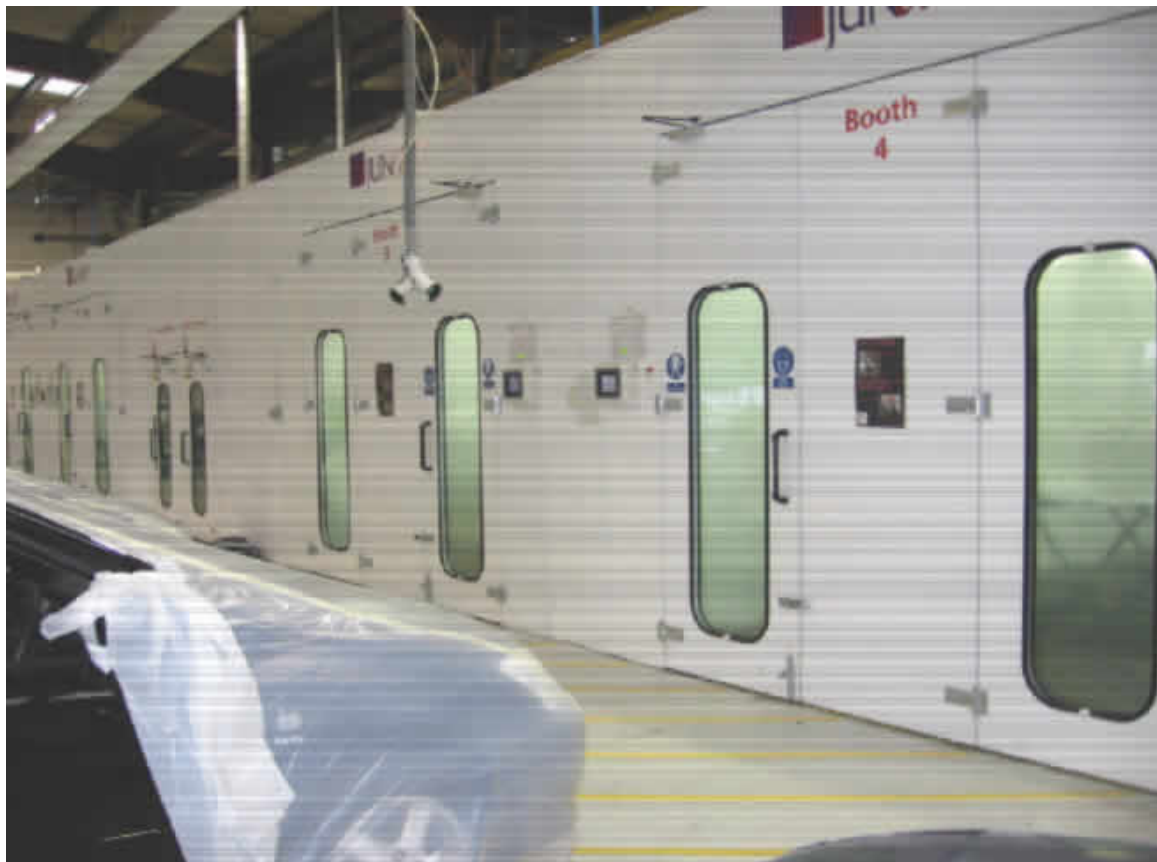
Figure 1: Spray Booth Company One

The work environment was clean and tidy; this is illustrated by figure 1. There was very little dust as every stage of the prepping process was ventilated well. All air fed masks were stored in a clean safe area in the mixing room. Equipment appeared to be in good working order. There was a separate rest room available for all staff to use with a vending machine and kettle. The rest room and office areas were away from the paint spraying area however the prepping area surrounded the booths, which were in the middle of the room, therefore non sprayers could be exposed to isocyanate should the booths be leaking. These were maintained regularly and negative pressure was monitored.

There were HSE posters on the front of each of the spray booths, although there were no noticeable signs indicating the clearance times of the booths. Until the observers conducted smoke tests in the booths this was unknown.

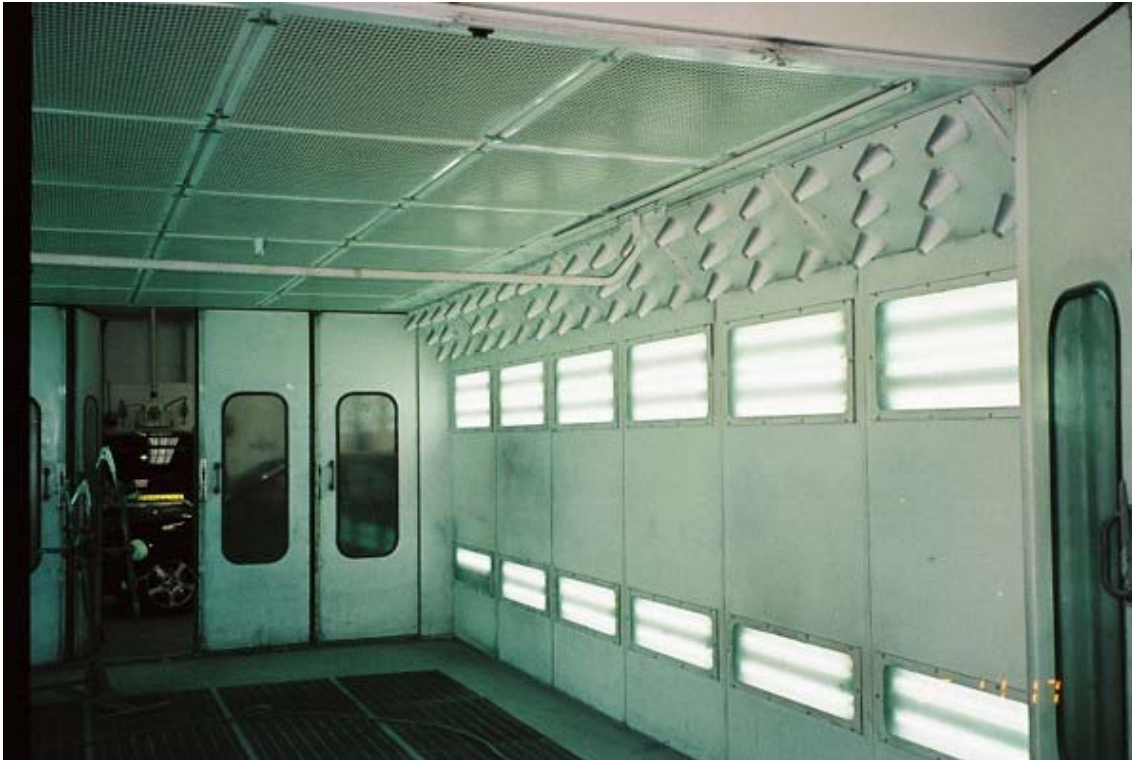
Figure 2: Company Six Spray Booth

- One booth was smoke tested and cleared in under a minute. There were blowers along the length of the booths at the join between the ceiling and the walls that moved any circulating smoke downwards (see figure 2). The exit filters in the pit had recently been changed.
