**Impact Effects on Scaffold from Safety Harness  
Attachments**

**HSL/2007/46**

To determine what the consequences would be to the scaffold structure, when a scaffolder falls off during construction. To investigate forces on a lanyard during a simulated fall, and the effects this would have on the scaffold structure itself.

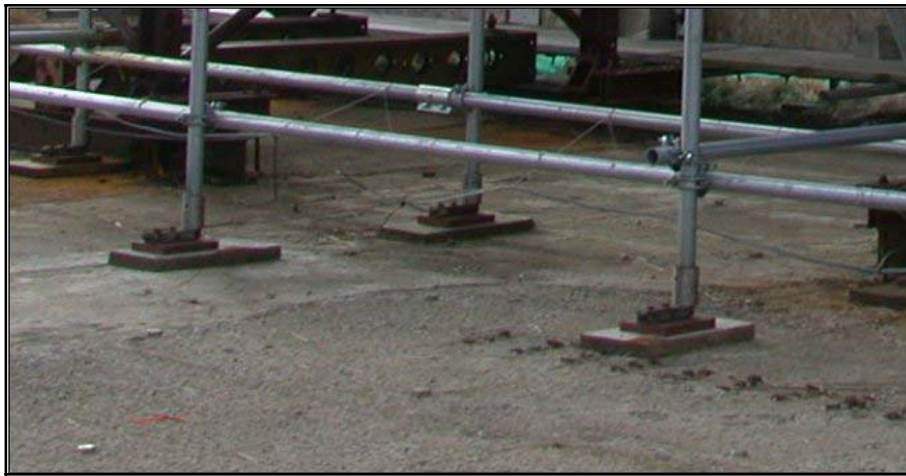
**Figure 2 - Showing Base Loadcells**

Each upright had a 2 tonne shear beam loadcell located at the base to record the vertical reactive force upon the concrete test pad as shown in Figures 2 and 3.

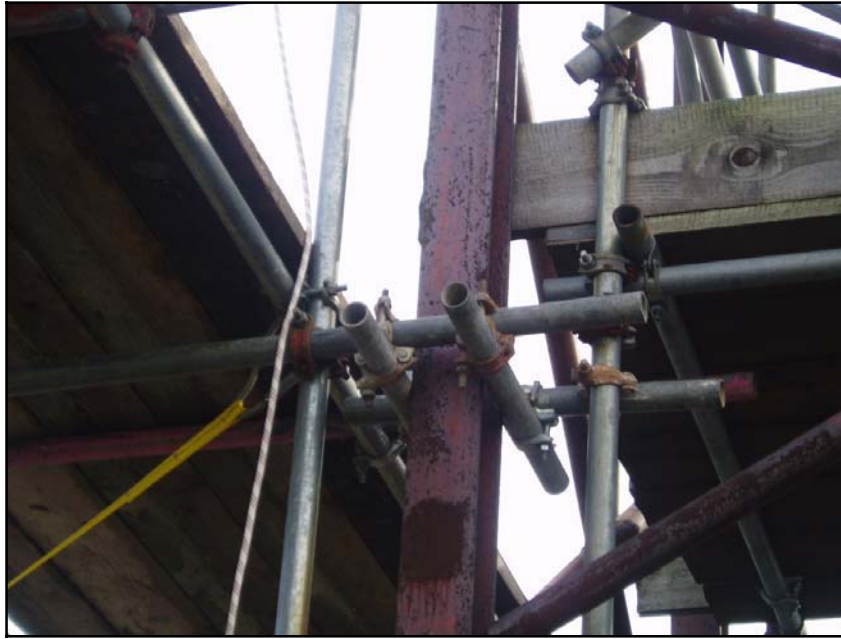
**Figure 6 - As installed Box Tie**

As each stage progressed a further lift was added to simulate a structure being constructed. At the second lift, two box ties were installed back to the supporting RMD towers. One of the box ties was replaced by an instrumented loadcell system to record the horizontal force experienced by the tie. All tests were conducted in the bays (increasing lifts) immediately to the left of the instrumented tie, see Figure 4 (note Figure 4 is a schematic and to avoid complexity, bracing handrails and hoisting mechanism are not shown). Figure 5 shows the test facility in its final stage. Figure 6 shows the original rear box tie between the scaffold and the right hand RMD tower. Figure 7 shows how this was modified to provide an instrumented tie.

Commissioning tests on the first lift showed that the scaffold structure was unstable at low force levels (base loadcells indicated that the two standards had lifted from the ground) and had a tendency to bend the ledger at the attachment point. It was decided to progress to the second lift and fit ties back to the supporting structure, as shown in Figures 6 & 7.

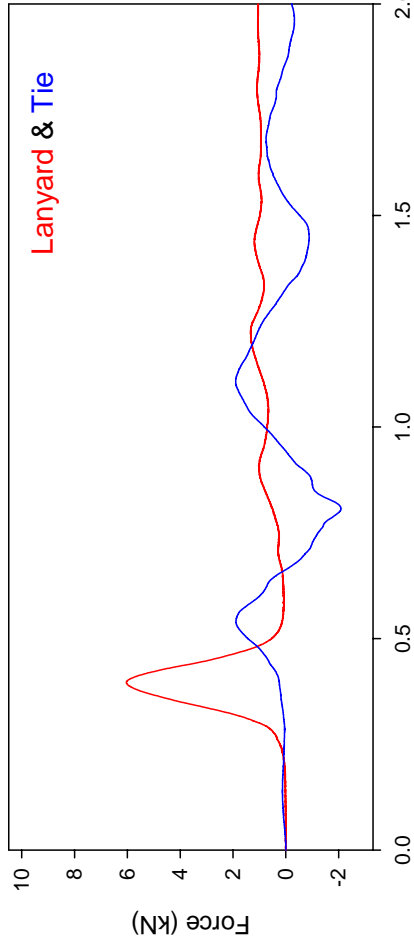
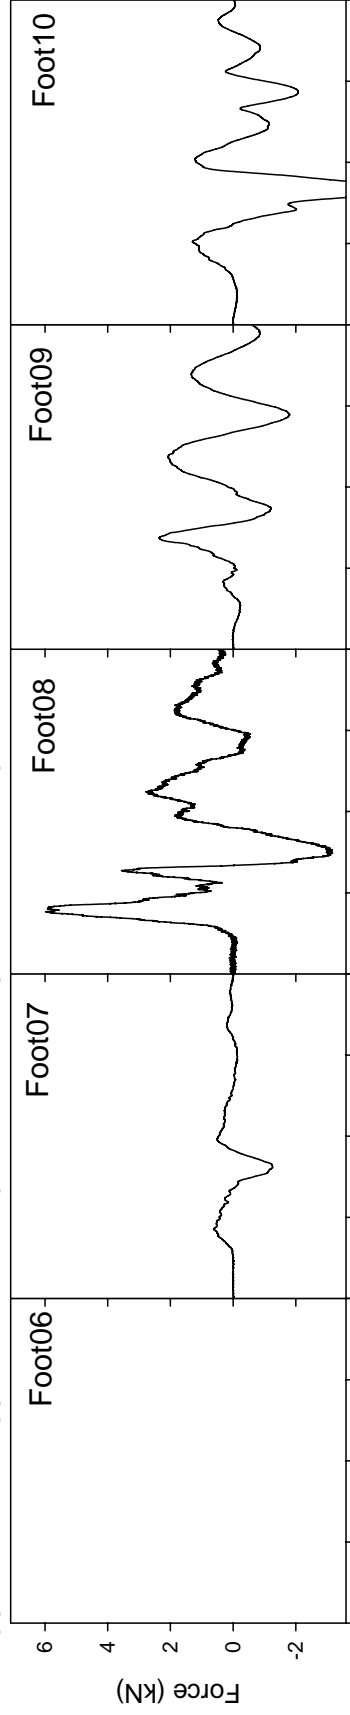
**Test T68**  
**4<sup>th</sup> Lift**  
**Upper Left Ledger**

Base forces and sample graph T68 are shown in Appendix C

Appendix C shows three sample graphs, one for each lift, out of the 68 in total.
