# **The use of castors on racks in the food processing industry**

Prepared by the  
**Health and Safety Laboratory**  
for the Health and Safety Executive 2003

**RESEARCH REPORT 099**

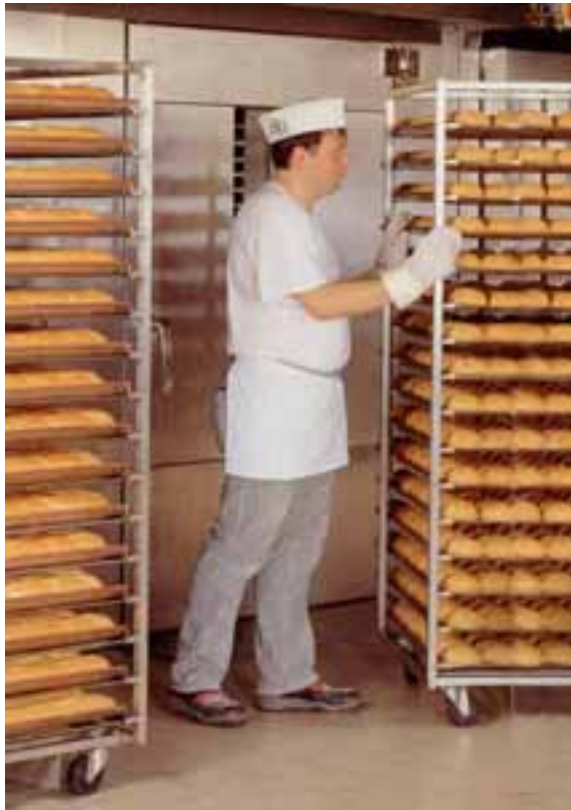
Figure 1 - Food processing racking

Mobile racks are used to store and transport food products during production. Racks are produced in many forms but typically appear as shown in Figure 1. The racks typically support removable shelving which is transferred from production lines to the racks manually. The racks are then pushed or pulled manually from one area of production to another. The racks and castors supporting them have to withstand the range of temperatures encountered during food production as well as the physical demands of day to day use. A drawing of a typical castor identifying the main components is shown in Figure 2.

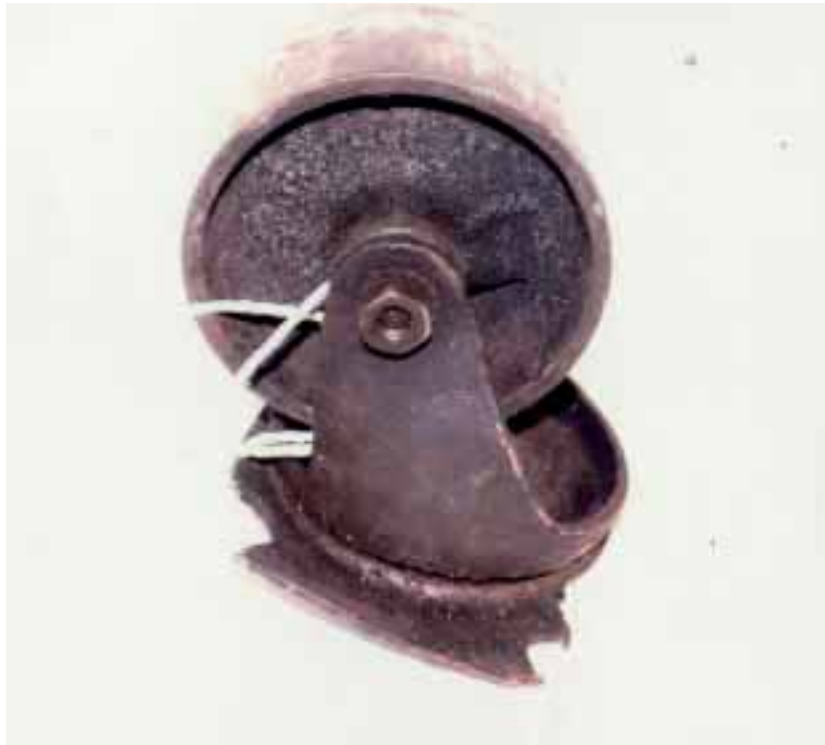
Figure 3 - Cast iron wheeled castor

The engineering manager advised the author that the types of castor which were a particular problem on his site were an older type, with a wheel manufactured from cast iron. Some newer racks had phenolic wheels. It was his opinion that the noise problem was mainly due to the cast iron wheels, while the phenolic wheels were prone to damage and wear, needing replacement when damage became so severe that it prevented easy movement of the racks. Generally the cast iron wheels were considered to be indestructible, and were not being replaced due to being noisy alone.

While on site I was able to inspect a number of the different types of castor currently in use at the bakery. These were mainly the original cast iron wheeled type, but some had been replaced with phenolic wheels, including the type introduced by the engineering manager. It was noted that the phenolic wheels, said to have been in use for about 10 months, did not appear to have deteriorated significantly.

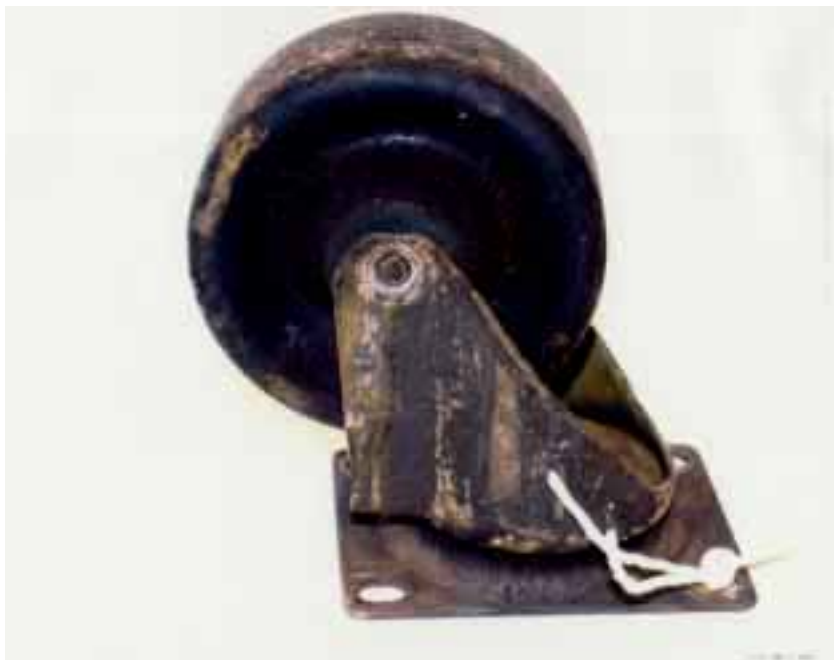
Figure 4 - Phenolic wheeled castor

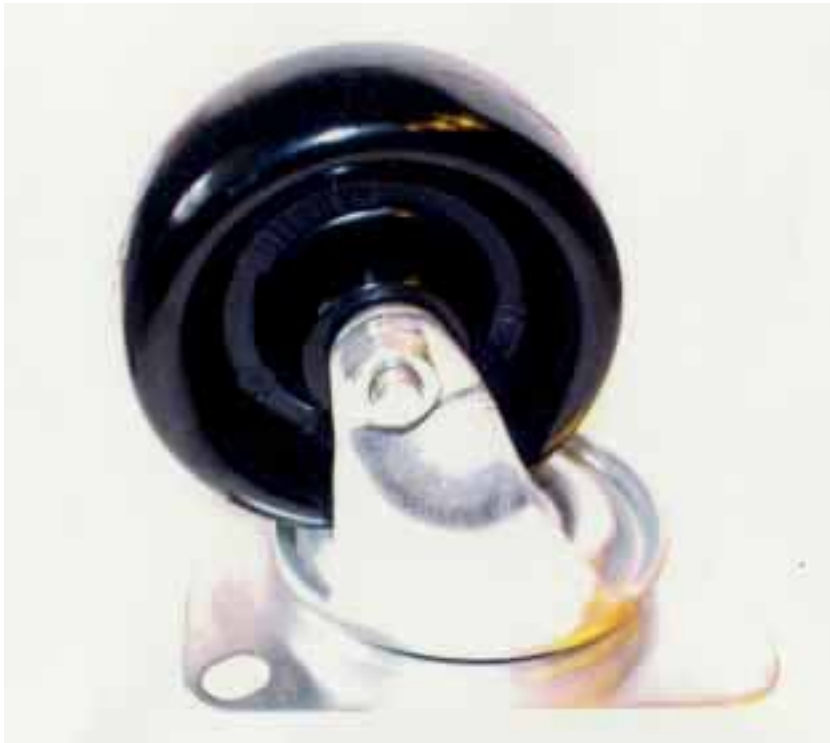
Figure 6 - Phenolic wheeled castor

Figures 6 and 7 show the high temperature phenolic wheel and the high temperature rubber wheel respectively.

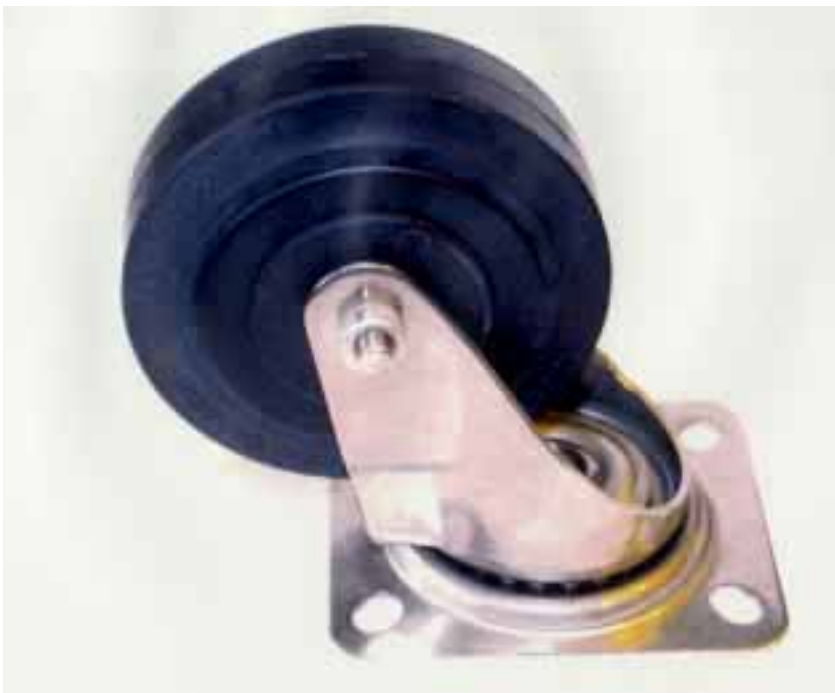
Figure 7 - High temperature rubber wheeled castor

Another alternative to the phenolic wheel described above was a high temperature rubber wheeled castor. The wheel has a high temperature thermoplastic centre with a bonded high temperature rubber tyre. This type of castor is not commonly available in the UK, but is used widely in Europe. The castor had similar temperature rating to the basic phenolic wheel but did not have the same load rating. This type of castor was currently approximately twice the cost of comparative phenolic wheeled castors.
