Axial fatigue tests on wire rope slings used for offshore containers

Prepared by the **Health and Safety Laboratory**
for the Health and Safety Executive 2006

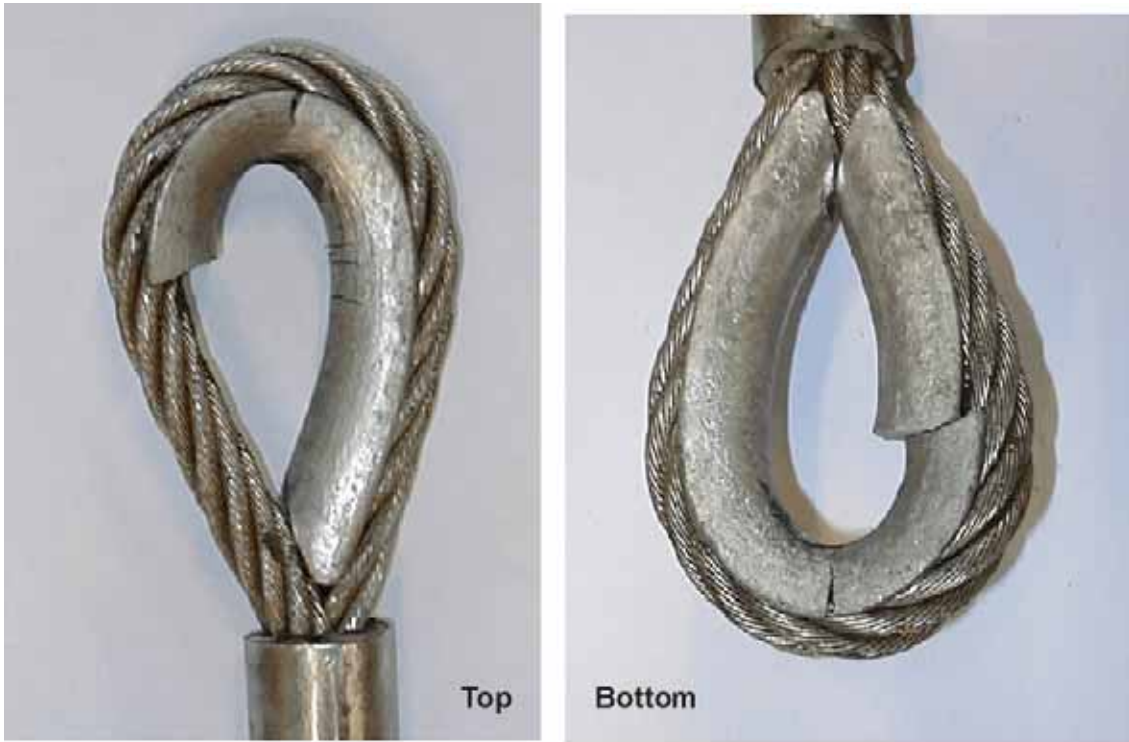
Figure 7 Collapsed thimbles on sample 4 after 5,185 cycles

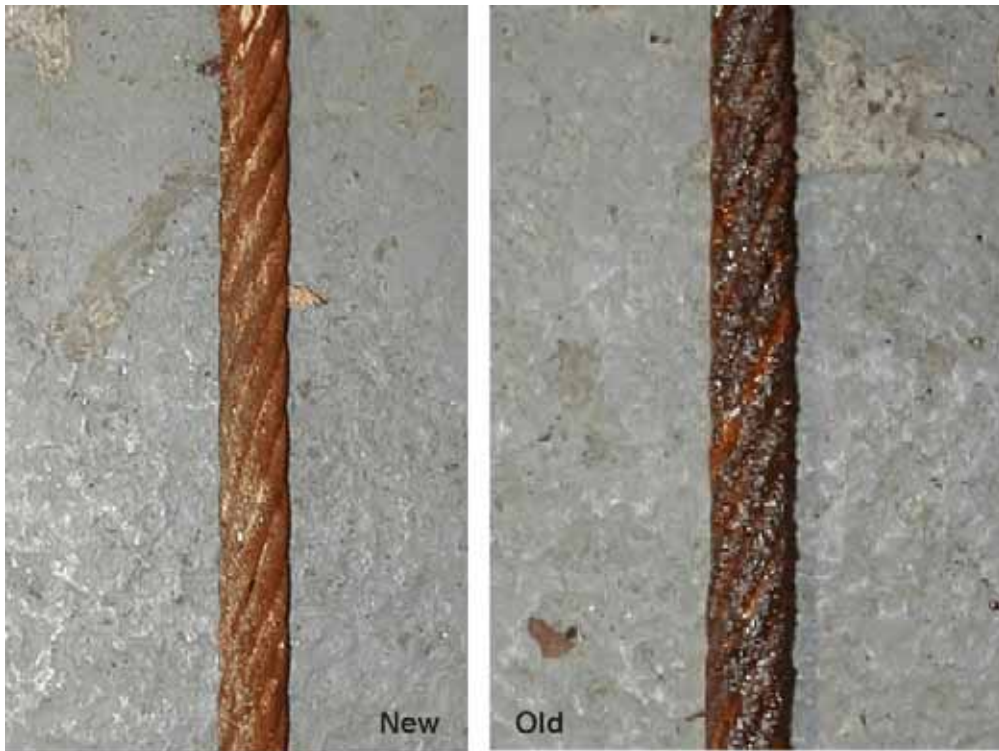
Figure 8 Rope samples after accelerated corrosion for 5 weeks

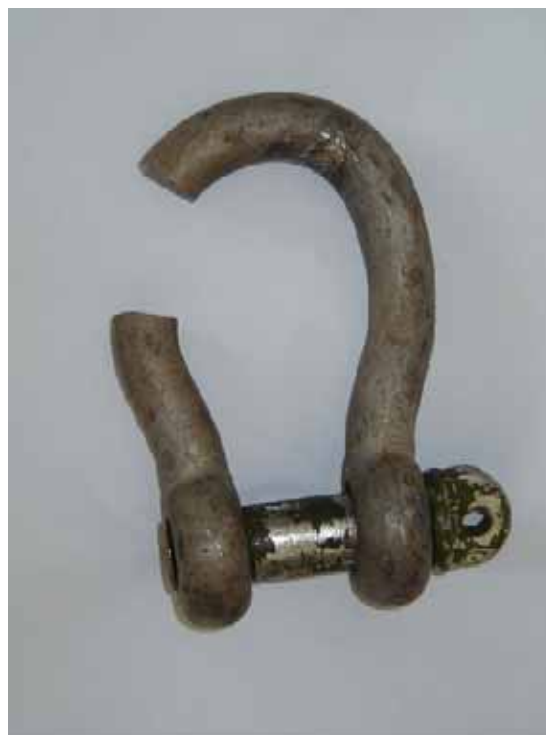
Figure 9 Failure in the upper attachment shackle after 58,100 cycles
