# Novel slip characteristics of conglomerate tiles

Prepared by the **Health and Safety Laboratory**  
for the Health and Safety Executive 2008

The following report outlines the results of laboratory based slipperiness assessments to investigate the novel slip resistance behaviour of conglomerate tiles. All measurements were carried out using HSL standard procedures, in line with The UK Slip Resistance Group Guidelines where applicable.

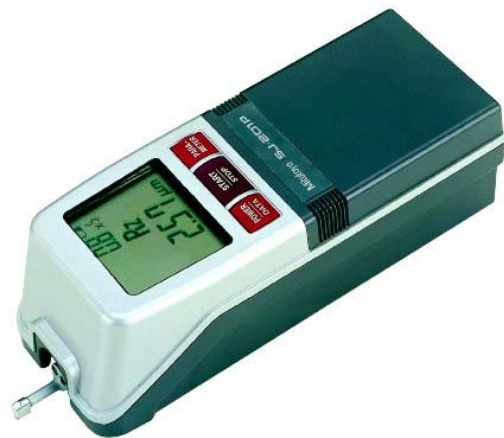
Figure 2.2. The Mitutoyo SJ-201P surface microroughness transducer

The Pendulum was calibrated by the British Standards Institution and slider preparation was carried out as per the UKSRG Guidelines. The Mitutoyo was calibrated against a UKAS roughness standard and checked in-situ using a calibrated roughness plate. Interpretations of pendulum and surface roughness data are based on the UKSRG Guidelines (Appendix A).

Initial testing of each surface to assess the surface roughness was carried out using a calibrated Mitutoyo SJ201-P surface microroughness transducer. The following 11 roughness parameters were recorded:

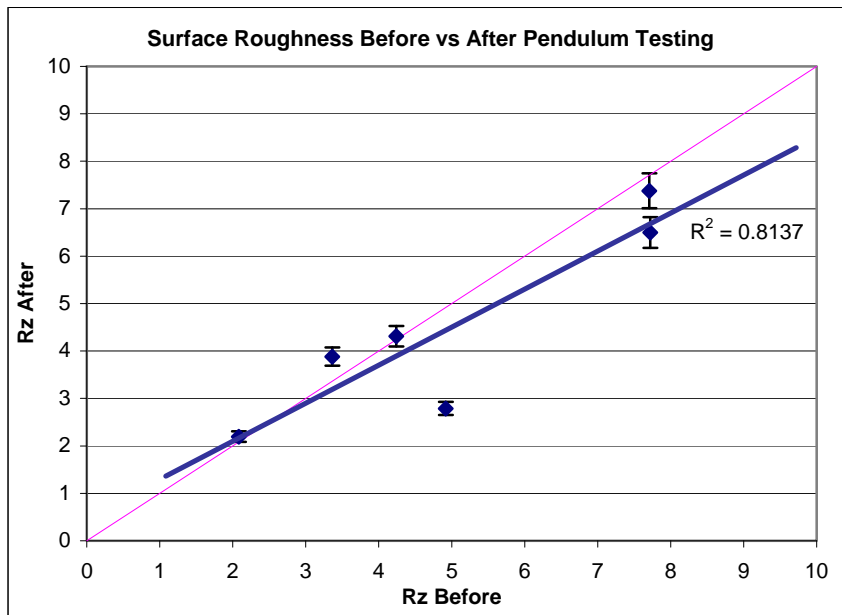
The results are shown in Figure 3.3. The error bars indicate variance set at  $\pm 5\%$ , the tolerance of the Mitutoyo’s daily calibration check.

Number	Rz	
	Before	After
PED/07/022	2.08	2.20
PED/07/052	7.71	7.38
PED/07/053	4.92	2.79
PED/07/054	4.24	4.31
PED/07/055	3.37	3.88
PED/07/056	7.72	6.50

Figure 3.3. Rz surface microroughness before and after pendulum testing. Pink line shows 1:1 relationship. Trend line shown in blue.

Most of the Rz values recorded after testing are similar (close to the pink 1:1 line) to the measurements made before pendulum testing. The most variation shown, i.e. the furthest point from the pink 1:1 line, indicates a decrease of  $2\mu\text{m}$ , which may be accepted as within the measurement repeatability. Without this point on the graph (before =  $5\mu\text{m}$ , after =  $3\mu\text{m}$ ) the trend line would be much closer to the pink 1:1 line and show almost no variance from a 1:1 relationship. At this range of Rz much change is unlikely; a change of 20% would be equivalent to Rz  $10\mu\text{m}$  reducing to Rz  $8\mu\text{m}$ ; the extension of the trend line suggests that this may be a reasonable expectation.

With the exception of the testing on the unfinished reverse side of one of the tiles, the roughest surface tested was below Rz  $10\mu\text{m}$ . What is unknown is whether the relationship observed would extend to rougher surfaces. A 20% change to a surface of Rz  $40\mu\text{m}$  would result in Rz  $32\mu\text{m}$ . For a surface to change by Rz  $8\mu\text{m}$  with as much wear as is applied here would be very unlikely. However, what may be expected is that over the lifetime of the flooring the surface will gradually wear, and the slip potential will continually change.

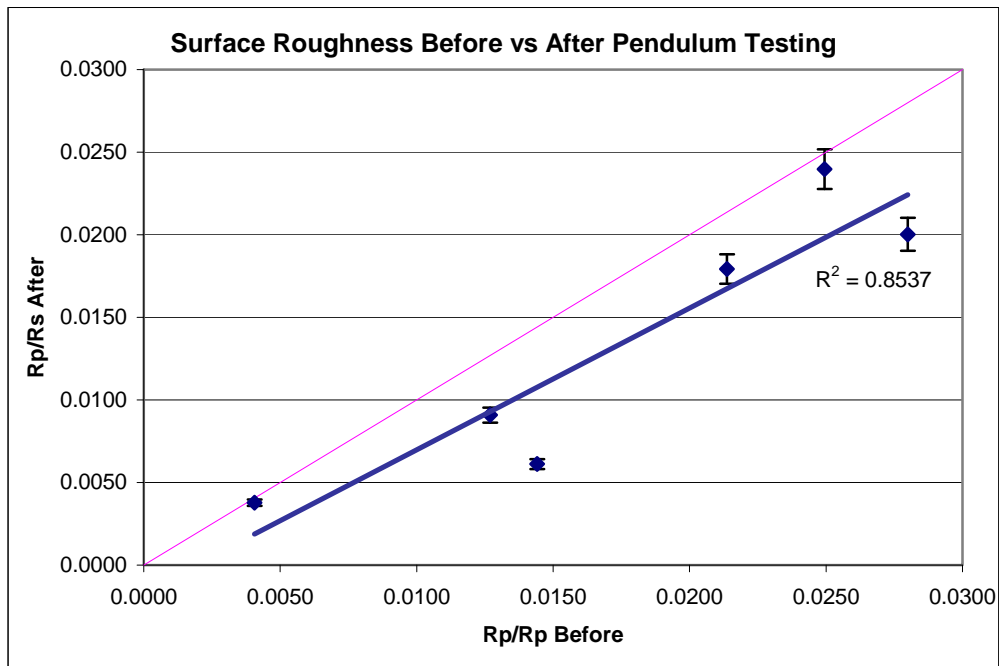
A hybrid surface roughness parameter,  $R_p/R_s$ , has been found to correlate more closely with the PTV than Rz in some instances. An equivalent graph to Figure. 3.3 for this combined surface roughness parameter is given in Figure. 3.4.

Figure 3.4. Rp/RS surface microroughness before and after pendulum testing. Pink line shows 1:1 relationship. Trend line shown in blue.

The  $R^2$  value of the relationship shown in Fig. 3.4 is slightly higher than that shown in Fig. 3.3, indicating a closer fit of the data points to the trend line. The trend line is also closer to being parallel with the 1:1 indicator line, suggesting that a more consistent level of change of the roughness was achieved over the course of the testing. The result trend line is again below the 1:1 indicator line, showing a trend of decreased surface roughness after testing compared to before testing.

The maximum peak height,  $R_p$ , usually decreased and the mean spacing between peaks,  $R_s$ , tended to increase during testing. This is a likely consequence of microscopic peaks being smoothed, and leads to a significant change to the  $R_p/R_s$  value, in one case a reduction of over 50% was recorded (0.0144 before to 0.0061 after) but the trend line suggests an average reduction of 20%. This is in line with the values suggested for  $R_z$  roughness.

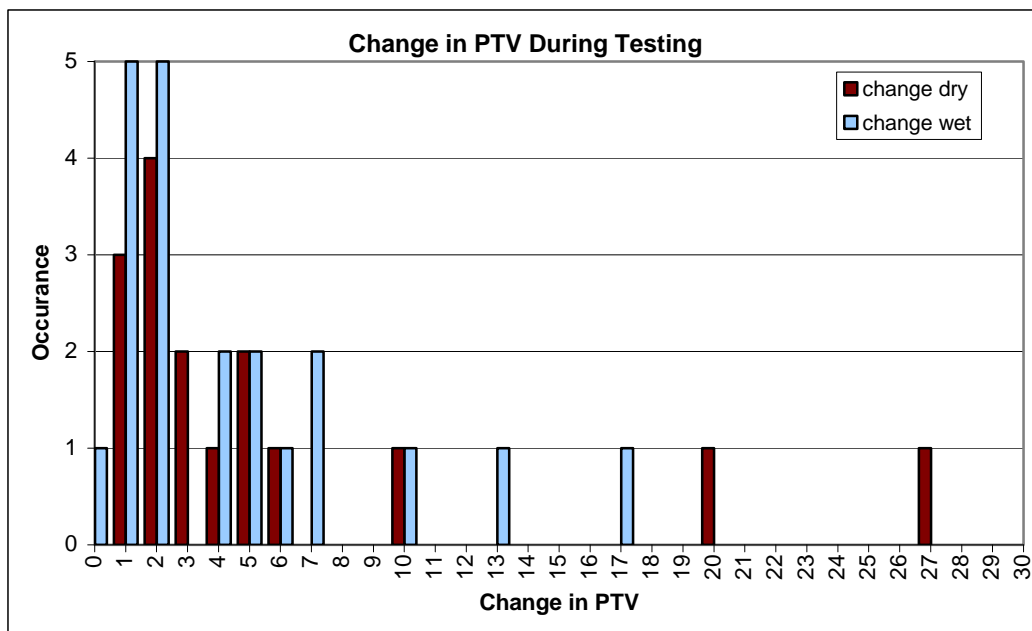
Figure 4.1. Change in PTV over the course of repeated testing. Pendulum tests were repeated until the same PTV was achieved in 3 consecutive tests

These values suggest that although the wet PTV is only shown to change by 0 to 5 PTV in the majority of cases, when considered as a percentage change in relation to the starting point, this

accounts for a much greater difference. Over a third of the tiles tested changed by 20% or more in the wet over the course of the testing, and over three quarters changed by 10% or more. These values could indicate a significant change with regards the slip potential presented to the user. A 20% reduction of PTV and Rz surface roughness could significantly alter the slip resistance of an installed flooring surface, and may significantly alter the systems required to maintain the floor in a safe manner.
