Application of a testing regime for offshore fire dampers

Prepared by the **Health and Safety Laboratory**
for the Health and Safety Executive 2013

S F Jagger
Harpur Hill
Buxton
Derbyshire
SK17 9JN

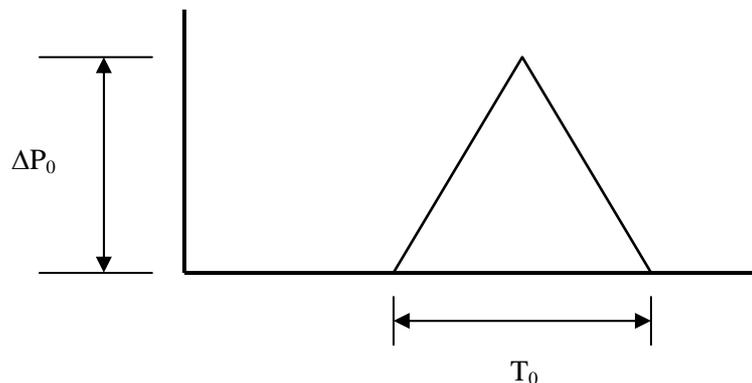
Figure 2 A typical design explosion pulse of over pressure of ΔP_0 and duration T_0

The technical specification indicates that the pressure load can be tested in steady state or in dynamic conditions resembling a triangular pressure pulse of minimum 300 ms duration as shown in Figure 2. A typical gas explosion pressure wave will have a duration of 100-300 ms. The fire dampers blast pressure rating is the maximum overpressure to which it can be subjected without losing its ability to provide protection as a fire barrier. Dampers can be classified according to the following scheme detailed in ISO/TS 27469:

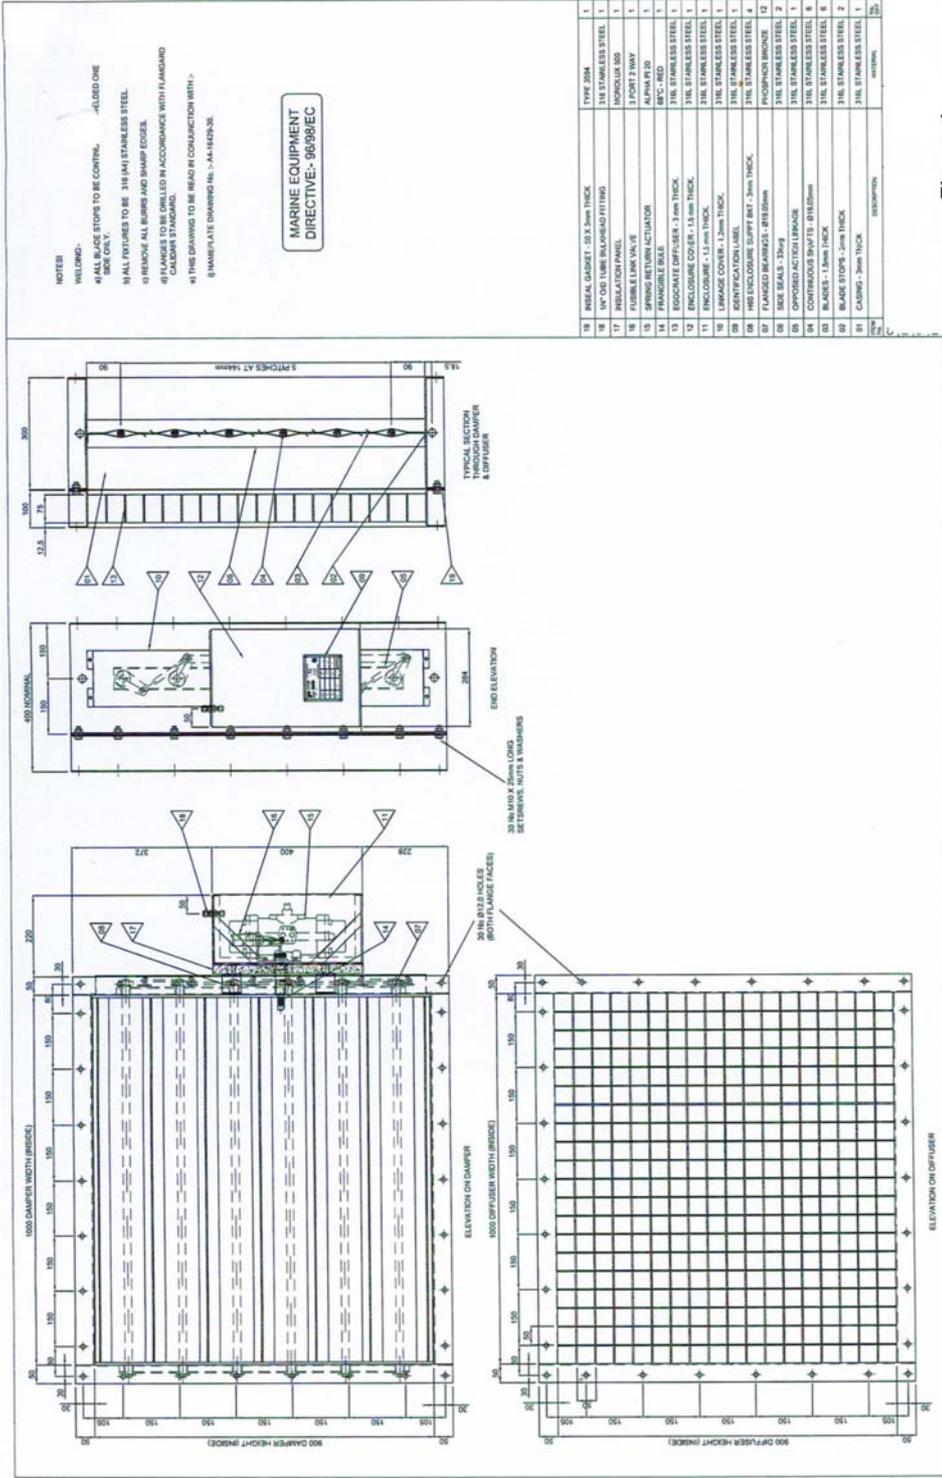
Figure 1
 An Engineering drawing
 of the dampers used
 in this work

A fire damper was acquired from a well-known UK manufacturer. This was specially prepared for this programme and an engineering drawing is shown in Figure 1. Figure 8a shows the damper as delivered with the internal side upwards. This comprised a horizontal-bladed damper with an opening measuring 1000 mm in the horizontal and 900 mm in the vertical manufactured from 316 stainless steel. When closed the set of six 1.5 mm thick blades interlocked to form a continuous barrier. The damper was opened against a spring by the application of compressed air. There was no fusible link closing mechanism provided.

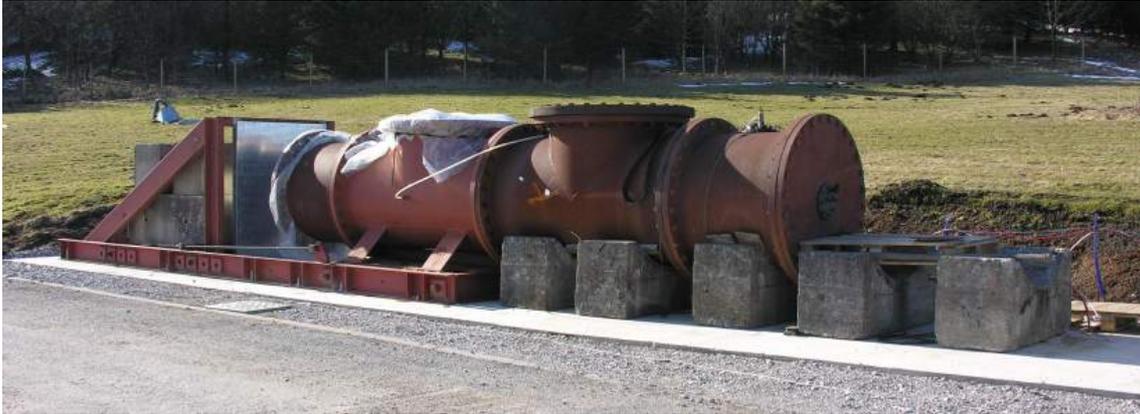
Figure 3: General view of 1.04 m diameter pipe vessel and target support frame (6 m length shown)

The explosion facility used at HSL is constructed using a number of 1.04 m internal diameter steel pipe sections bolted together as shown in Figure 3. Gas is introduced into the vessel and ignited to generate the explosion.

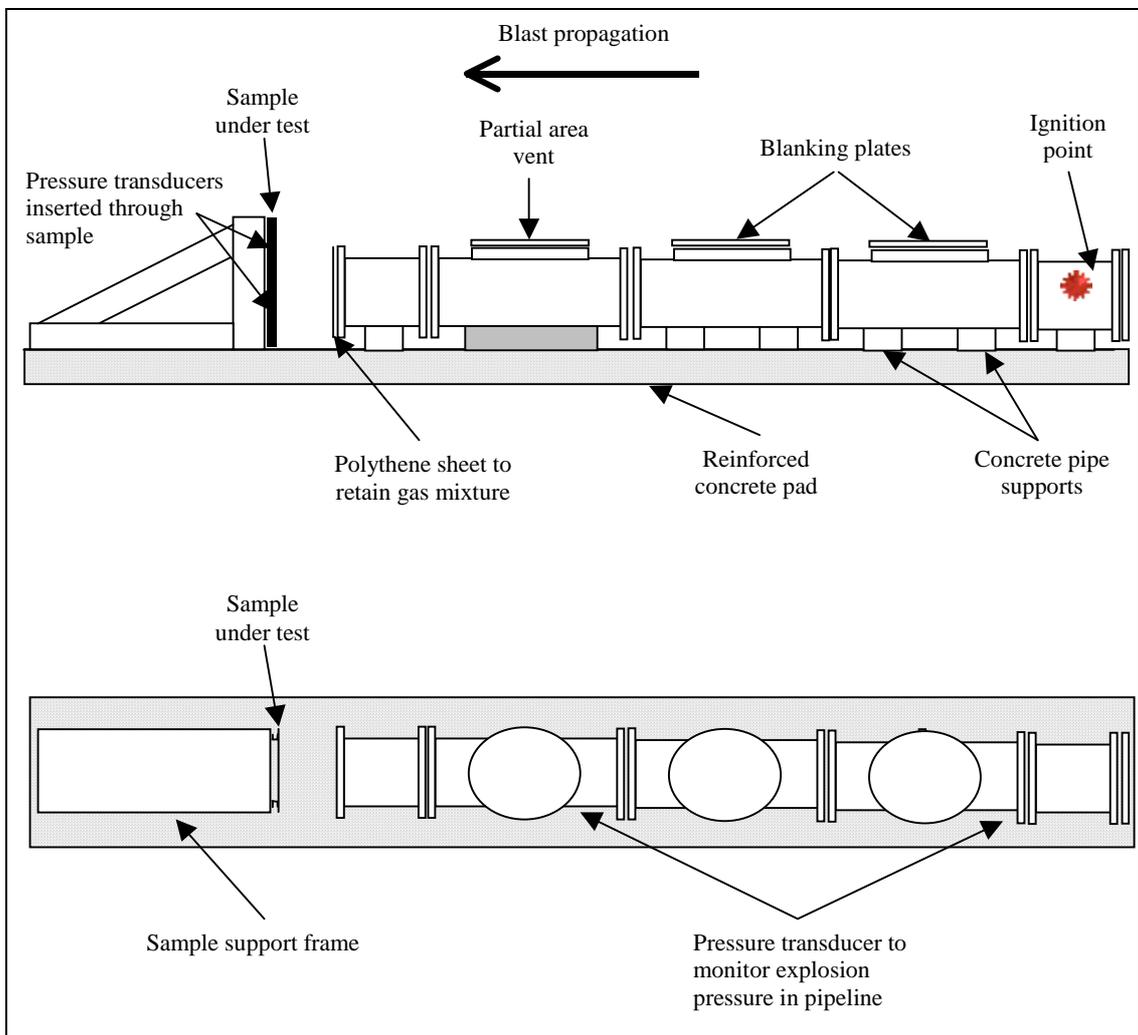
**Figure 4: Schematic diagrams of blast exposure pipe vessel;
a) side view, b) plan view**

The general appearance of the pipeline and target support frame is shown in the schematic diagrams of Figure 4. Figure 5 shows the removable vent arrangement used to tune the explosion pressure to the desired range. In this instance, it is $\frac{3}{4}$ open.

The pipe configuration used was the same as that employed for the preparatory test programme, shown schematically in Figure 4.

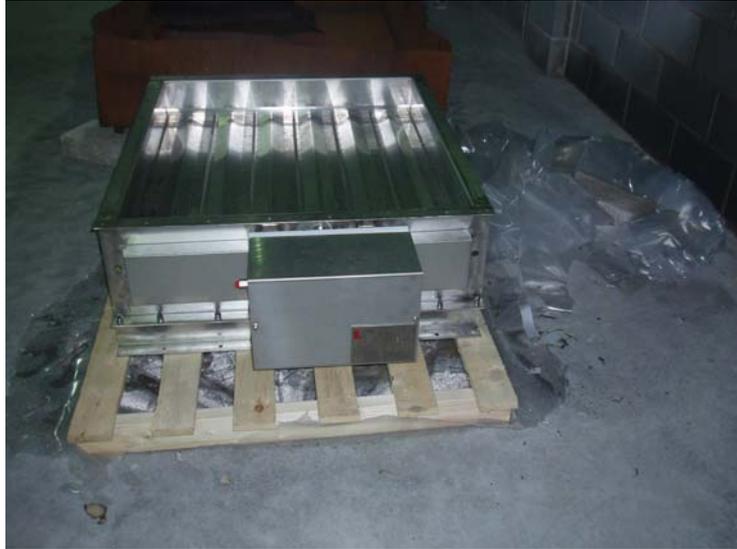
Figure 8 A photograph of the fire damper as delivered. The damper is front face down with the actuator mechanism nearest the camera.

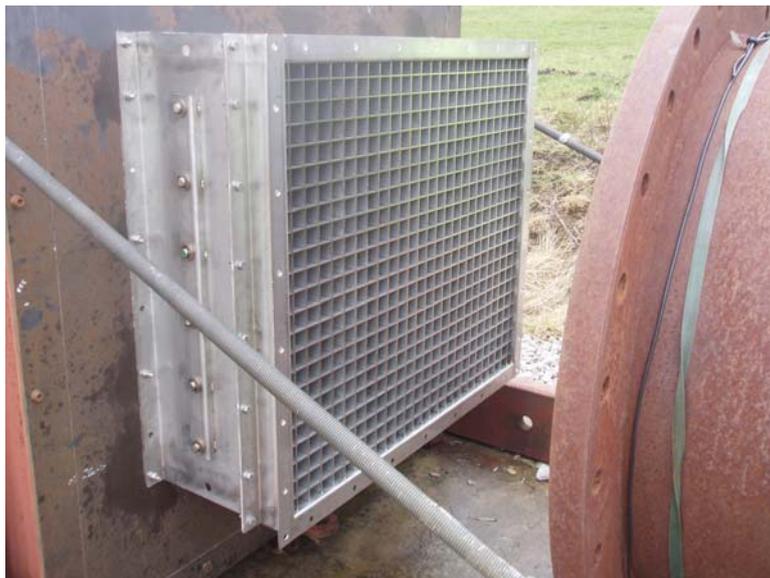
For the blast test on the fire damper, the damper was first mounted in the vertical orientation on to a mild steel annulus plate measuring 1620 mm square and 10 mm thick with a cut out 1000 mm square, by bolting through the flange. This in turn was drilled and bolted to the sample holder. The diffuser was front on to the open end of the pipe. This arrangement is shown in Figures 9 and 10 which show the damper and the damper pipe arrangement.

Figure 9 The damper mounted ready for the blast test. The diffuser attached to the front of the damper can clearly be seen.

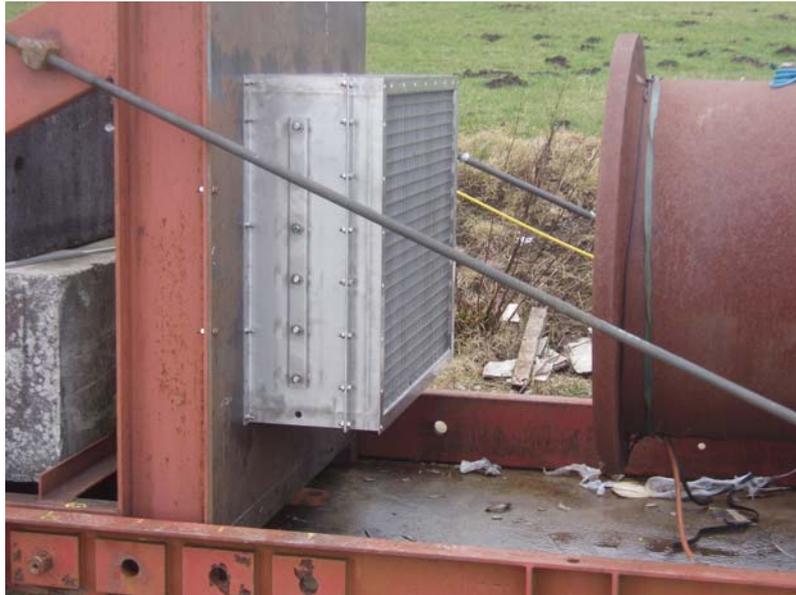
Figure 10 The damper in position ready for the blast test, showing its position relative to the open end of the pipe.

Prior to the test the position of the damper relative to the open end of the pipe was adjusted so that the distance from the damper blades to the open end of the pipe was as close as possible to 750 mm – the distance at which the pressure measurement at the sample position was taken during the pre-tests. Thus, using the most appropriate stop on the rails, positioned the front face of the diffuser 595 mm from the open end of the pipe – this gave a blade distance of 820 mm.

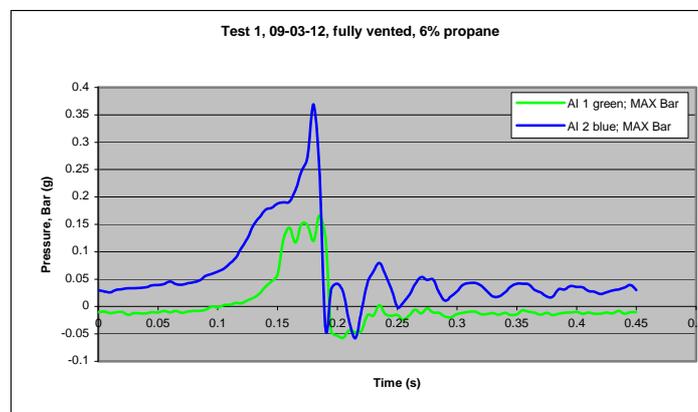
Figure 11 Measured pressures during the fire damper blast test

The pipe was then filled with propane to close to the required concentration, mixed with air and the vapour-air mixture ignited. The time variation of pressure measured below the vent and at the rear of the pipe are shown in Figure 11. The peak pressures measured at these locations were 0.166 and 0.369 bar respectively. From previous experience, this implies that the peak pressure seen by the test sample was 0.37 bar \pm ~10%. The duration of the pressure pulse was of the order of 100 ms, close to the requirement of ISO/TS 27469.

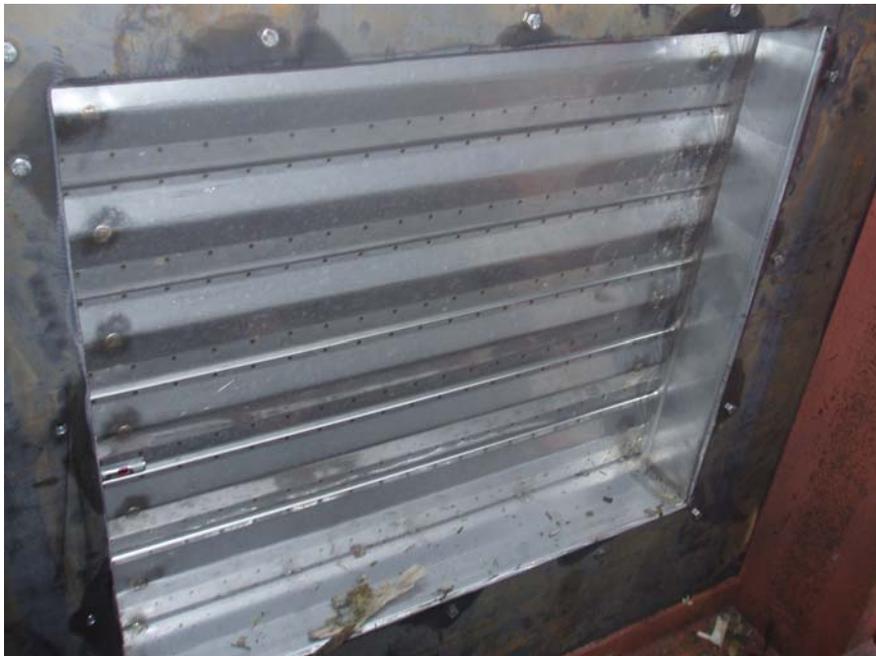
The damper was examined after the test. It was not possible to inspect the front face due to the presence of the diffuser. No attempt was made to remove this. There appeared to be little deformation of the damper blades. There were no gaps around the perimeter of the damper both along the vertical and horizontal edges. Measurements were taken across each blade working from the top to bottom blades. Measurements were taken of the dimension from the rear of each blade to the lip of the next one down. No distortion in excess of 1-2 mm was observed. The blades interlocked as completely after the test as before.

Figures 12 and 13 show the blades as seen from the rear of the damper after the test. Figure 12 is a general view and Figure 13 a close up of the lower part of the damper. No distortion of the blades can be seen and the blades interlock completely.

Figure 12 A general view of the rear of the damper post-test

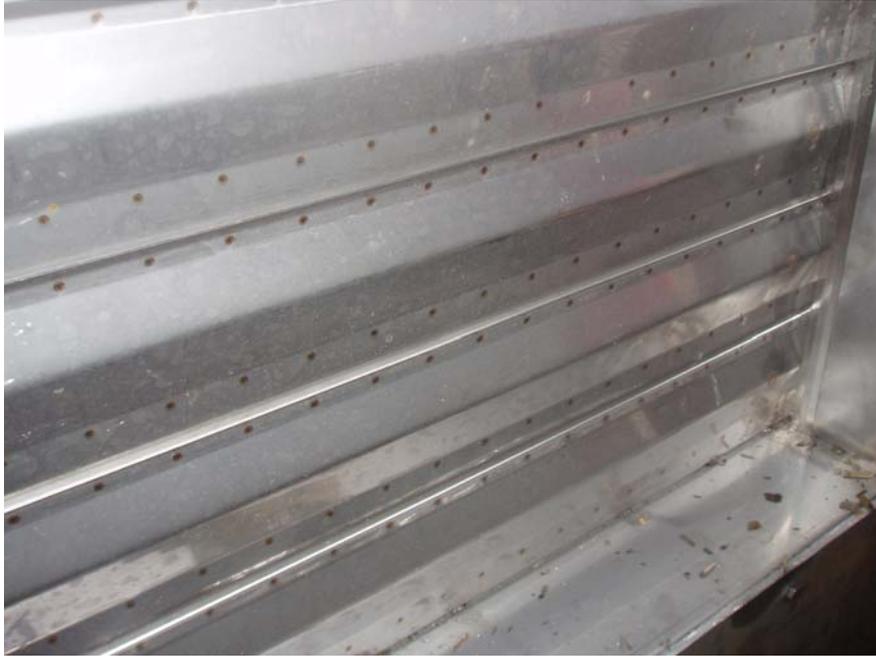
Figure 13 A close-up of the lower rear part of the damper post-test

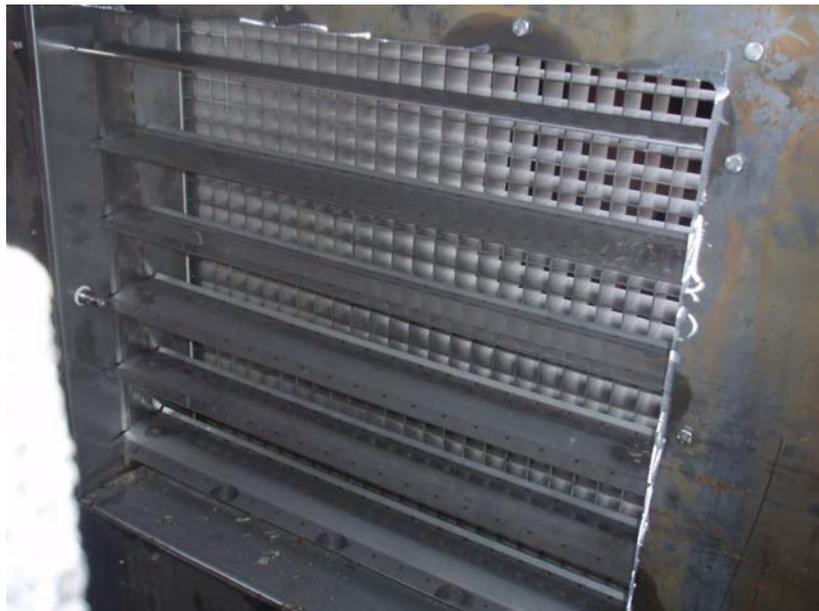
An opening and closing test was then performed. The air supply to the actuator was cycled several times and the damper opened and closed without delay and without fouling any part of the mechanism on each occasion. Further, during this process, the blades interlocked completely as required. Figure 14 shows a view of the open damper post-test. No distortion of the damper can be seen. Some measurements were taken from the rear of the assembly of the blade positions using the frame as a reference. Measurements of the position at 0.75, 0.50 of the damper height and along the bottom blade showed differences of <math><1.11\text{ mm}</math> in the horizontal and 1.35 mm in the vertical direction. No measurements were taken prior to the test so it is not known if these deviations were as a result of the blast.

Figure 14 A view of the open damper post-test. The damper behaved normally during this test.

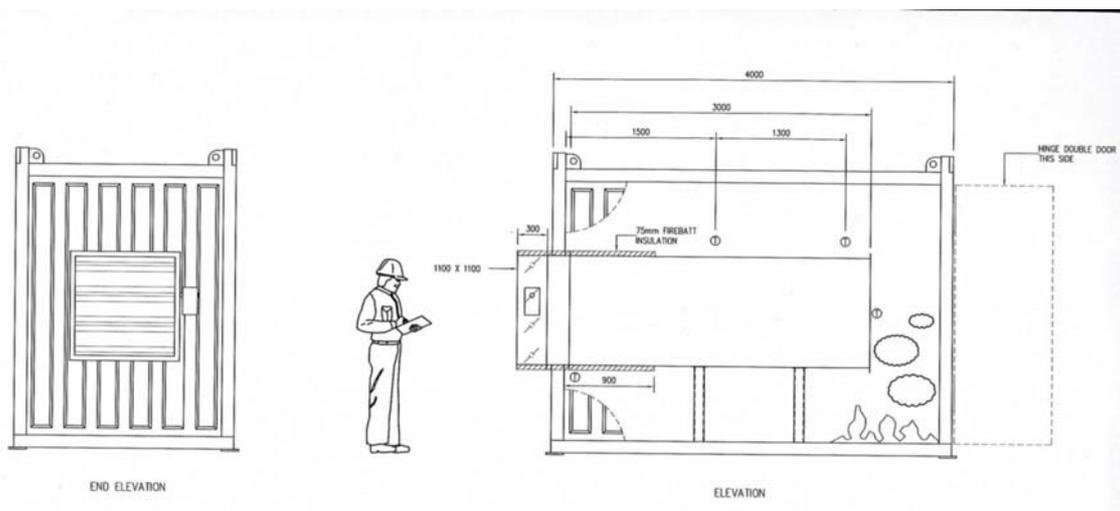
Initially a suitably-sized opening was cut in the closed end of the container and a length of ducting inserted into the container. The ducting was manufactured from 6 mm thick stainless steel and measured 900 x 1000 mm in cross section and was 3 m long. It was fitted with two 50 mm stainless steel flanges to each end and was supported inside the container by four legs. The mild steel 12 mm thick plate was bolted to the end wall of the container and the damper and duct flanges offered up the plate, one outside the container and the other inside. Both were bolted through the plate and secured. The diffuser formed the front face of the arrangement and was positioned forward of the container end wall with the damper aligned just forward of the container end wall. Any openings through the container between the in- and out-side were closed by forcing Kaowool mineral fibre insulation into them. Figures 16(a) and 16(b) show front and rear views of the damper installed in the container.

Figure 15 The arrangement of the damper/ducting arrangement in the ISO container for the jet fire test.

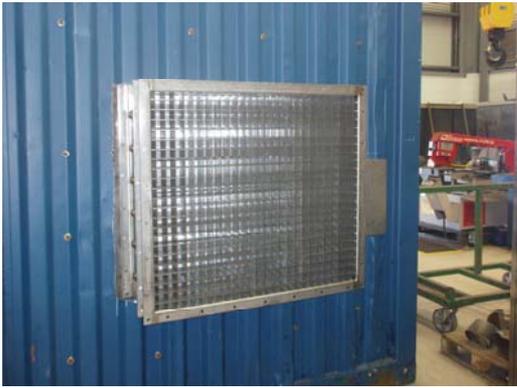
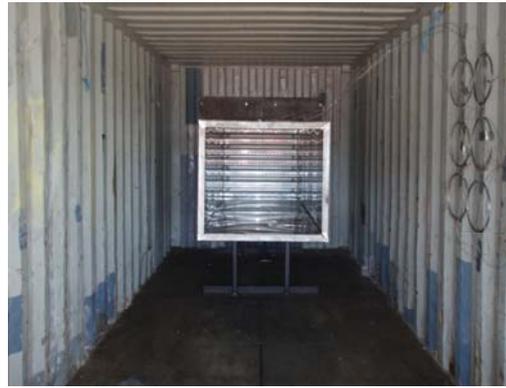
Figure 16 Front and rear views of the damper installed in the container

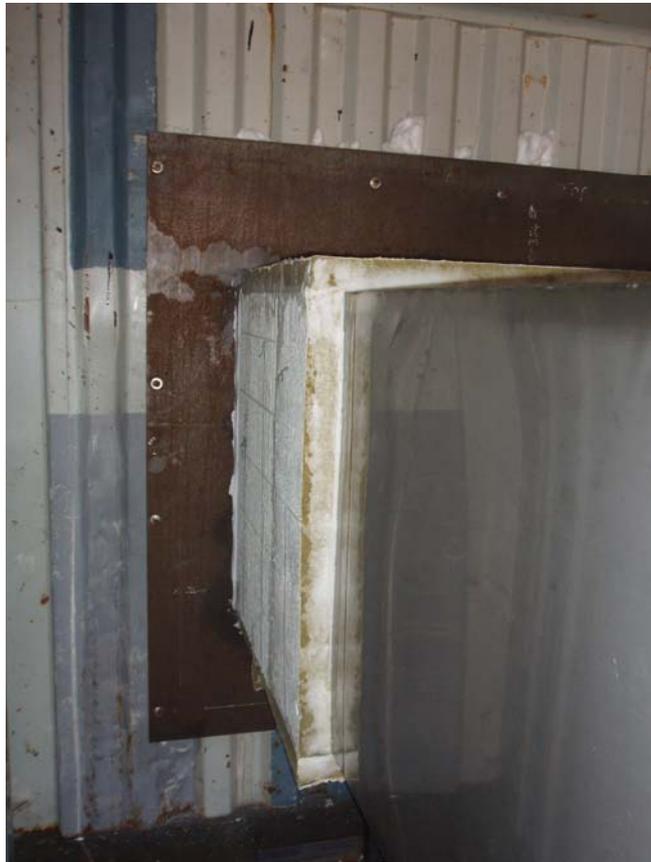
For its first 900 mm inside the container, measured from the front flange, the duct was then encased in 50 mm thick Firebatt mineral wool insulation. This was glued and wired to the ducting and the joints sealed with fireproof filler. This insulation did not extend outside the container as shown in Figure 15 – this area was insulated differently. The insulation as attached to the duct is shown in Figure 17.

Figure 17 A view of the insulation installed at the forward end of the ducting

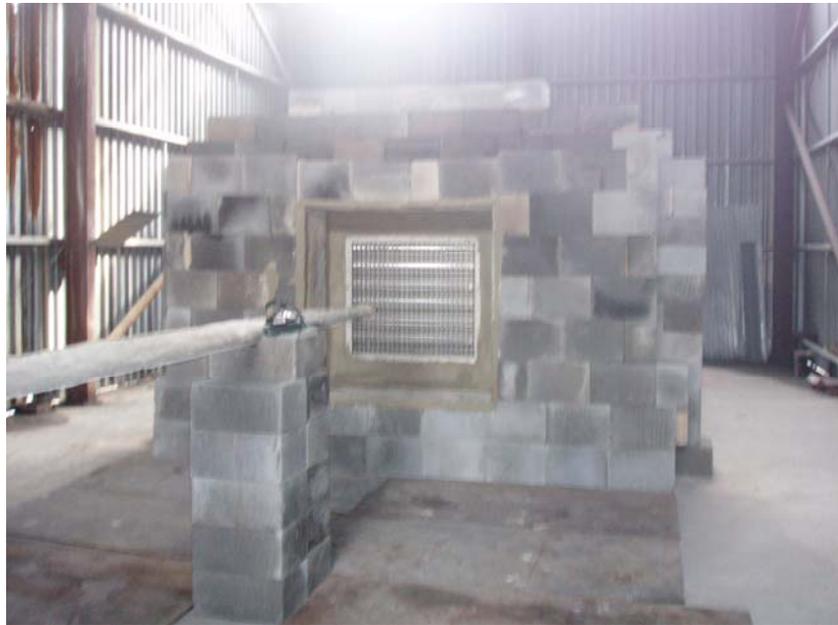
Subsequently this protection was removed and the standard jet fire flame recirculation chamber installed forward of and around the damper as shown in Figure 18. This measures 500 mm deep by 1500 mm square. A thermal block wall was then built up around the protruding recirculation box so that the blockwork and front of the box presented a flush vertical surface normal to the jet flame. Only the diffuser front panel was exposed to the flame. Figure 18 shows the damper in place in the test building with the blockwork wall surrounding it.

Figure 18 The damper installed in the test building with the surrounding blockwork wall. The fuel supply pipe for the jet fire can be seen running from the left to the centre of the photograph.

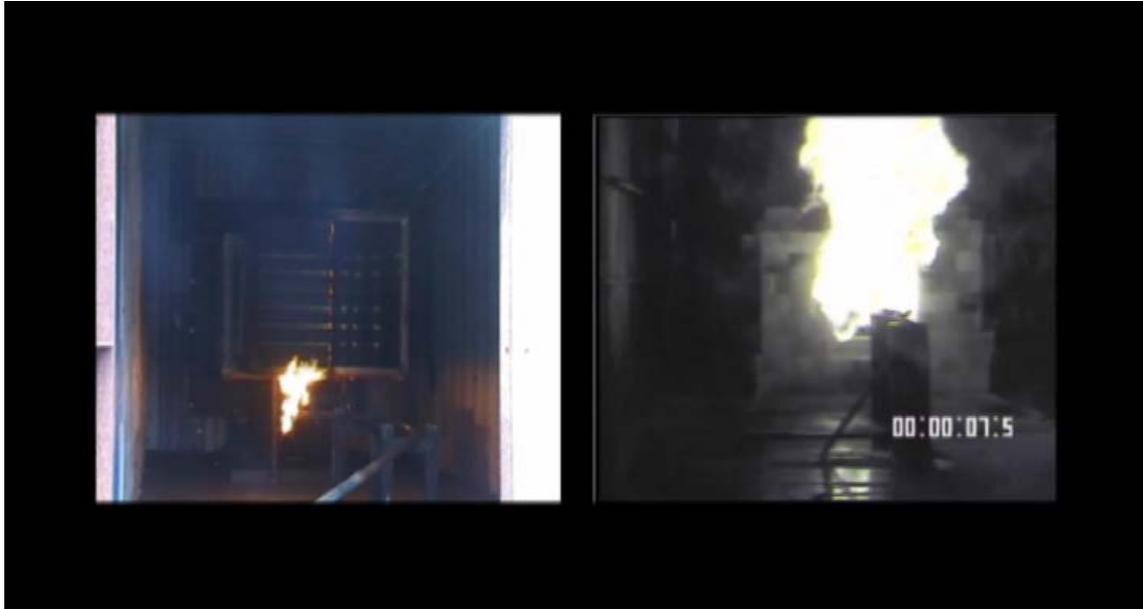
Figure 19 Simultaneous front and rear views of the jet fire test taken after 7.5 s. The enveloping flame of the jet fire can be clearly with no penetration of flame into the ducting.

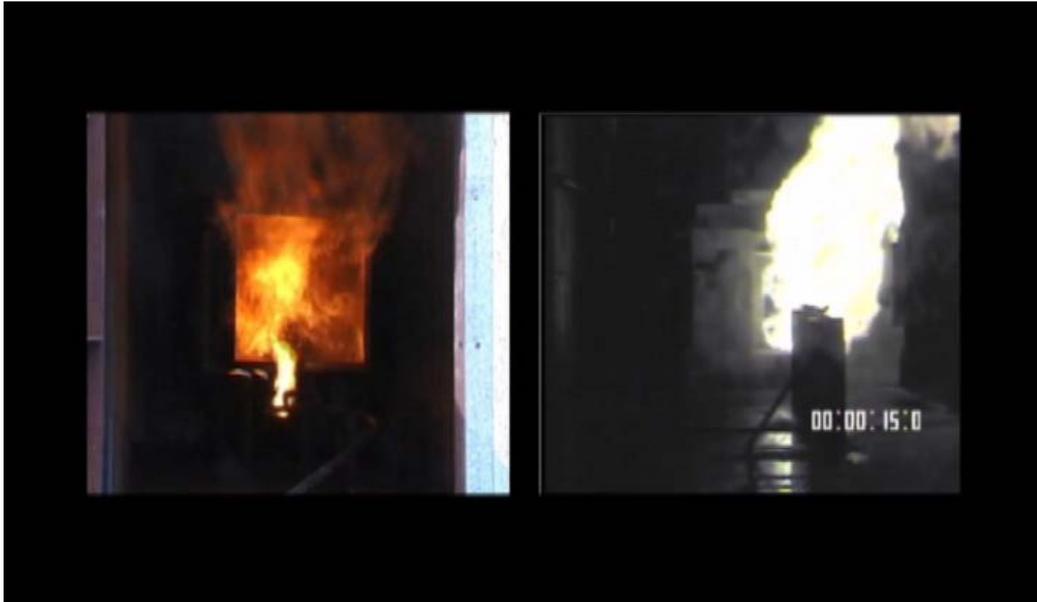
The video and CCTV records were processed and combined in a single video view. The rear video combined visual and audio tracks and allowed synchronisation of the two visual records. This was achieved by identifying the report produced by jet start-up on the video record and aligning that with the visual record of jet start-up on the CCTV record. A single video record was thus produced with the rear video and front CCTV images combined side-by-side. Figures 19 and 20 show two stills from this combined video record. Figure 19 shows the front and rear views after 7.5 s. The operation of the jet is clear with the entire front of the damper enveloped in flame. There is no penetration of flaming into the ducting but the rear pilot flame is clearly visible. Figure 20 shows the same views after 15 s following flame breakthrough into the ducting behind the damper. In the rear view, flaming obviously fills the duct and spills out from the rear of the duct into the container. A closer examination of the visual record indicates that the damper was penetrated by flame after 9.4 s from commencement of the jet.

Figure 20 Simultaneous front and rear views of the jet fire test after 15 s, after penetration of flame into the ducting.

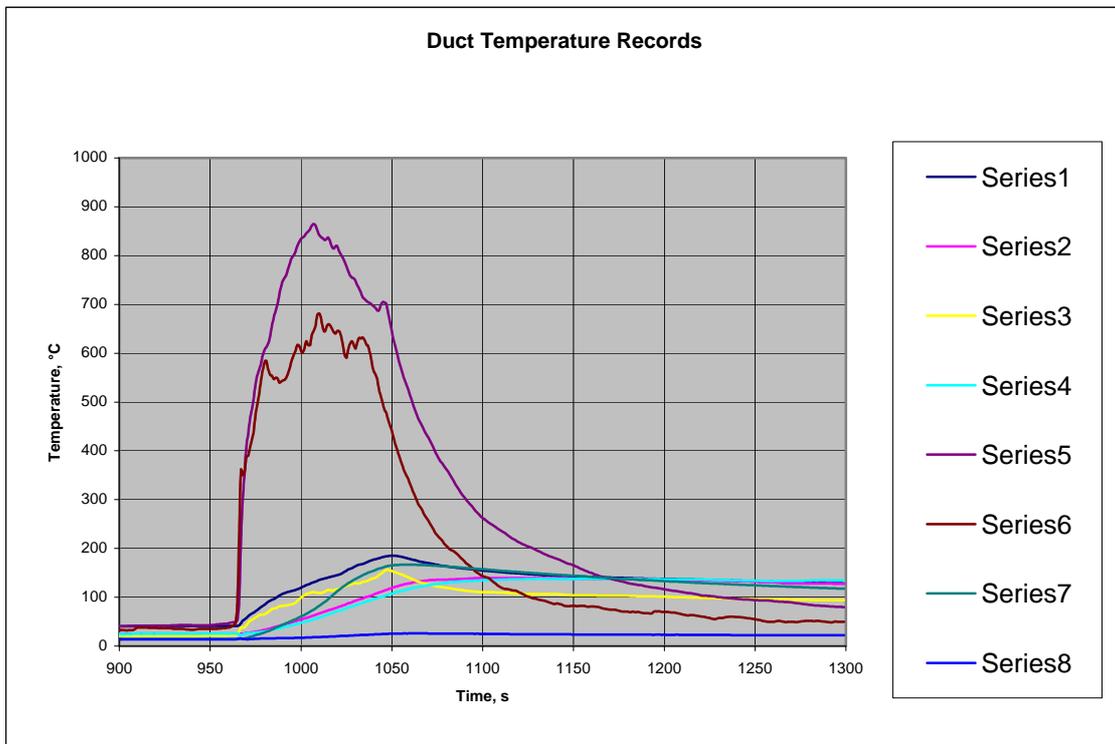
Figure 21 Temperature records from thermocouples taken during the test.

Figure 21 shows the thermocouple temperature records taken during the test. The flaming inside the duct was of ~40 s duration. Thermocouples 5 and 6 were located inside the duct near the top duct surface, with Thermocouple 5 close to the damper and 6 farther down the duct. Maximum temperatures of about 860 and 690°C respectively indicate that they were exposed to direct flame impingement. The time lag of the thermocouples can be clearly seen in the gradient of the thermocouple response both during heating and cooling. Flaming in the duct was of about 40-50 s duration before the jet flame was extinguished. The other thermocouples were located outside the duct and thus the delayed maximum temperatures at those positions were due to the thermal lag provided by the duct wall. Maximum temperatures outside the duct were all in excess of 100°C and decayed with distance down the duct from the damper. Those thermocouples located closest to the damper recorded temperatures close to 200°C.

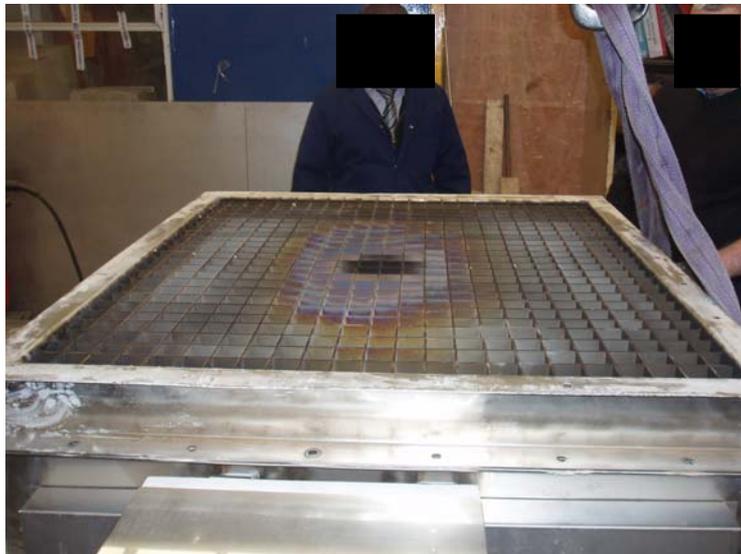
At the manufacturer the diffuser was first removed from the front of the assembly. Figure 22 shows a view of the damage to front face of the diffuser. There is clear heat damage to the centre of the diffuser as evidenced by the discolouration. There is also deformation of the front face, probably due to thermal effects with the metal retreating from the flame.

Figure 22 A view of the damper diffuser at the manufacturers prior to dismantling.

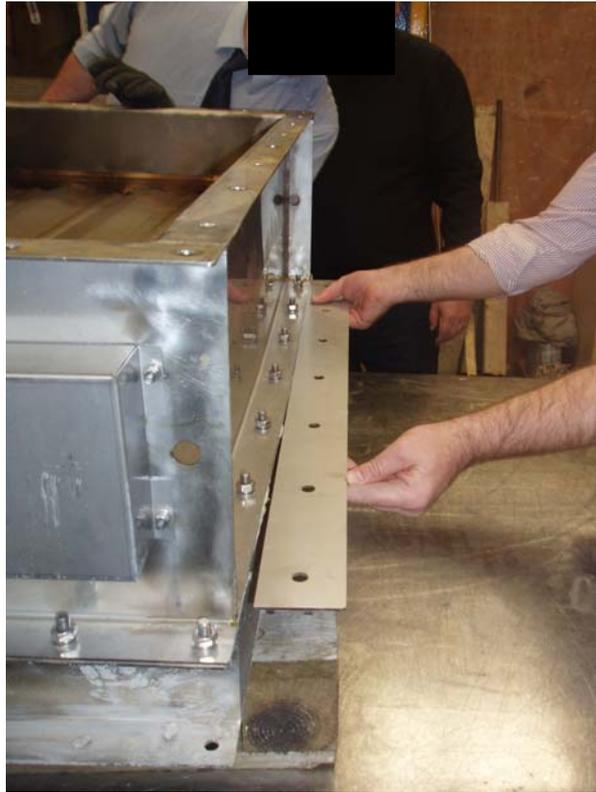
Figure 23 shows the deformation to the frame observed after removal of the diffuser. This deformation was in the horizontal direction and amounted to ~8-10 mm over the damper width. It is likely to have been due to the differential heating produced by the jet flame.

Figure 23 The deformation to the damper frame observed during dismantling.

- During the jet fire test, it is recommended that the damper be mounted in the recirculation box and then in a barrier identical to the one to which it will be coupled in end use – a J-rated bulkhead. This should be combined with ca 225 mm of ceramic insulation around and to the rear of the damper to protect the rear-mounted ducting. This should possibly be substituted for the blockwork wall used in this programme which may have been partly responsible for the deformation to the damper frame.

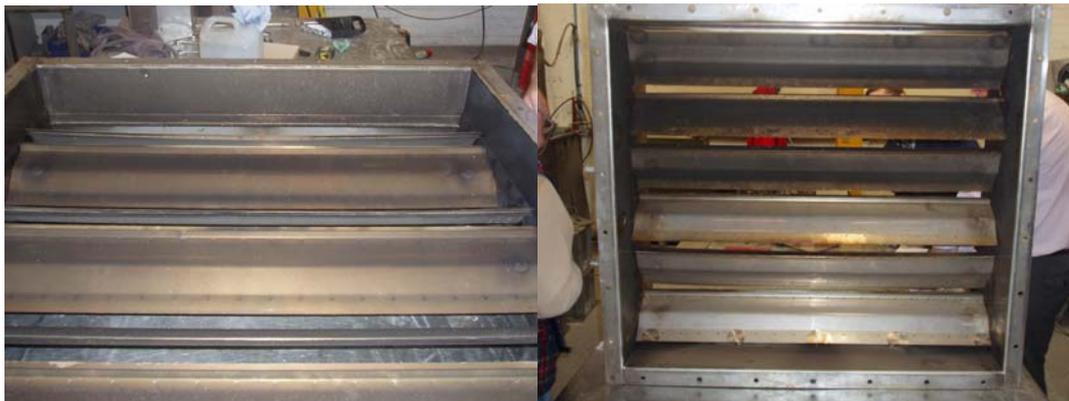
Figures 24(a) and 24(b) show close-ups of the damper blades taken during the dismantling process.
