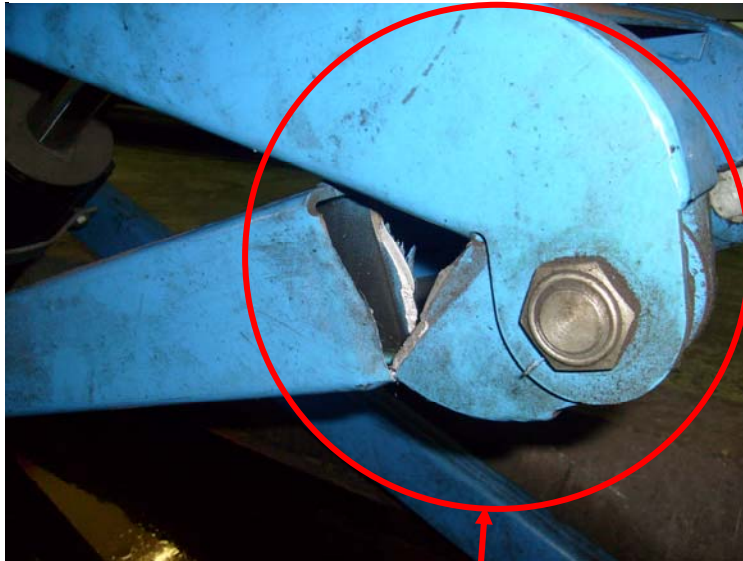
Photograph 2 - failed section of the lifting arm

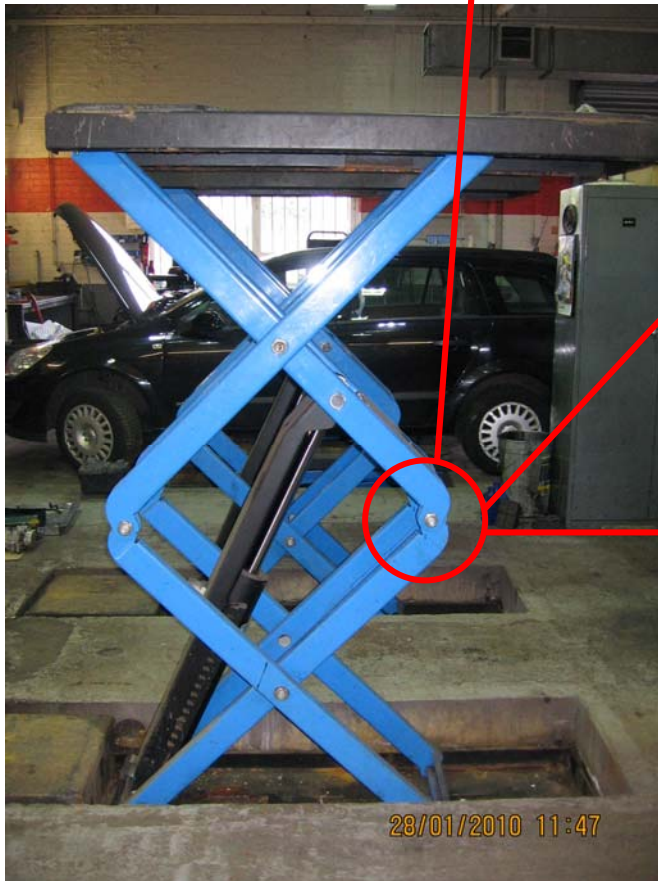
Photograph 3 - Similar lift showing area of failure

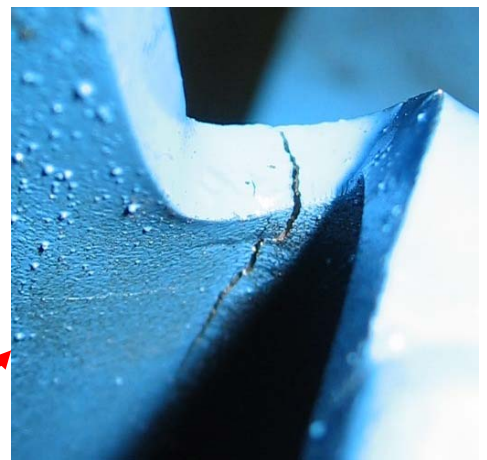
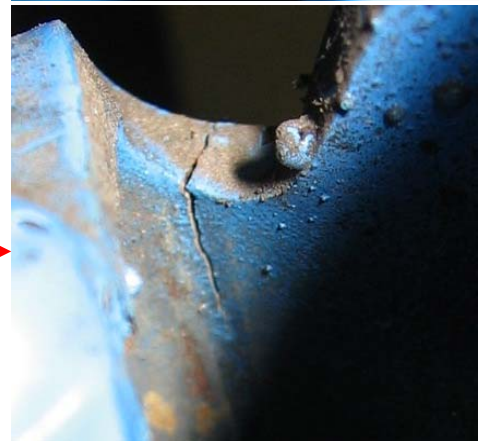
Photographs 4 and 5 showing cracks in similar lifts
