ASBESTOS IN SYSTEM BUILDINGS

Control of Asbestos Regulations 2006

Guidance for duty holders

Updated 18 September 2008

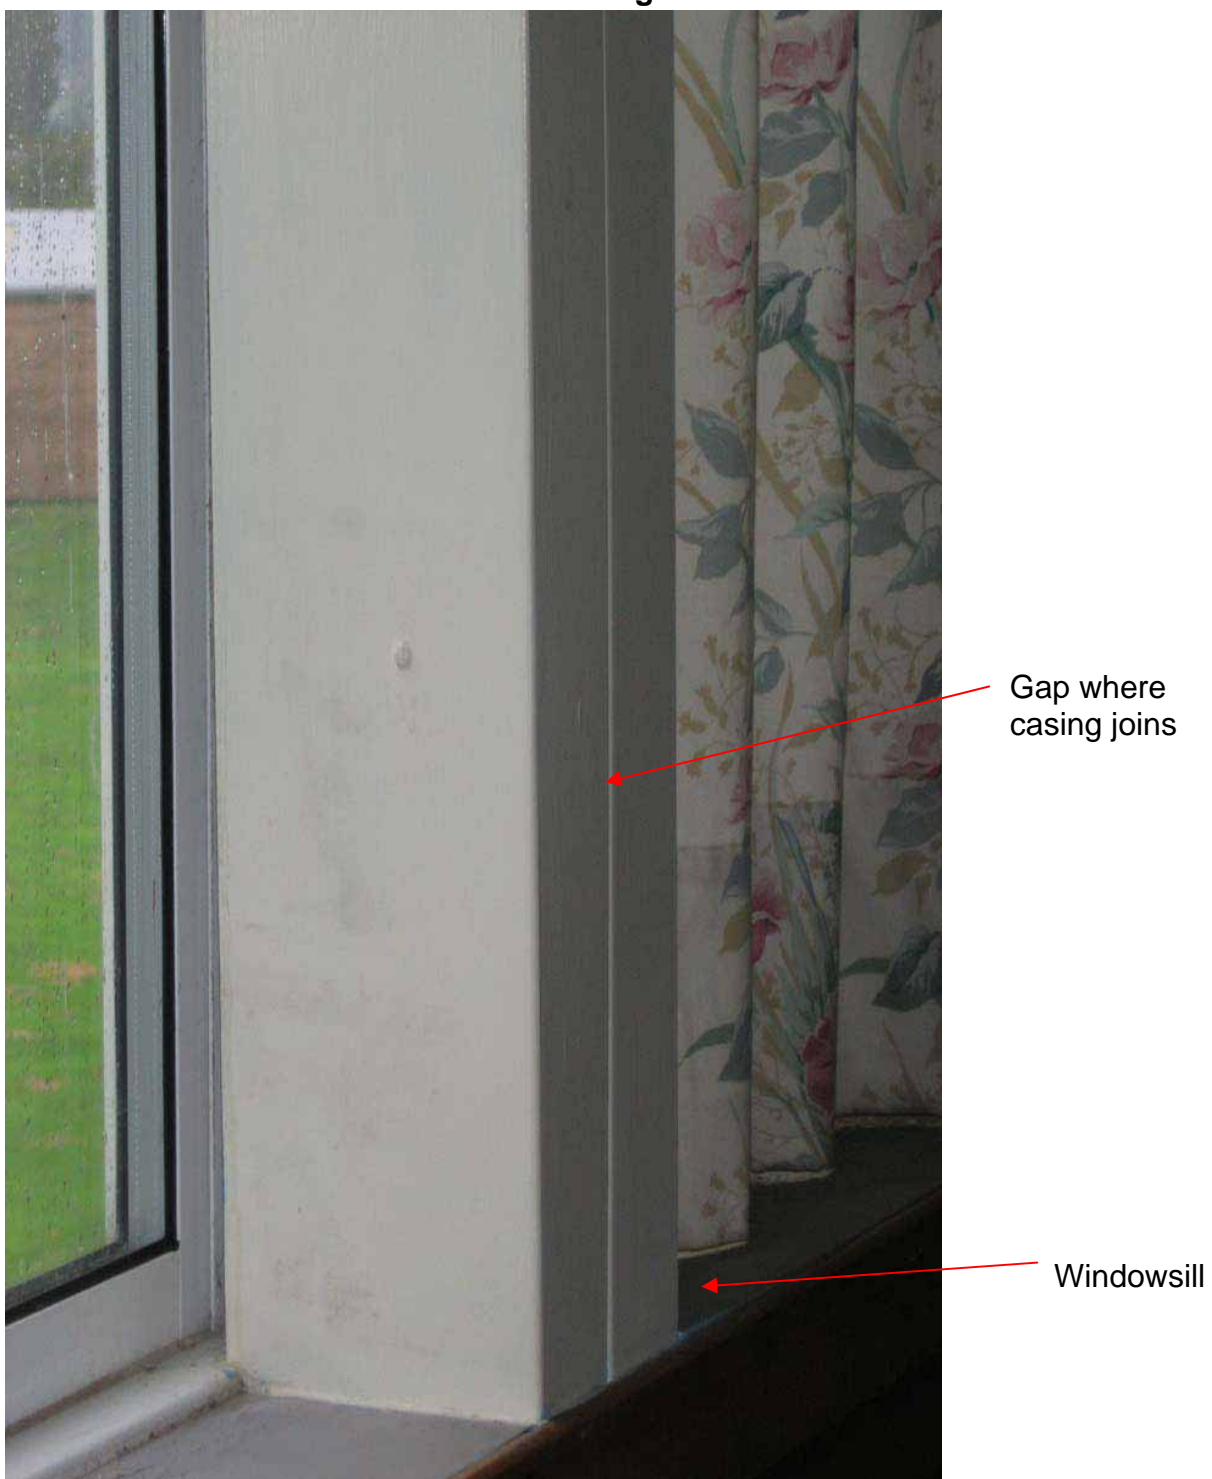
Figure 2: Metal clad column showing gap at front of column where the two halves of the cladding meet

- (iii) a poor seal in some of the metal column casings that are meant to enclose the AIB, causing gaps through which fibres can escape into the room. Gaps are most likely to occur between joints in the metal casing around the columns, between the casing and skirting or wall (see figures 1-4). They are most likely to be present if the metal casing has been cut in some way, for example, by maintenance and installation work or if the casing has been removed and then repositioned. However, even where none of these activities have occurred, gaps may still be found along the 2 joints to the column casings or at the bottom of the casing.

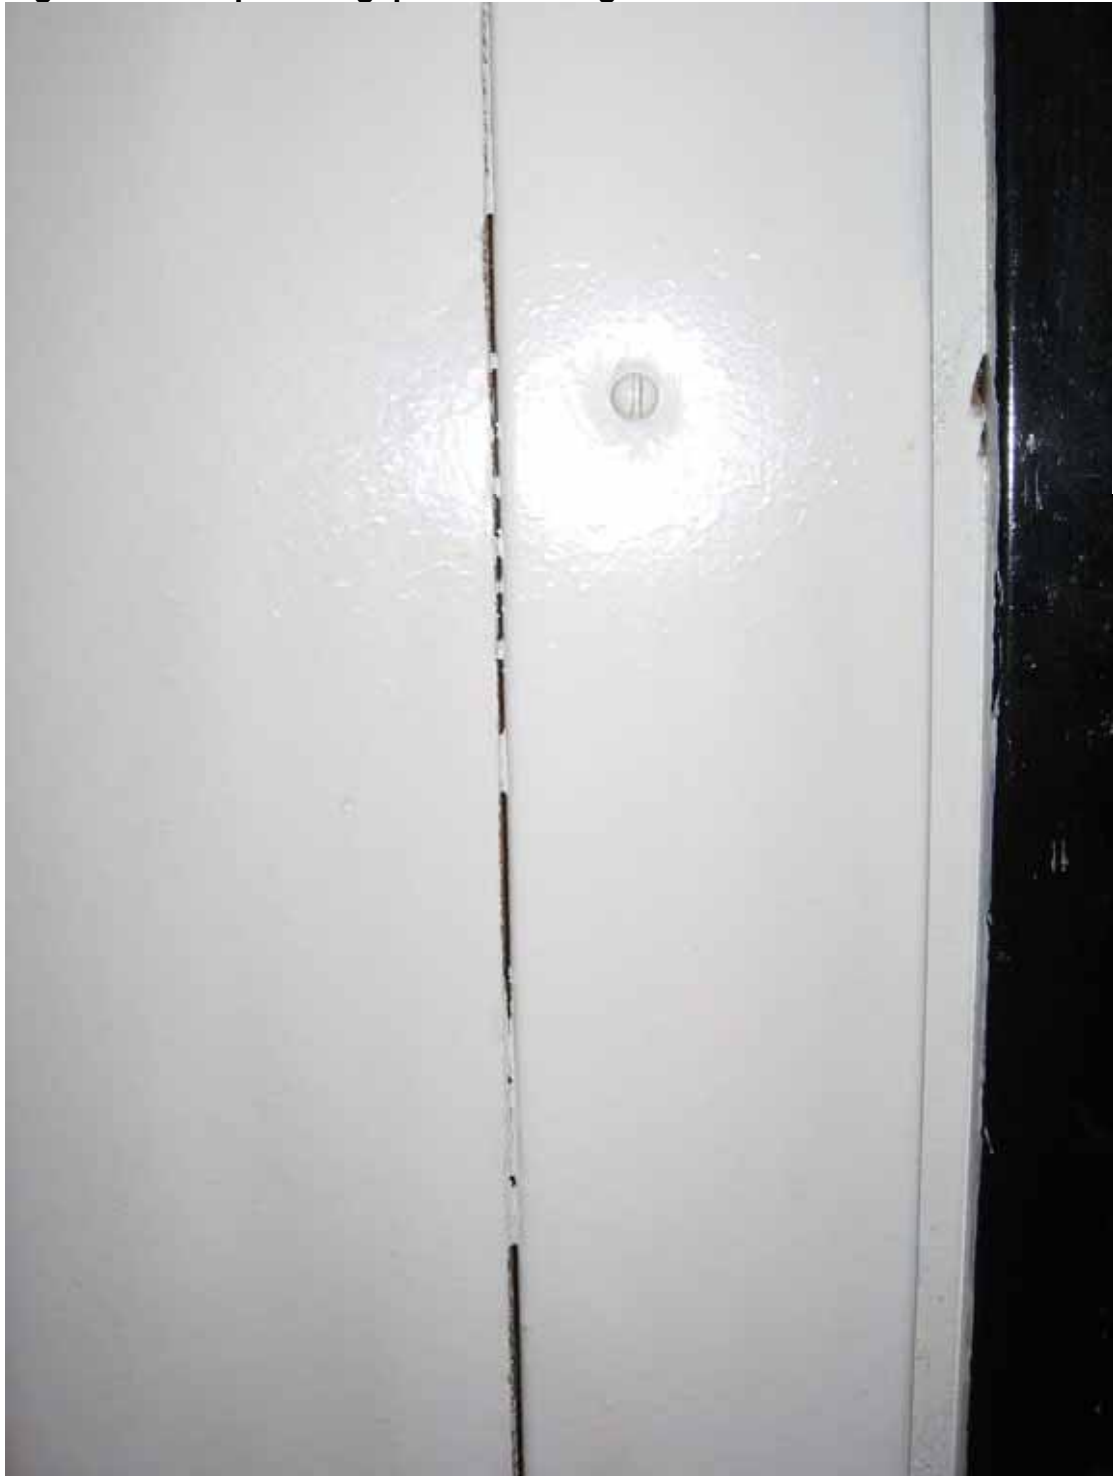
Figure 4: Example of a gap in the casing
