ASBESTOS IN CLASP AND OTHER SYSTEM BUILDINGS

Control of Asbestos Regulations 2006

Guidance for duty holders produced by the HSE Asbestos in Schools 'CLASP' Working Group – March 2007

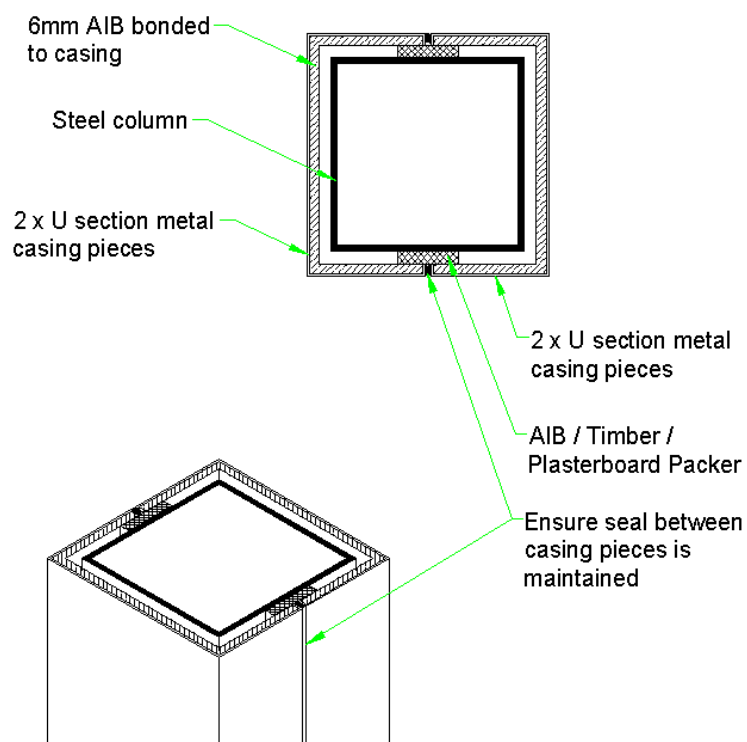
Figure 1 - DIAGRAM OF CASING AROUND COLUMNS

- i) Identify all CLASP (and other building systems) buildings, particularly mark 4 and 4b as a priority, but also include CLASP buildings built between 1945 and 1980. Assistance on identifying CLASP buildings can be obtained from SCAPE (see para 30). Carrying out a desktop survey of building plans can also help with this but note that these plans may not always be wholly accurate (see para 5).
- ii) Where the building is a CLASP or other system design, visually inspect (see para 16 for priority areas for inspection)
 - the full lengths of all the column casings for cracks, gaps, presence of screws, dents, damage and movement
 - the back of the casings as there is potential for gaps to occur here
 - the top and bottom of the column casings

- check also for signs of maintenance work after installation e.g. fixtures attached to casing, holes drilled or improper installation.

iii) Seal all gaps in the joints between:

- column casing to casing
- column casing to skirting
- column casing to walls

using a silicone based sealant to enclose dust and debris within the casing. UPVC strips can be used as finishing over the top of the sealed gaps using the same sealant.

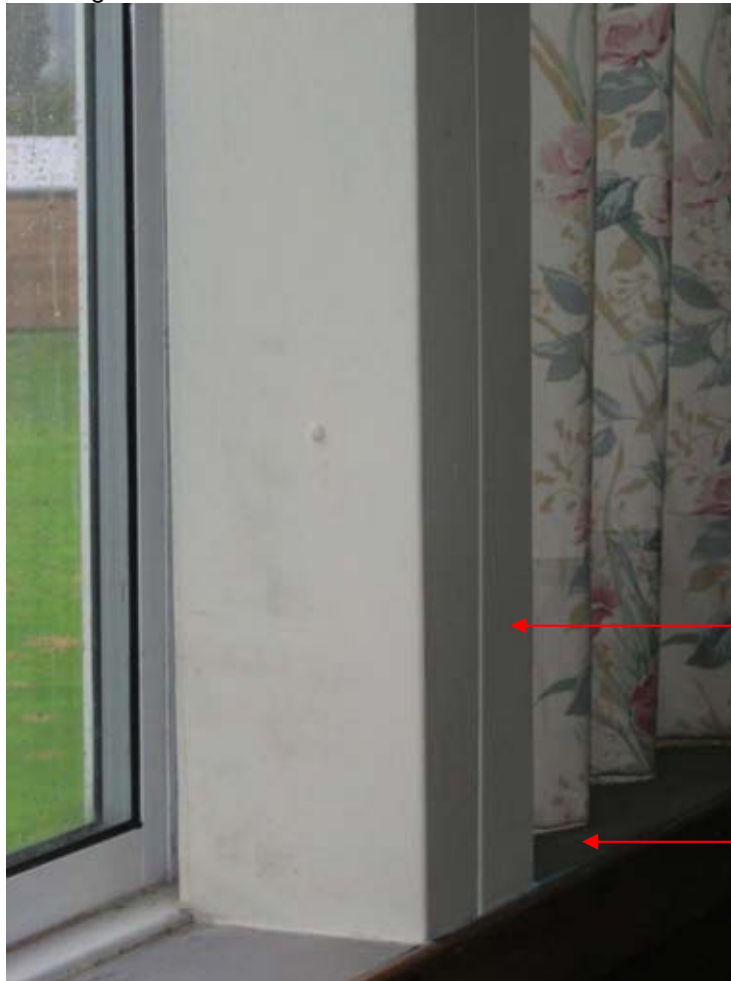
Figure 2: Metal clad column showing gap at front of column where the two halves of the cladding meet

← Gap where casing joins

← Windowsill

- (iii) a poor seal in some of the metal column casings that are meant to enclose the AIB, causing gaps through which fibres can escape into the room. Gaps are most likely to occur between joints in the metal casing around the columns, between the casing and skirting or wall (see figures 1-4). They are most likely to be present if the metal casing has been cut in some way, for example, by maintenance and installation work or if the casing has been removed and then repositioned. However, even where none of these activities have occurred, gaps may still be found along the 2 joints to the column casings or at the bottom of the casing.
