The safety of free steered vehicle operations below ground in British coal mines

This publication, based on a report, examines the safety of free steered vehicle (FSV) operations below ground in British coal mines and recommends areas where safety might be improved. This publication will be of use to managers, supervisory staff, engineers and operatives at the mine.

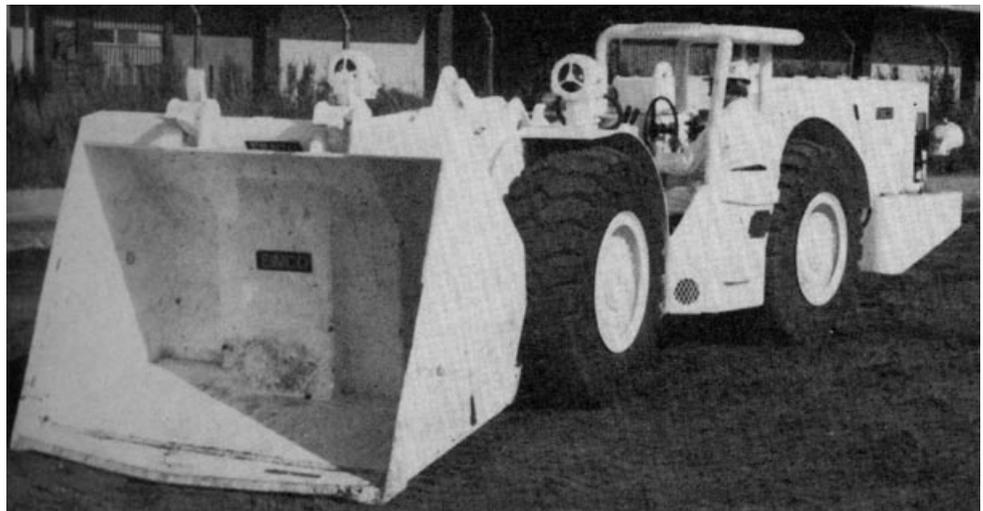
Photograph 1

A typical free steered vehicle

3 A typical FSV (photograph 1) is a self propelled vehicle running on rubber tyred wheels, generally operating without much roadway floor preparation, designed to be driven in either direction from a centrally placed driver's cab, and used primarily for transporting material and equipment. Pivot steering and the capacity to carry an outboard load make the FSV a most versatile and manoeuvrable vehicle.

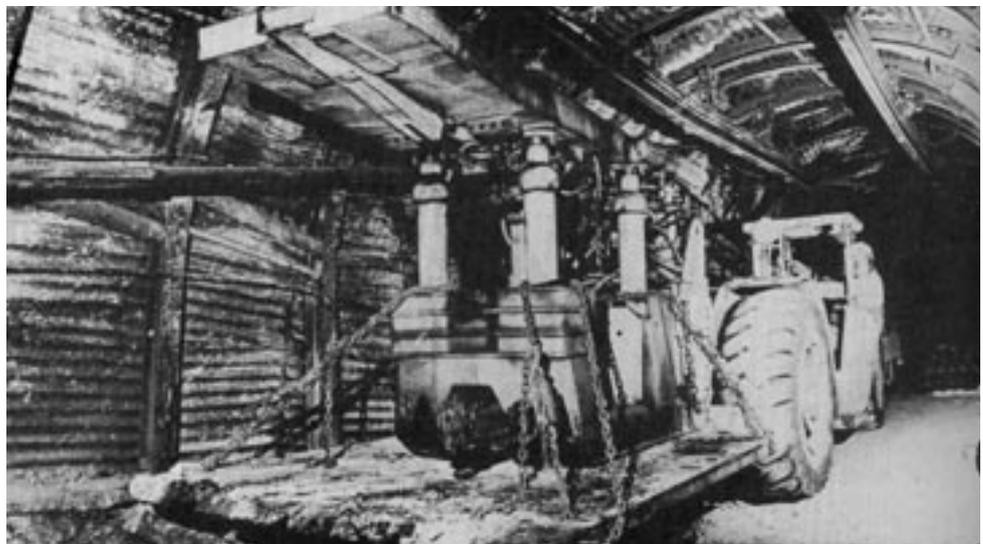
Photograph 2
A flat bed type FSV carrying
a powered support

7 Priority in the development of FSVs in coal mines was to transport material direct to the point of usage without intermediate transfer. The flat bed type vehicle (photograph 2) was developed to carry bulky material loads and heavy machinery without dismantling. FSVs fitted with loading winches became an accepted means of recovering, transferring and installing powered roof supports and other face equipment. Design has sought to provide a narrow vehicle with heavy load carrying capabilities, the most popular being 1.5m wide with a carrying capacity of around 8 tonnes, and powered by a 75kW flameproof diesel engine. Vehicles with carrying capacities of up to 20 tonnes have been developed for larger loads. A variety of vehicle attachments have been designed, such as lorry loader cranes, chock pulling arms, stone dusters, back actors, floor plough blades and roof bolting equipment.

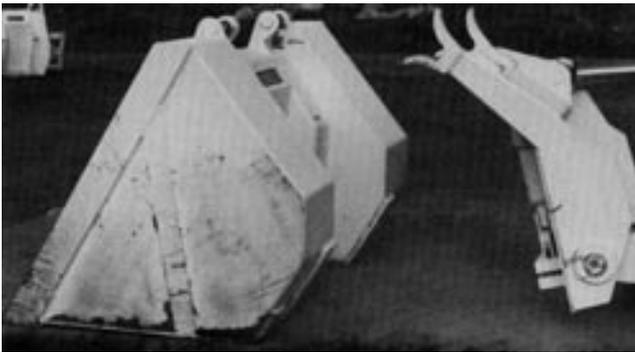
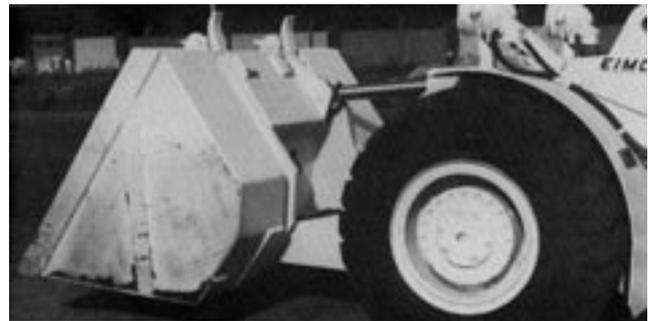
Photographs 3a and 3b

A quick detachable system (QDS) engaging a loading bucket

8 LHDs, typically with two to three cubic metre capacity buckets, were introduced to assist dinting and to transport materials. Quick detachable systems (QDS) (photographs 3a and 3b) for interchanging buckets for material carriers were developed to make their use more versatile.

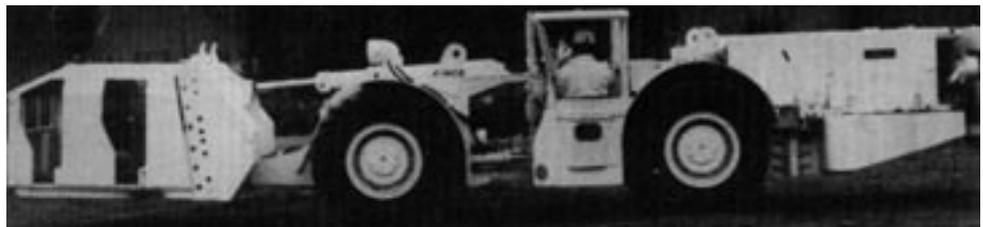
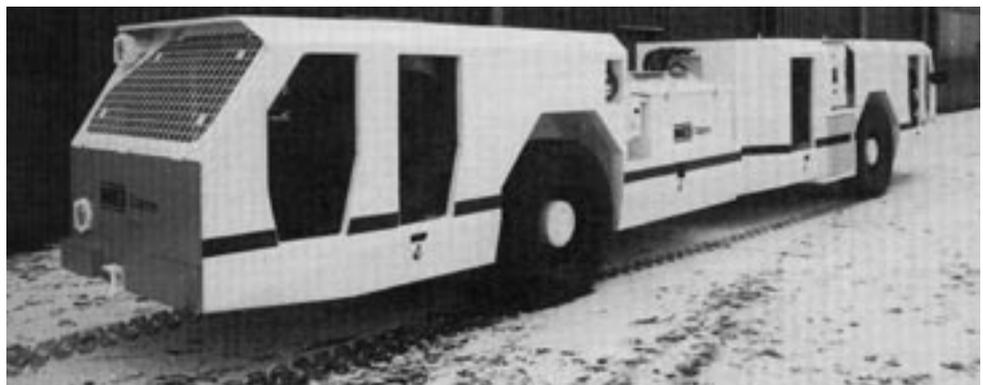
Photographs 4 and 5

Passenger carrying pod and purpose designed vehicle

9 An early concept was to adapt material vehicles for manriding by attaching a passenger carrying 'pod' (photograph 4). The conflicting requirement for soft vehicle suspension for manriding comfort against hard suspension for load carrying stability, and the limited driver vision, led to the introduction of purpose designed passenger carrying vehicles (photograph 5). These 'buses' generally have a driving cab at each end to give the driver good visibility in either direction of travel, and provide seating within a protected canopy for up to 30 passengers. Recently, there has been an upsurge of interest in passenger carrying FSVs.

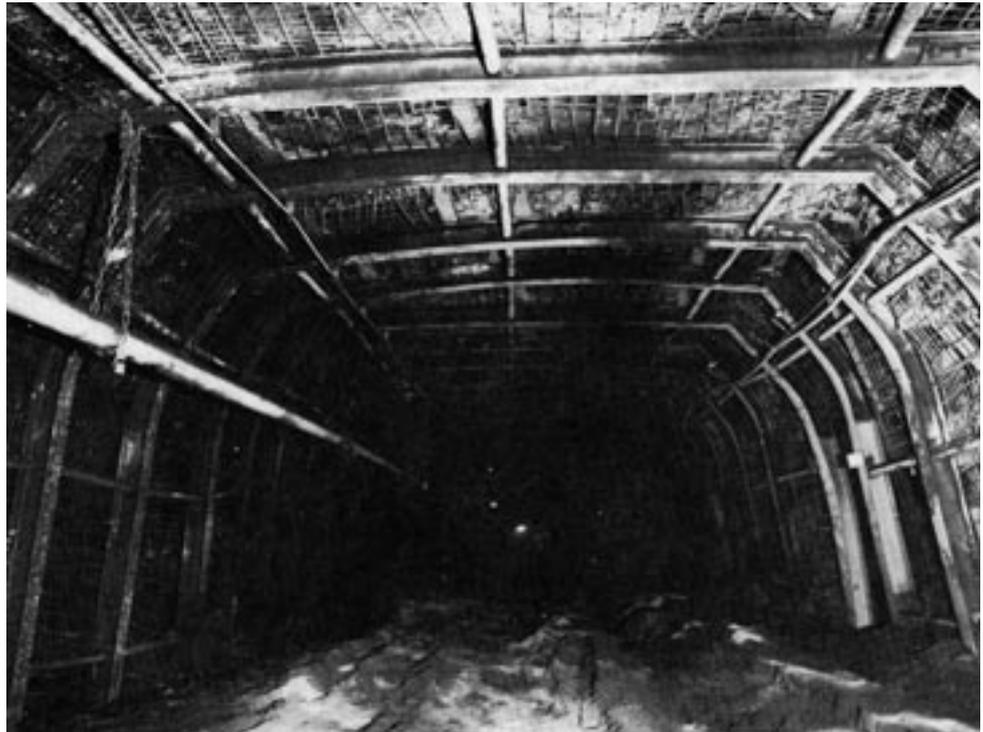
Photograph 6
A typical well-designed
FSV roadway with good
clearances

11 Collision damage to cabs or machine covers may indicate inadequate clearances. Clearance evaluation should be undertaken at the roadway design stage when the proposed function of the roadway and the intended types of FSV to be used should be determined. The evaluation must take account of any obstructions which are likely to be present in the roadway since these determine the available width for operation. Specified roadway dimensions should take into account possible reduction in cross section due to strata movement. Additional clearances should be considered for bends, junctions, material transfer stations, garages and other special places where the need is identified. Photograph 6 shows a typical well designed FSV roadway with good clearances.

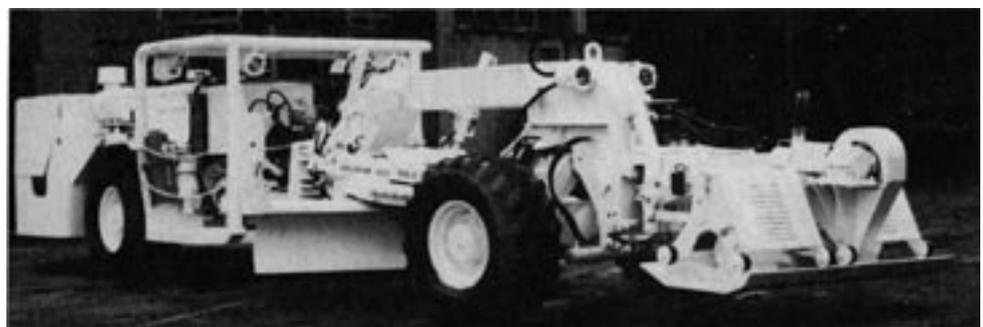
Photograph 7
A purpose designed
grading machine

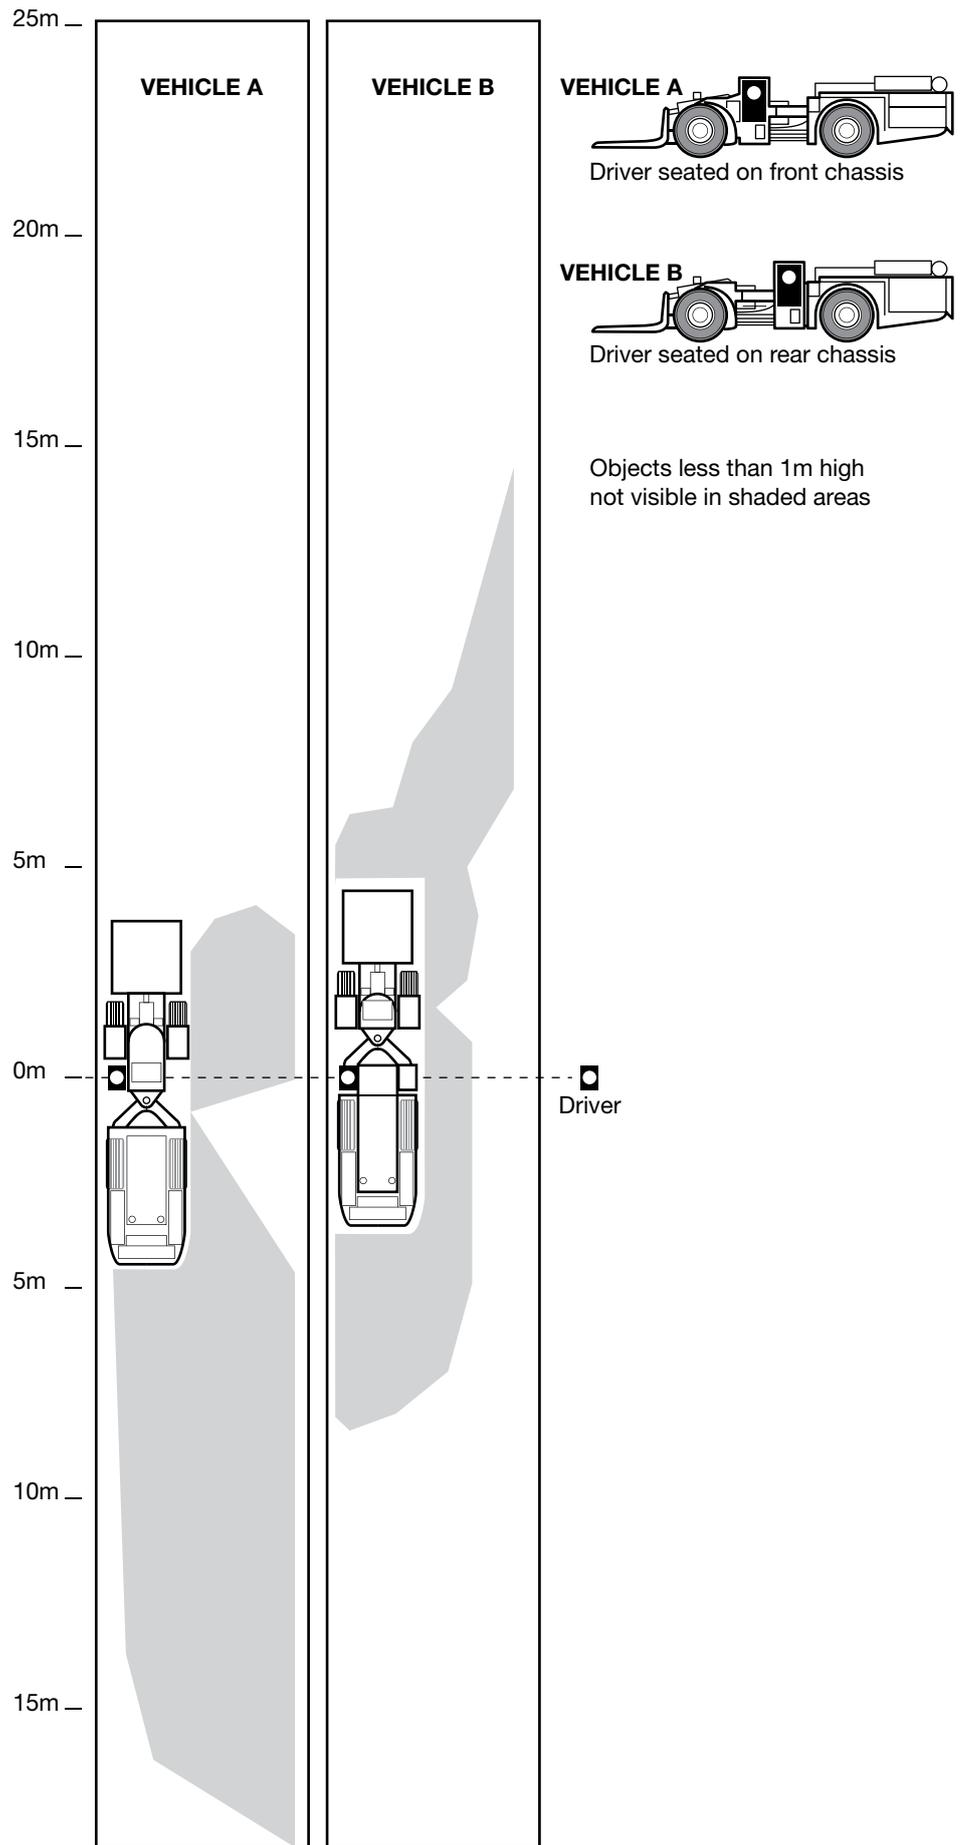
Figure 1 Unloaded flat bed vehicles

23 Figure 1 illustrates the variance in driver visibility for two makes of similarly sized flatbed vehicles when unloaded. The driver sits on the front chassis of vehicle A and on the rear chassis of vehicle B.

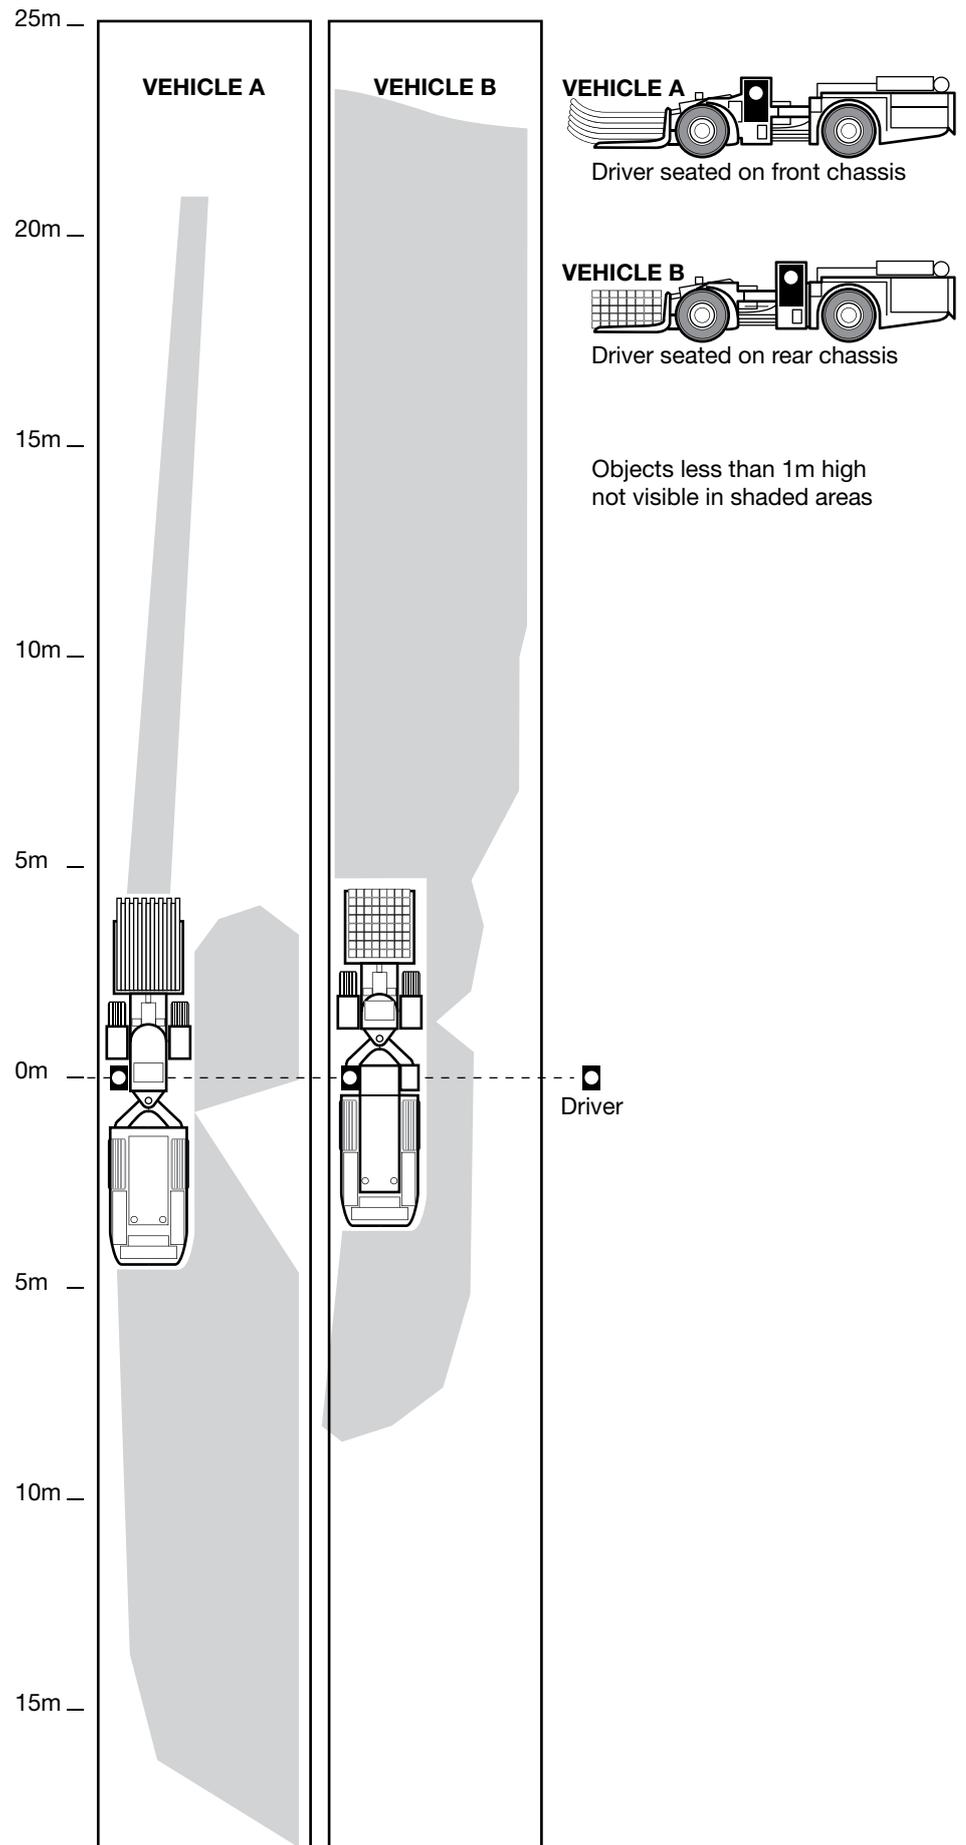
Figure 2 Loaded flat bed
vehicles

24 Figure 2 shows the extended blind areas when vehicles are loaded with typical material loads. Vehicle A is loaded with an arch pack and vehicle B with wood chocks.

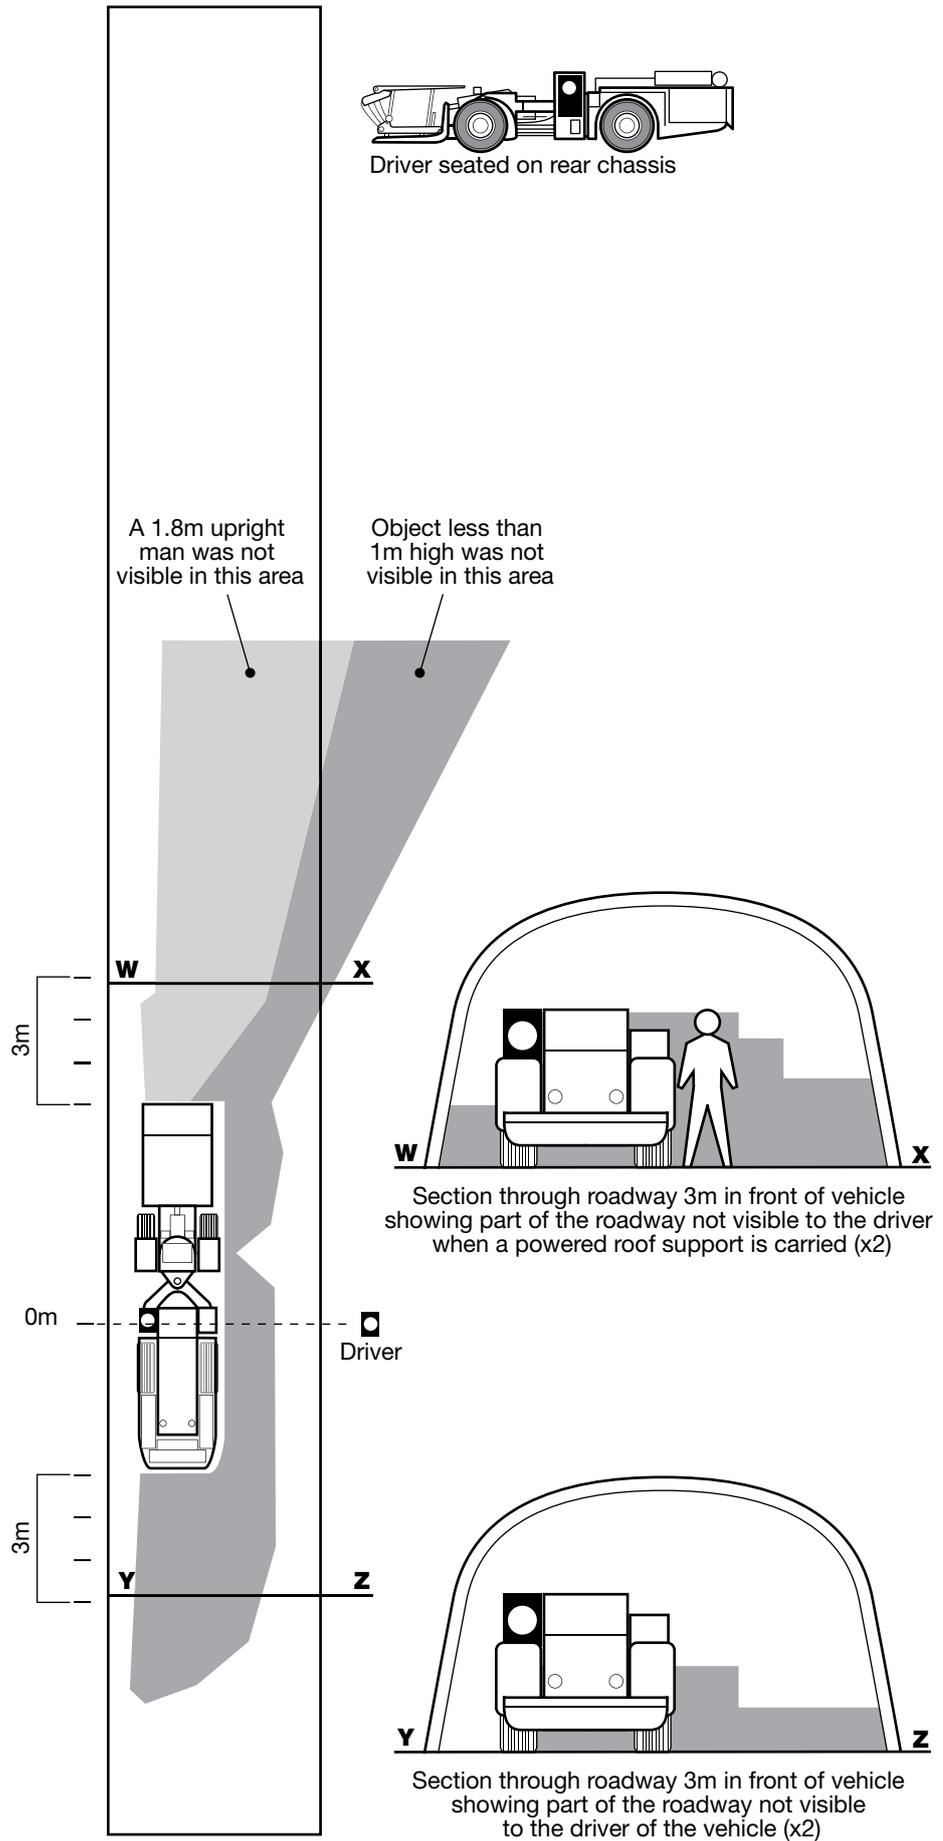
Figure 3 Flat bed vehicles
loaded with a powered
support

25 Figure 3 shows that when vehicle B is loaded with a 5 tonne powered roof support there is an extensive area in front of the vehicle where the driver is unable to see a 1.8m high upright person.

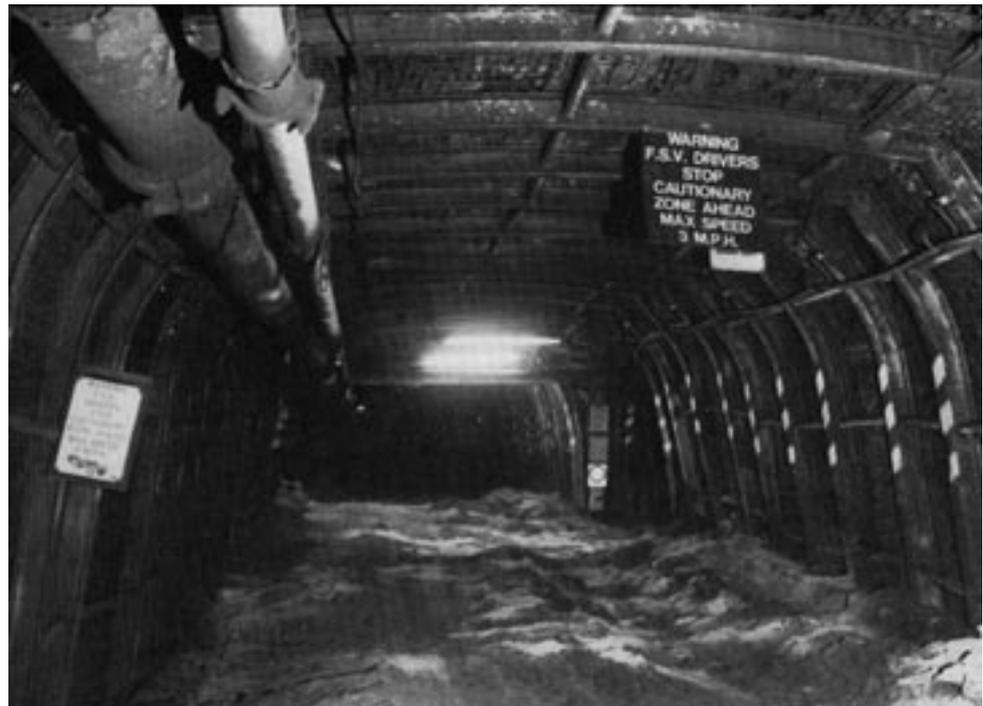
Photograph 8 A hazard zone at a roadway junction

34 Any pedestrian working in or travelling along a road where FSVs run should be considered to be at risk. Wherever practicable, pedestrians should be kept clear of roads where FSVs are operating. Hazard or cautionary zones (photograph 8) should be established at places where it is unavoidable that vehicles and pedestrians will meet, eg junctions, roadheads, transfer points and where persons have been deployed to repair or maintenance work. Manager's Transport Rules should specify the additional precautions to be taken when vehicles operate in these zones. Where persons have routinely to work in FSV roadways 'safe havens' should be provided wherever possible. One innovation has been to install pre-recorded talking messages at some hazard zones which can be activated by drivers and warn that an FSV is approaching.

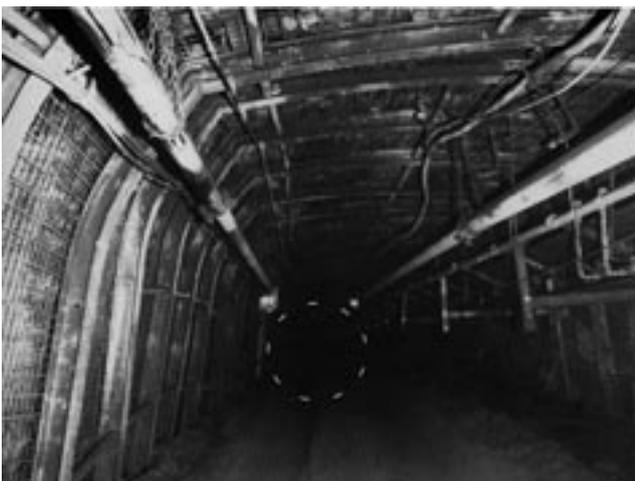
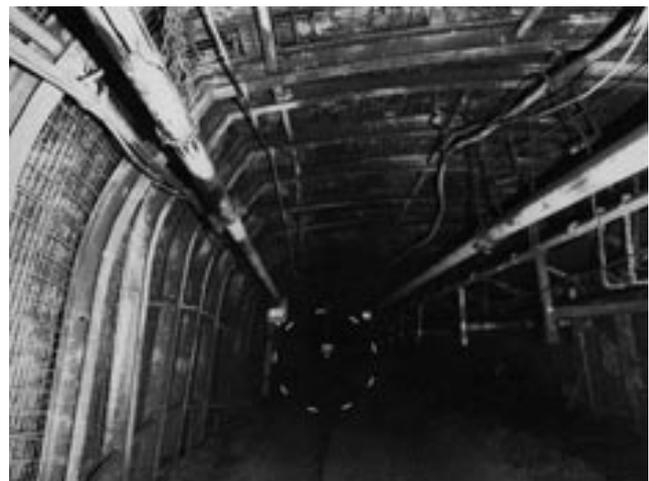
Photographs 9a and 9b
Photographs taken at 25m distance showing effective use of reflective markings on garments worn by a workman

35 In the context of visibility generally, and with the need for all persons below ground to be readily seen, especially where FSVs operate, the use by all persons below ground of reflective garments including general work wear, helmets, belts and cap lamp materials is recommended (photographs 9a and 9b). Whilst add-on adhesive reflective strips are frequently used with the above-mentioned equipment, there is a need for the future manufacture of such equipment to incorporate reflective elements by design.
