Six herbicides (atrazine, diuron, oxadiazon, glyphosate, oryzalin, isoxaben), selected to represent a range of physico-chemical properties and application rates, were applied to the kerb edge of a section of asphalt road. A weir fitted with automatic sampling equipment was used to sample runoff from the outlet of a gully pot drain until 25 mm rain had fallen. In order to avoid possible saturation of adsorption sites, the six compounds were applied in two groups on separate occasions. Atrazine was included in both application groups so that the effect of the different application dates could be seen. Although rain fell within a few hours of application on both of the application days, the amount was only sufficient to trigger drain flow sampling on one occasion. As a result there was a large difference in the lag time between application and drain flow sampling for the two application groups.

1 Introduction

In order to gather preliminary data, a 'pilot study' was carried out to investigate the extent to which herbicides were washed off a kerb edge and drainage channel alongside an asphalt trunk road (the A6) running through the village of Shardlow, Derbyshire. The study aimed to c

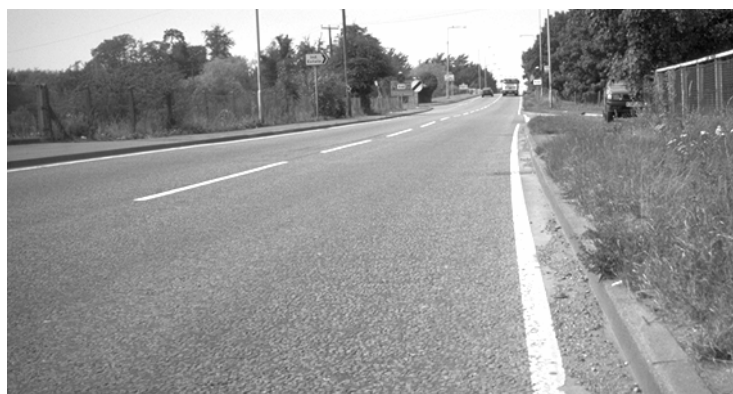
Plate 1: View of the road where the study was carried out, looking north showing debris in the gutter

Prior to the first herbicide application, stones and debris were removed from the road gutter which was then swept using a yard brush. This was not normal practice but was necessary to remove an accumulation of dirt resulting from road construction work nearby (see Plate 1) and to avoid the need for the road to be swept by the County Council.

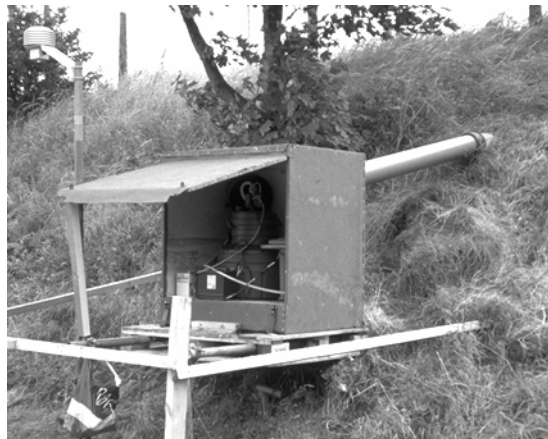
Plate 3: Overview of the monitoring installation

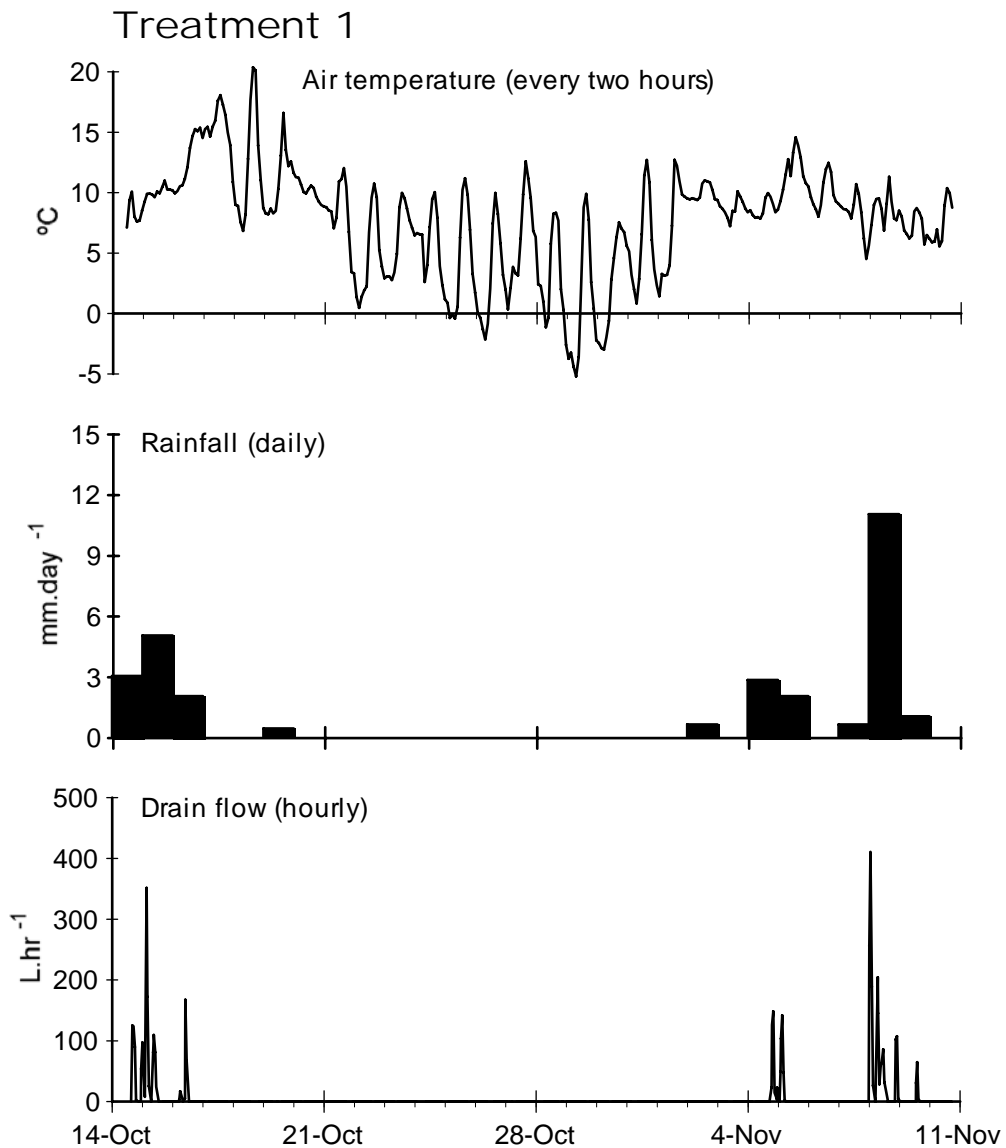
Drain flow after the two treatments is shown at hourly intervals in Figure 3 and Figure 4. The hydrographs show clearly how the drain responds to rainfall, with

both a steep increase and decrease in flow. Events were often complete within two hours. The hydrographs demonstrate that no water moved between rainfall events, unlike a river where there is usually a base flow.

Rainfall on the day of the first treatment caused a peak flow of over $100 \text{ L}\cdot\text{hr}^{-1}$, followed by greater drain flow on the following day. A smaller, separate flow event followed on the third day. There was then a 19 day period of no drain flow until early November when the rainfall described above caused two flow peaks during the night of 04-05 November. There were then two wet days with large flow at the end of the study.

Figure 3: Air temperature, rainfall and drain flow after the first treatment

Daily rainfall during the two study periods is shown in Figure 3 and Figure 4. It can be seen that there was some rainfall on the spray day of both treatments.

The first application of herbicides (14 October 1997) was made in the morning and rain started to fall within six hours. This was a sufficiently large event (3 mm) to cause drain flow and sampling during the first day after application. There was then a relatively dry period lasting until early November, when a succession of heavy showers led to more drain flow and sampling. The 25 mm target rainfall fell by 08 November - 25 days after application.

Air temperature for each treatment is shown in Figure 4. It can be seen that the diurnal range was greater during the middle period of the first treatment, with air frosts at night. This led to heavy dews which were dried out by direct sunlight in the mornings. The rainy period at the end of October was relatively warm with little night-time drop in temperature.

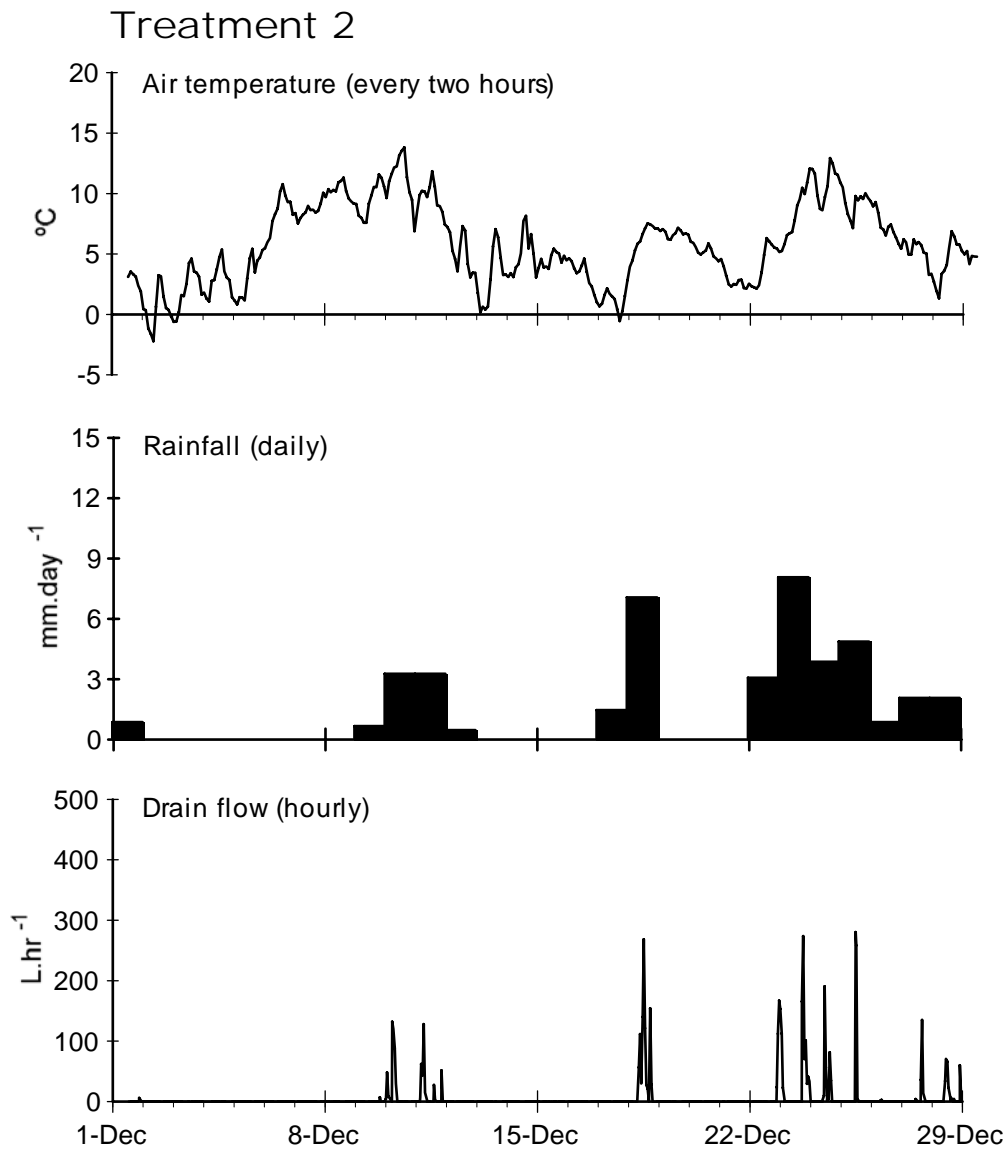
Figure 4: Air temperature, rainfall and drain flow after the second treatment

The effect of the rainfall on the day of the second treatment can just be seen as a small mark on the hydrograph during the night of 01-02 December. There was then no flow until late on the ninth day after application when another small mark on the hydrograph indicates minor drain flow in response to the small amount of rain that fell. Significant amounts of rain on the two subsequent days initiated sampling, with drain flow of up to 100 L.hr⁻¹. The second treatment was then characterised by more events yielding flow at around 200 L.hr⁻¹ with no more than five consecutive dry days.

Rain also fell on the spray day of the second treatment, but only amounted to 0.8 mm. Due to a change in the behaviour of the weir (discussed in section 3.2) this was insufficient to trigger the sampler, although approximately 7 L was discharged through the drain over a period of two hours. No further rain fell until 9 days after spraying, when 0.6 mm fell, with a further 6.4 mm falling over the next two days. The 25 mm target rainfall fell within 23 days of application.

The second treatment was characterised by more frontal activity and thus a lower diurnal range and less frost. There was also less direct sunlight on the study area. The mean temperature for the 28 days after application was a little lower for the second treatment than the first (5.8°C compared to 7.8°C after the first treatment).

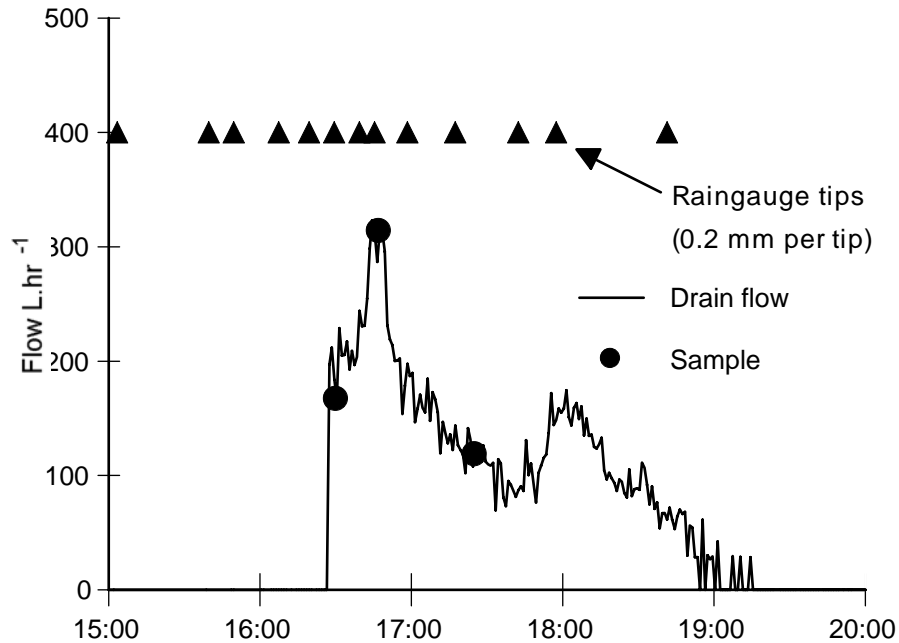
A more detailed example of the hydrograph for a single event is given in Figure 5 which shows the flow from the drain at one minute intervals. The drain began to flow after the fifth tip of the rain gauge (*i.e.* after 1 mm rain) and the rate flow increased quickly over about three minutes. Flow increased again in response to more intense rain but fell when the rainfall intensity fell. The drain stopped flowing within about 30 minutes of rain stopping.

Figure 5: Drain flow hydrograph for 14 October 1997
