**Investigation Into Fibre Release From Church
Organ Blower Boxes**

HSL/2006/115

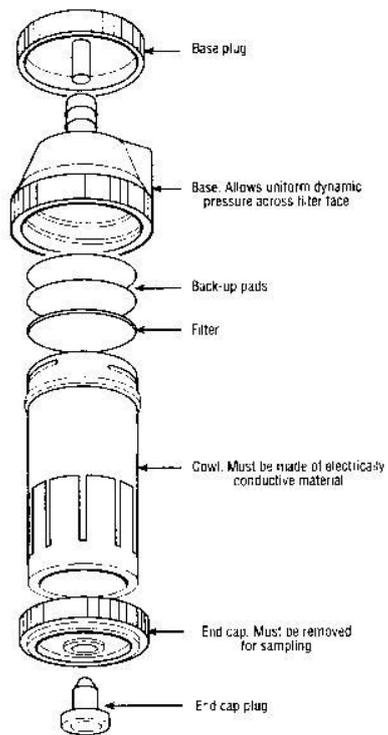
Figure 1 Diagram of Sampling Head Used

The swab and air sampling was carried out by Mr. V. Sandys (HSL Outbased Field Scientist, East Grinstead) with the assistance of Mr. M. K. Cross (church organ builders). Samples were taken from inside the organ pipes using both in-line filter holders and standard asbestos sampling cowls (as shown in figure 1) loaded with filters (cellulose acetate), by sucking the air up from inside the pipes using high volume air sampling pumps. Swab samples were taken using cellulose acetate filters as the collective medium and dust debris was also collected for PLM analysis. The samples collected using the air from inside the pipes were analysed using PCM fibre counting (WHO counting rules, HSG248¹) and those filters that were found to be heavily loaded were also analysed by PLM.

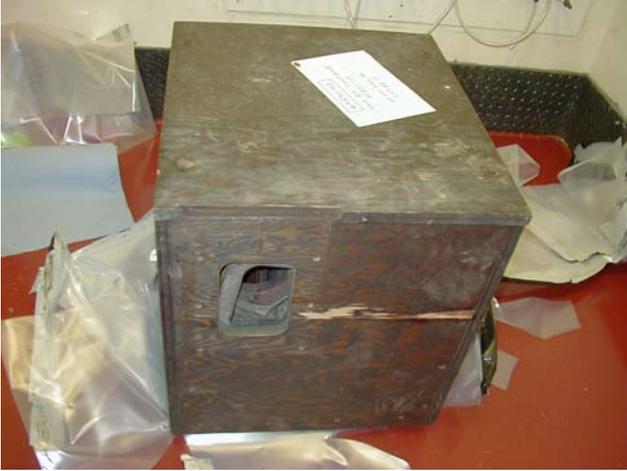
Photograph A1: The Organ Blower Box

The blower box, a one-metre cube weighing about 500 kg, was received sealed in plastic and labelled as containing asbestos. On removing the plastic and tilting the box to examine the underside, loose asbestos was seen to fall from the box onto the plastic sheet on which it was standing. This dust had fallen through a 3-inch rectangular hole running the full width of the floor of the box (photograph A3). PLM (Polarised Light Microscopy) analysis of this dry and friable dust found it to contain, crocidolite, amosite and chrysotile asbestos.

A series of photographs were taken showing the construction of the box and the major components of the blower. These are included in appendix 5.1 as photographs A1 – A7. From the photographs it can be observed that all of the walls are lined with asbestos insulation boards measuring approximately one inch in thickness. It is thought that the blower boxes were lined with these boards to act as a heat or fire-guard and also to suppress the noise of the motor and blower.

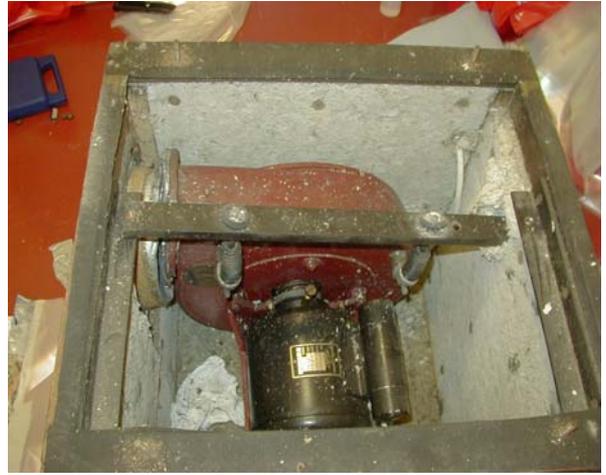
Photograph A2: The Inside of the Box Showing the Motor and the Blower Unit.

Air is drawn into the box through the rectangular opening (~10 x 80 cm) underneath the box, which is supported by four 'feet' (~ 2 x 10 cm) that raise it slightly from the floor on which it would rest. The air then moves into the blower and is expelled through the smaller hole via a flexible coupling in the side of the box into the organ pipes. The organ blower was not in a functioning state when received and was not operated at HSL. The organ blower box had been removed from the site by an external company and following initial examination of the box and lining material the asbestos content and friability of the material it was concluded unsafe to test.

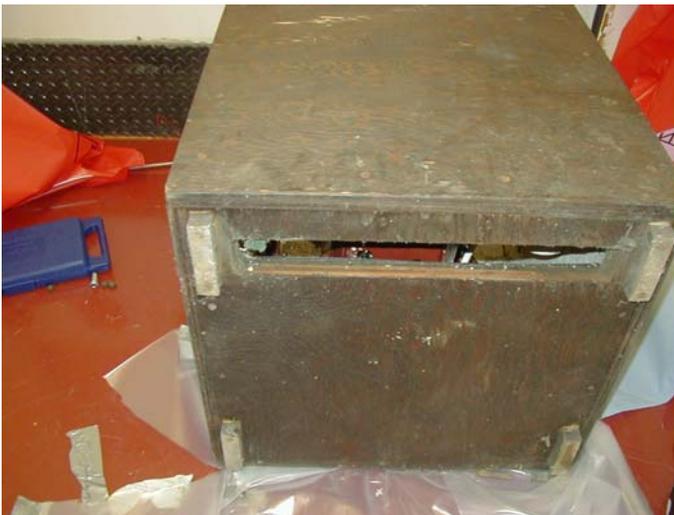
Photograph A3: The Underside of the Blower Box

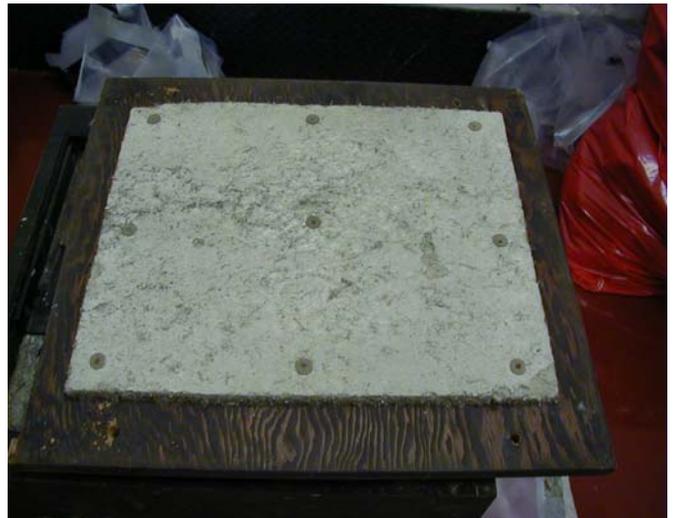
Photograph A4: Underside of Blower Box Lid

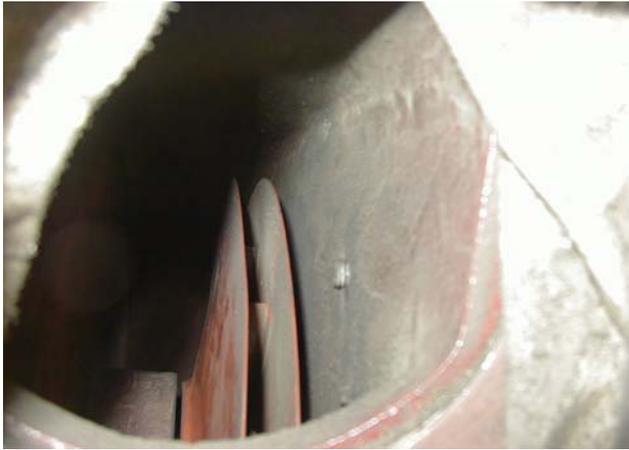
Photograph A5: Inside the Organ Blower (Via Flexible Coupling) from Air Outlet Hole

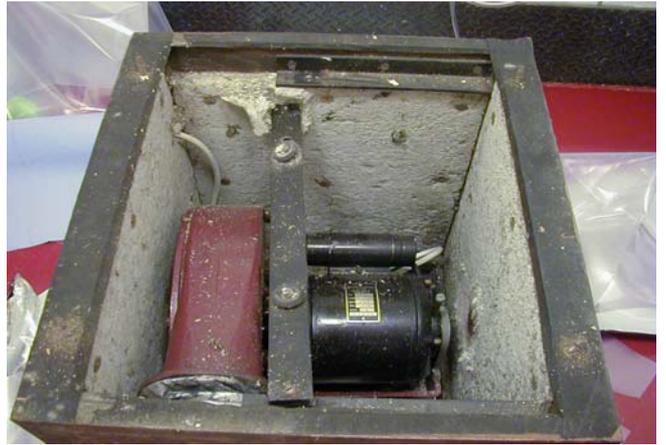
Photograph A6: Inside of Blower Box

The insulation material from the inside of the organ blower box was examined using Stereozoom and PLM (Polarised Light Microscopy) microscopy and a sub-sample was analysed for asbestos content to a UKAS accredited standard using the method in HSG248 Asbestos: The analyst's guide for sampling, analysis and clearance procedures¹. The sample was found to contain Amosite, Chrysotile and also Crocidolite asbestos fibres and was very friable. It is unclear if the material has become more friable with age, exposure to heat and moving air, but this may explain the current state of the blower box lining. (This can be seen in the photographs in appendix A.)

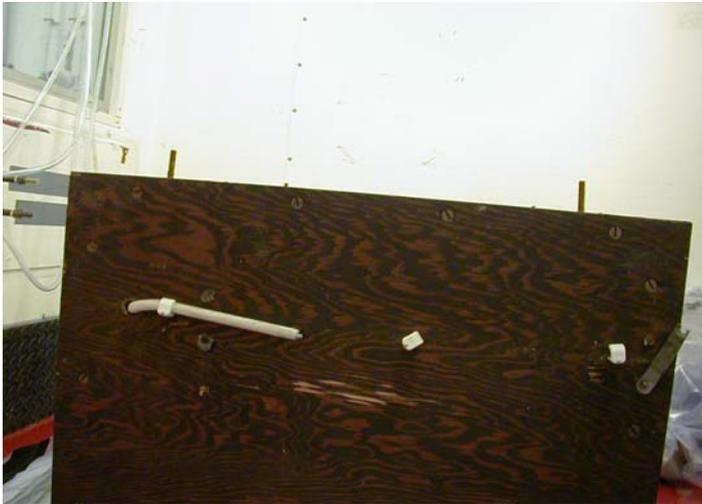
Photograph A7: Electric Cable to Motor
