Microbiologically influenced corrosion of mooring systems for floating offshore installations

Mooring Integrity Joint Industry Project Phase 2

RR1094

Research Report

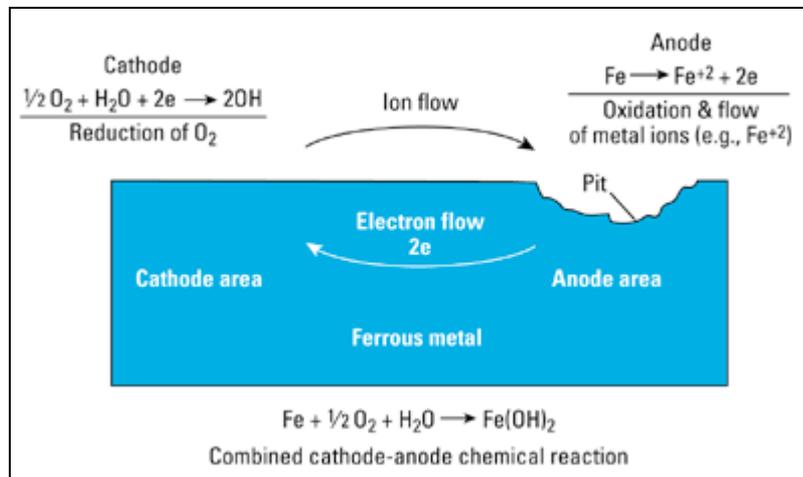
Figure 3-1: Schematic of Anodes, Cathodes and Pitting

Pitting corrosion will take place when anodic and cathodic sites stay in the same locations over time. There are many reasons for this such as:

When a corrosion pit has developed the conditions created by the topography and chemistry may favour further corrosion in the same location at a relatively high rate. Another reason for high corrosion rates in pits is that they represent small anodic areas relative to much larger cathodic regions. This means that “anodic pits” become sacrificial relative to the cathodic regions.

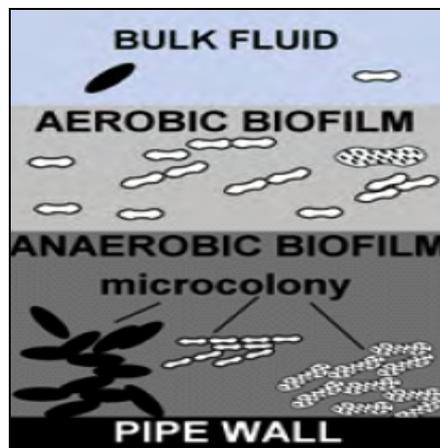
Figure 3-2: Illustration of build-up of bio film on a steel surface (represented by pipe wall)

Micro-organisms settle and multiply as parts of bio-films (as illustrated in Figure 3-2) that normally develop on all surfaces subsea, such as for instance steel exposed to water.

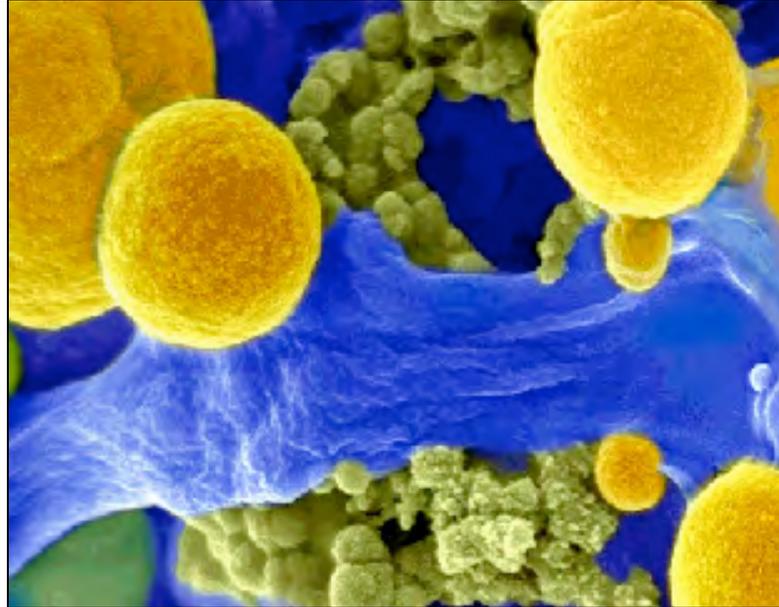
Figure 3-3: Example of Typical Sulphate Reducing Bacteria

There is a huge variety of bacteria in the sea environment, and there are probably more bacteria that have not been identified and characterised yet, than those that have. Figure 3-3 shows what typical Sulphate Reducing Bacteria look like when enlarged.

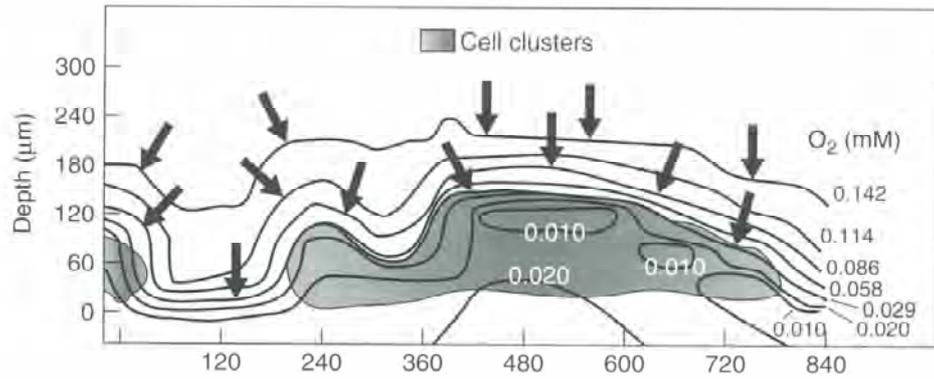
Figure 3-4: Illustration to show how the concentration of Oxygen can vary in a bio-film

Bio-films will normally be a heterogeneous composition of different bacteria, slime substances called extra cellular polymeric substances, organic macromolecules etc. It will consist of clusters of cells and bacteria, voids and channels. The adhesion to a steel surface will depend on a number of factors depending on the surface properties and film composition and chemistry. Bio-films will often be very irregular and can thus create concentration cells for certain compounds and thus influence the development of anodic and cathodic regions that can result in corrosion. Lateral variations in the bio-film build up can result in low oxygen concentrations in some regions creating anodic sites with cathodic sites in locations where oxygen is more abundant. Possible variation in oxygen concentration is shown in Figure 3-4.

When a bio film builds up in thickness (but still thin in comparison to macro fouling) there will typically be high consumption of oxygen on the surface. This results in a reduction in oxygen concentration as function of depth into the film possibly resulting in anaerobic conditions close to the steel surface, such as shown in Figure 3-5. Thus the bio film can generate environments where anaerobic bacteria can become active provided that they are present together with the components/elements they require for their metabolism.

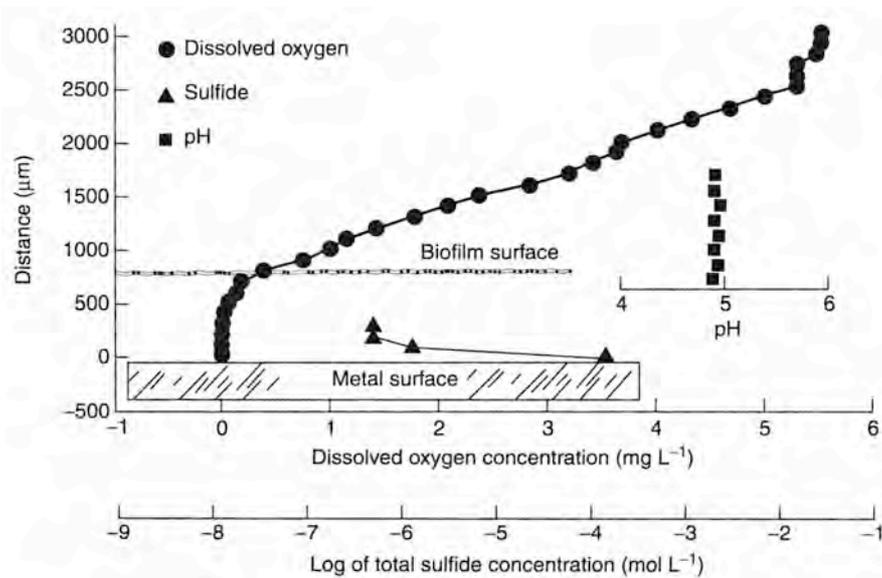
Figure 3-5: Typical variation of significant properties as function of biofilm depth

Through the thickness or bulk of a bio-film there will be gradients of different substances that can be important for the activity of different bacteria. In some regions of a biofilm the bacterial activity can be high and in other regions very low, reflecting the local conditions. The product of the metabolism of some bacteria, as well as dead bacteria, can constitute nutrients for other bacteria.

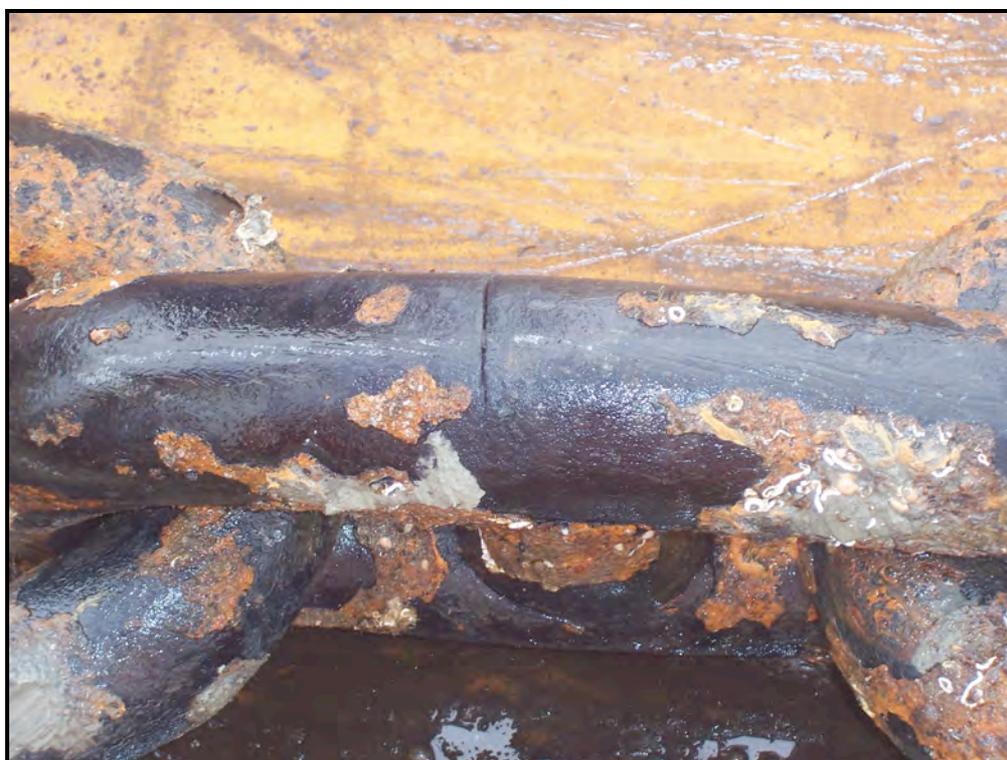
Figure 3-6: Black Coloured Link when first recovered on the back of an Anchor Handling Tug

Iron Sulphide has a very low solubility in water and will precipitate on the steel surfaces and generally be black in colour - see for example . Iron Sulphide films/layers attached to the steel surface can act as a cathodic site and thus promote Iron to go into solution at anodic sites thus stimulating the corrosion. In conditions with uniform exposure of steel surfaces to water with dissolved H_2S the FeS film will protect the surfaces as long as it is intact while high corrosion rates can develop where the film is damaged.

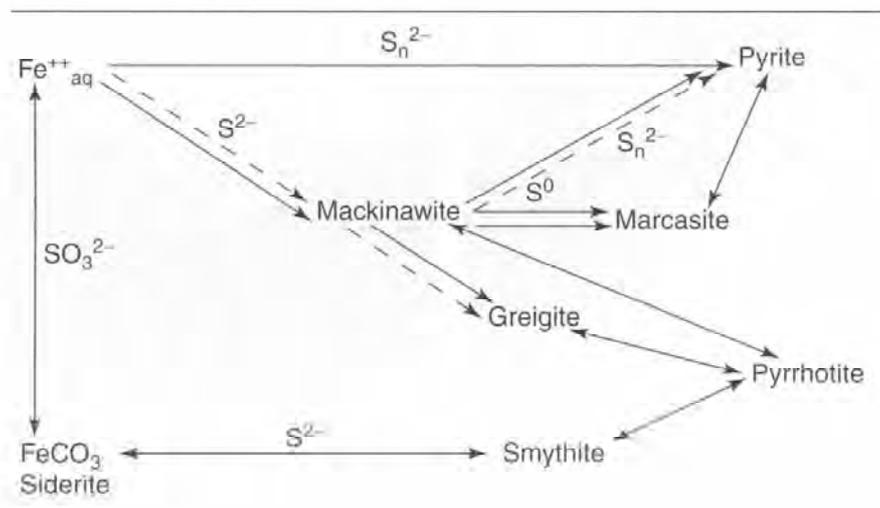
Figure 3-7: Illustration of formation and transportation of iron sulphide structures at pipeline corrosion sites

Dr. B. Little has through direct communication (and reference to the literature) indicated that SRB are unlikely to cause severe corrosion under stable conditions such as under permanent and protected biofilms. Under such conditions an iron sulphide film will develop on the steel surface and partly protect the steel from further corrosion. However, if the conditions change in terms of oxygen getting access or mechanical disturbance the iron sulphide film will be damaged and corrosion will accelerate. Sulphur oxidising bacteria and the production of sulphuric acid may play an important role in this process. There are hypotheses of a complete sulphur cycle where different bacteria participate, converting sulphate to sulphide to elemental sulphur and back to sulphate.

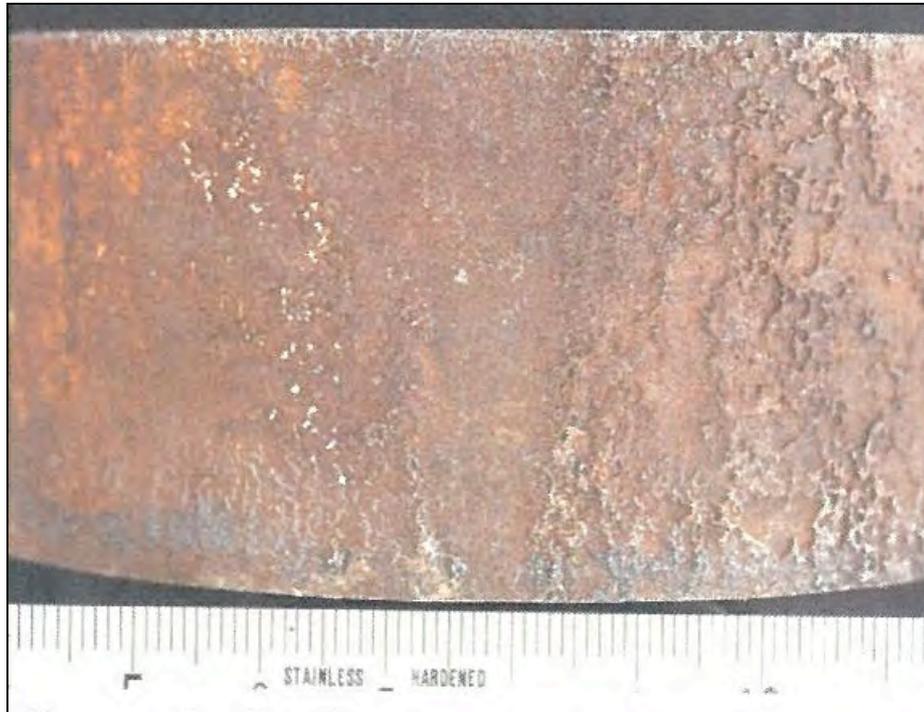
Figure 4-1: Corrosion pattern from case 1

In Figure 4-1 and Figure 4-2 provide pictures from case 1 showing the corrosion pattern and profile of pits detected.

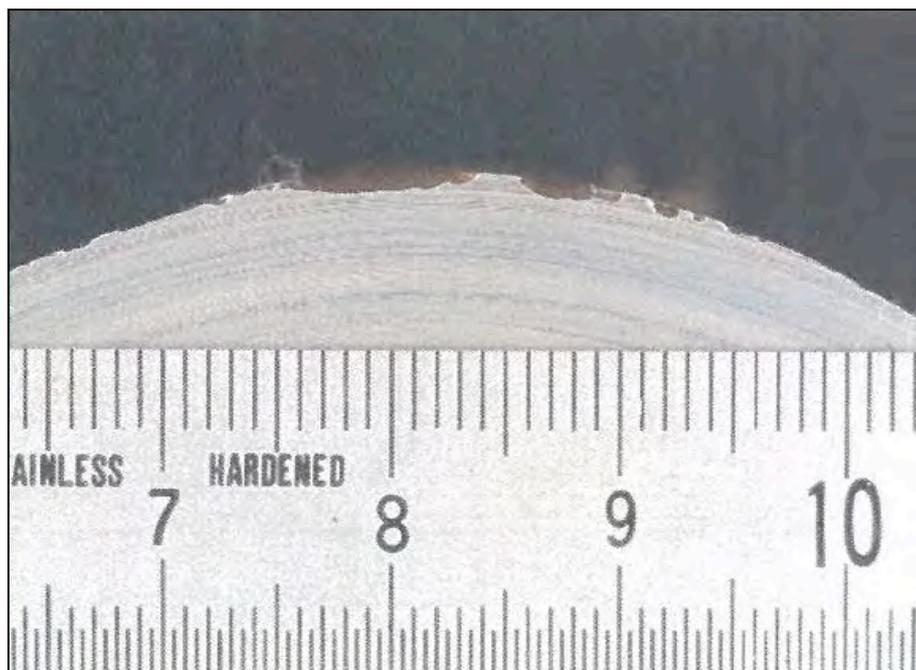
Figure 4-2: Pit profile from case 1 corrosion

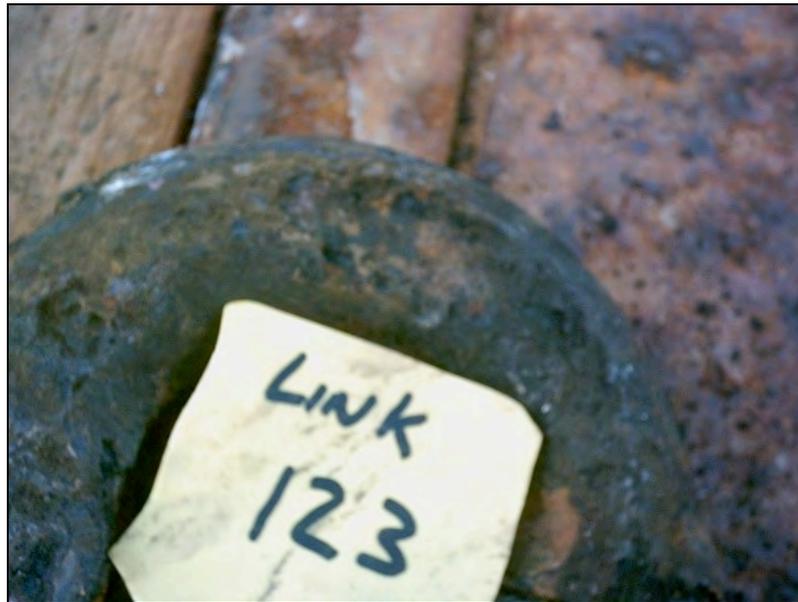
Figure 4-3: Corrosion pits among black patches from case 4

Figure 4-3 and Figure 4-4 show details of some of the affected links from case 4.

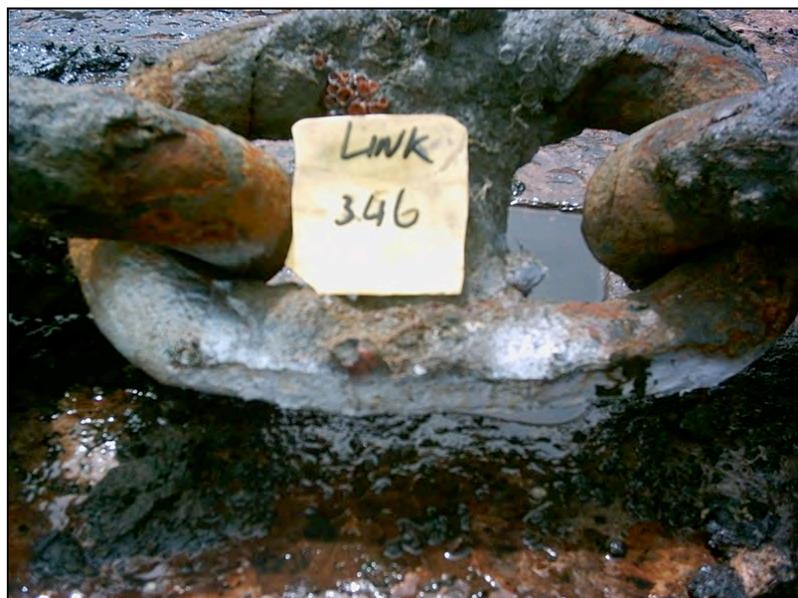
Figure 4-4: Corrosion pattern from case 4 showing significant loss of material

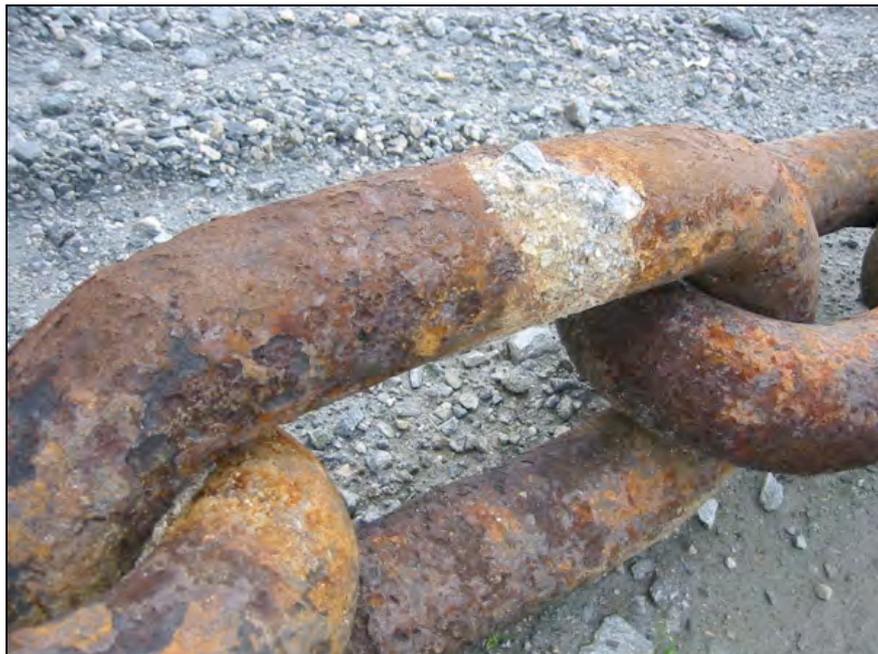
Figure 4-5: Link with corrosion pits with black patches from Case 5

Figure 4-5 shows corrosion pitting from Case 5:
