# **Trojan horse construction site safety messages**

Prepared by **Steel Construction Institute**  
for the Health and Safety Executive 2005

RESEARCH REPORT 336

This study was commissioned by the Health and Safety Executive to assess the efficacy of a novel means of messaging that delivers safety information directly to site operatives. The method involved attaching key messages to construction components.

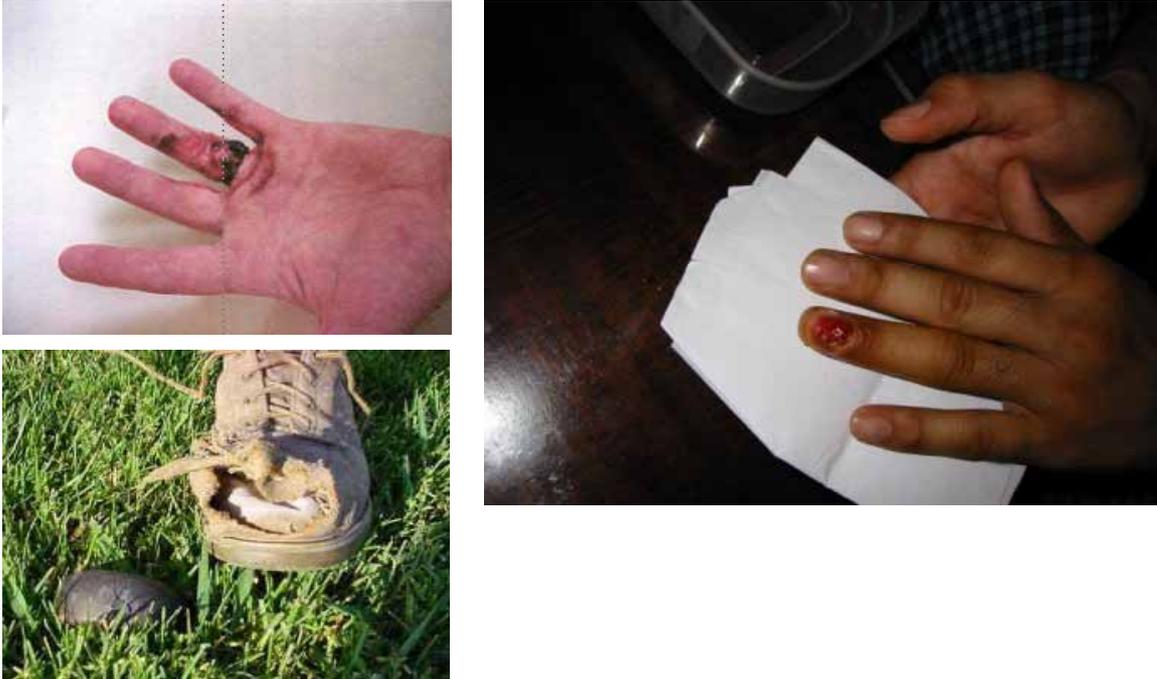
**Figure 2** Typical messages from SADIE website

The messages were designed to highlight specific safety issues relating to the construction types selected from this study. The philosophy adopted for the design was to produce messages that illustrate bad practice for maximum impact. Examples of such messages are provided on the Safety Alert and Database Exchange Information (SADIE) website and are shown in Figure 2.

SADIE was developed as part of the Step Change in Safety programme initiated by the major offshore operators following the Piper Alpha disaster. The photographs shown in Figure 2 together with summary sheets of lessons learnt from the incidents are disseminated to the employees to reinforce safety awareness.

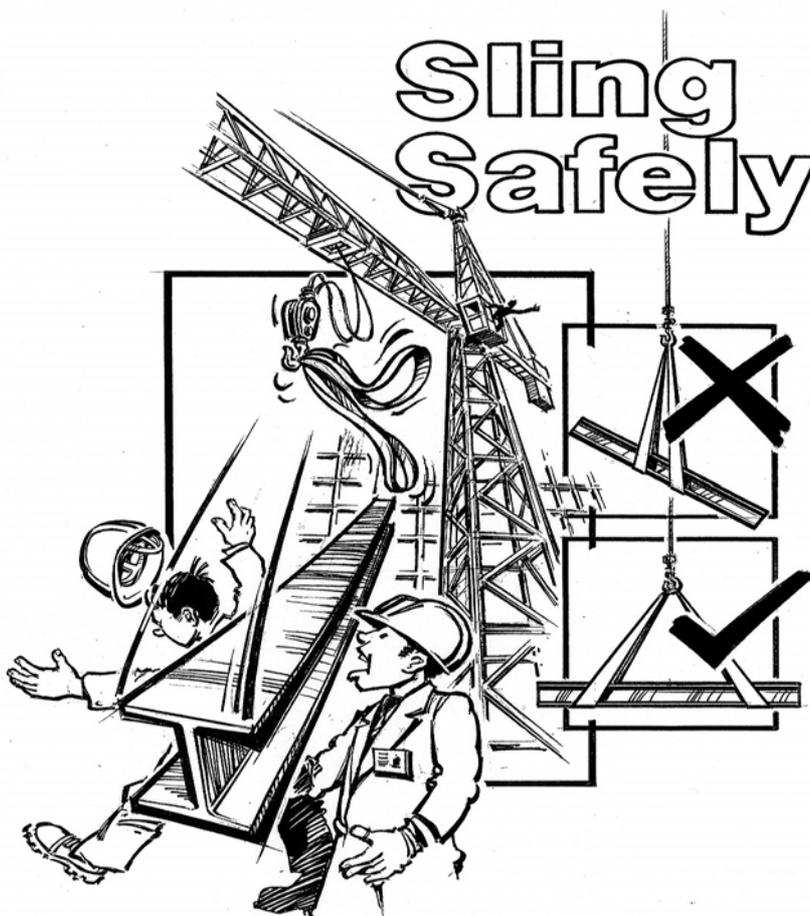
**Figure 3** Safety message for steel frame erection (used for site trials)

The issue selected for this construction type related to the slinging of components during erection. The message (used in site trials) is shown in Figure 3 and illustrates the hazard from improper slinging of steel components whereby slippage may occur. Also shown as a caption is the proper way of slinging components with the slings inclined at an angle of approximately 60°.

However, during the site trials, it was observed that the operatives used a different procedure for slinging of components. The use of chains, instead of slings, was common practice and the slinging procedure involved 'choking' (i.e. double wrapping) the chain around the component.

In addition, the participating companies expressed their concern at the depiction of the crane operator leaning out of the cab and the steel component hitting the operative at ground level.

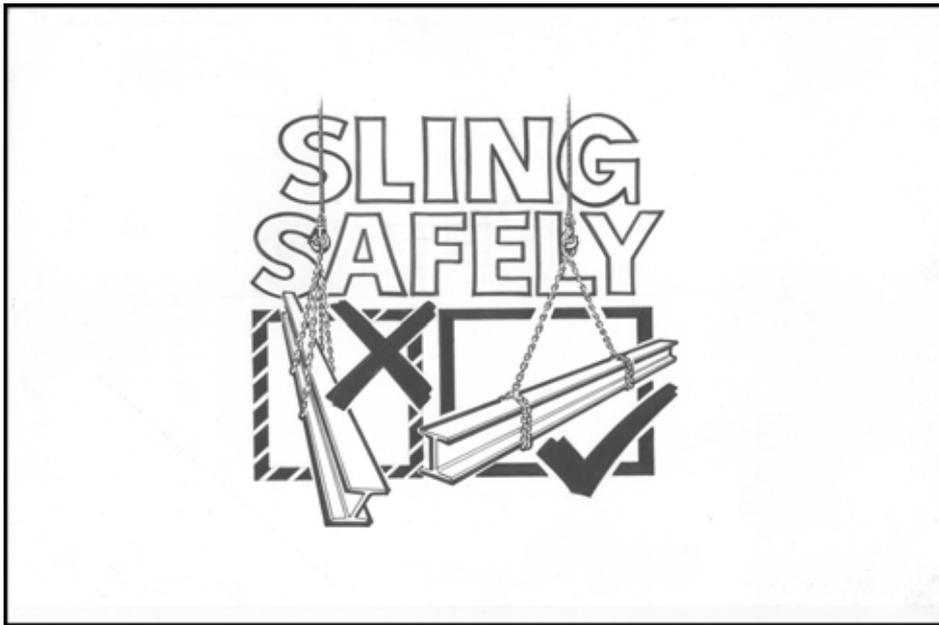
**Figure 4** Safety message for steel frame erection

Following advice from the companies, it was decided to alter the message to reflect actual site practice. The revised design is shown in Figure 4.

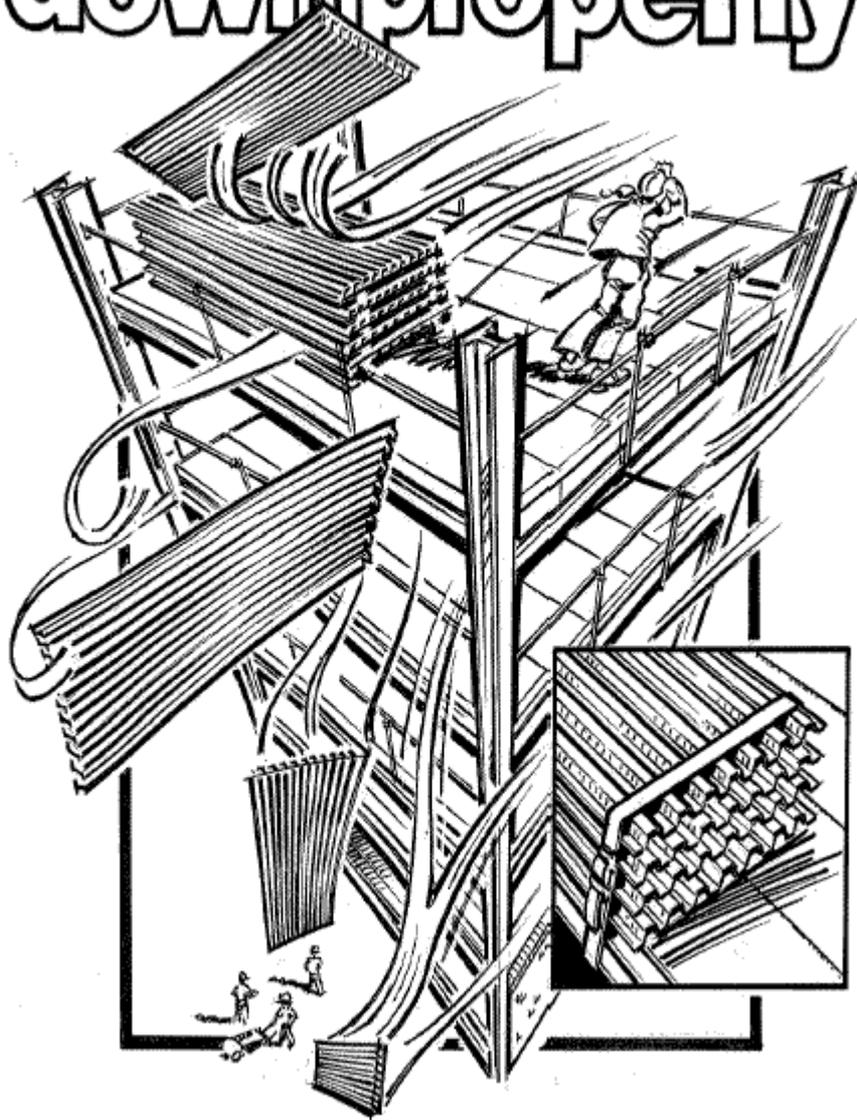
**Figure 5** Safety message for profiled steel decking

The cartoon illustration shown in Figure 5 was chosen to highlight the hazard arising from improper stacking of loose sheets at heights. Under strong wind conditions, loose sheets can act as missiles that can cause harm and injury to both site operatives and members of the public.

The decking is usually delivered in bundles of up to 24 sheets with the sheets secured with metal banding. Breaking of the bundles and installation can proceed if the sheets can be positioned and secured [12]. However, due to time constraints, it is sometimes not possible to install all the sheets. The partially used bundles must therefore be properly secured to avoid the hazard posed by loose sheets being blown in strong winds.

However, the manufacturers noted that the safety issue highlighted in the message, although relevant, was not particularly critical as installation of decking is stopped in windy conditions.

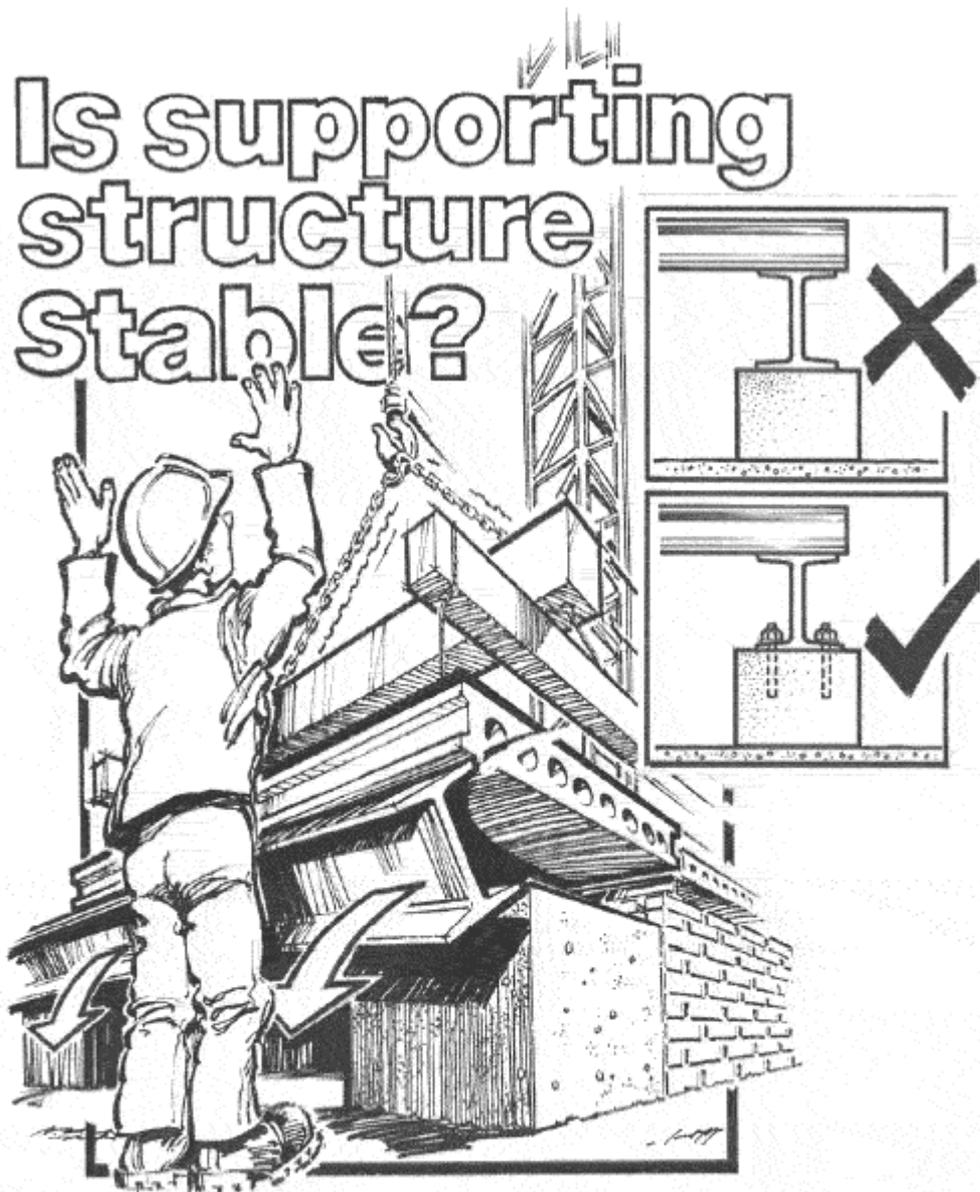
**Figure 7** Safety message for precast components

The steel beam shown in the figure is not properly fixed to the padstone and poses a hazard. Prior to installation of the precast component, the supporting structure must be checked to ensure that it is adequately supported and propped. The message also highlighted the proper way of fixing the steel component to the padstone.

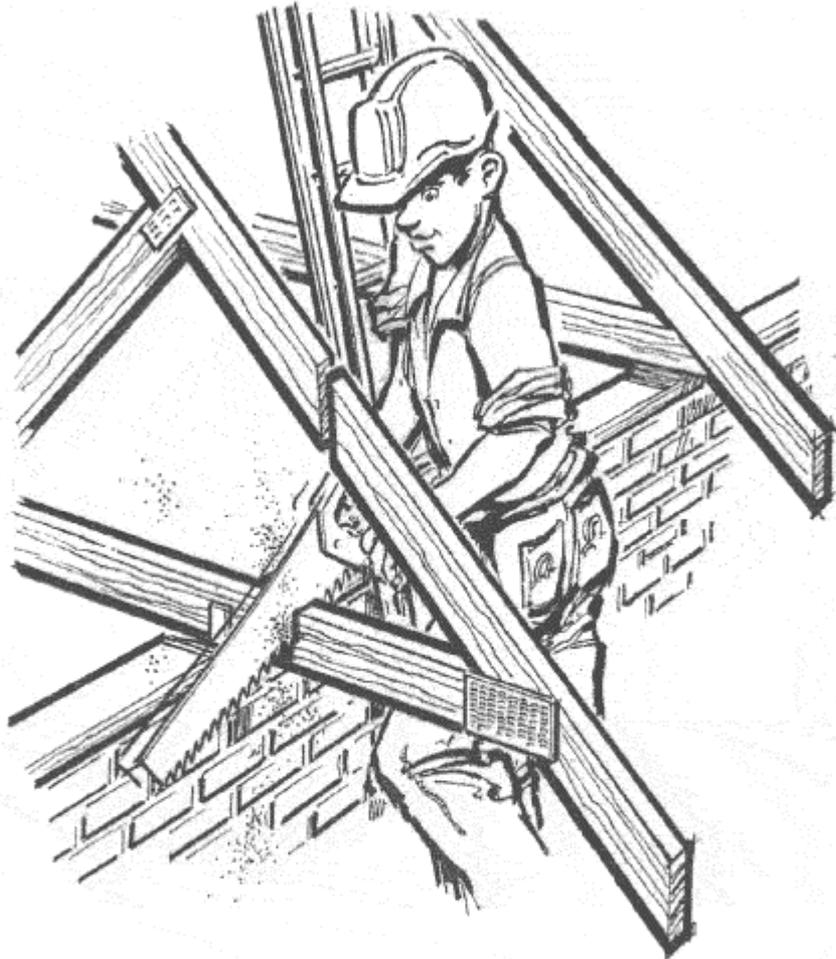
**Figure 8** Safety message for trussed rafters

The message is shown in Figure 8 where it is observed that the site operative is cutting the trussed rafter to suit the site dimensions. This will inevitably undermine the load-carrying ability of that particular rafter and may lead to an unsafe structure.

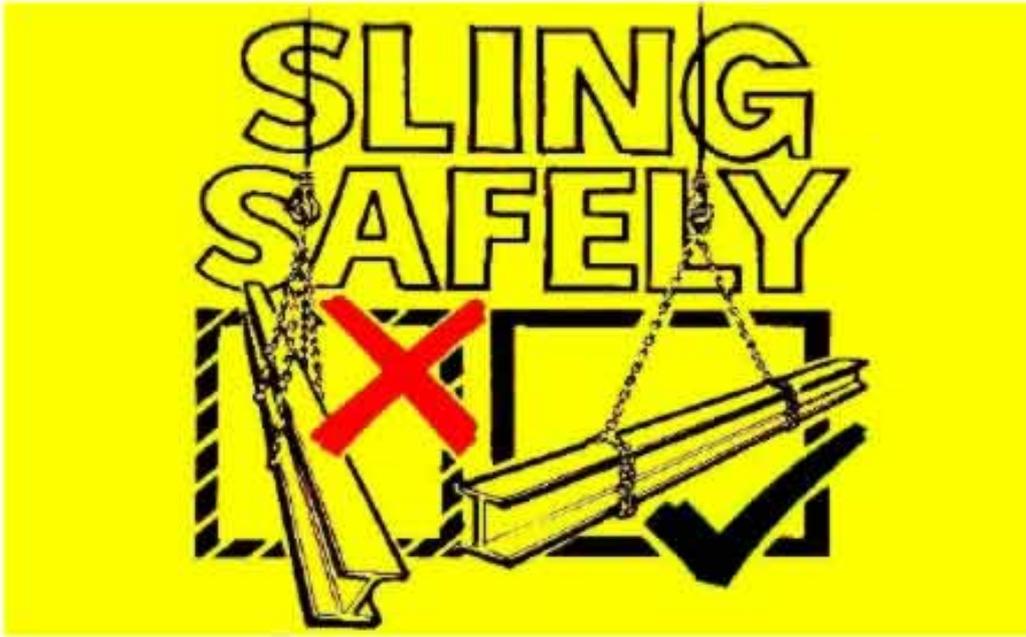
**Figure 9** Message for steel components

This format performed well during the site trials and the message (slinging of components) was observed by all the operatives within the gang. In this particular case, the messages were stuck to the base of the column so that there was no need for them to be removed, as they would be covered by the grouting.

The frequency of the messaging was approximately 1 in 10 components and the messages were found to be robust enough to withstand transportation and site handling.

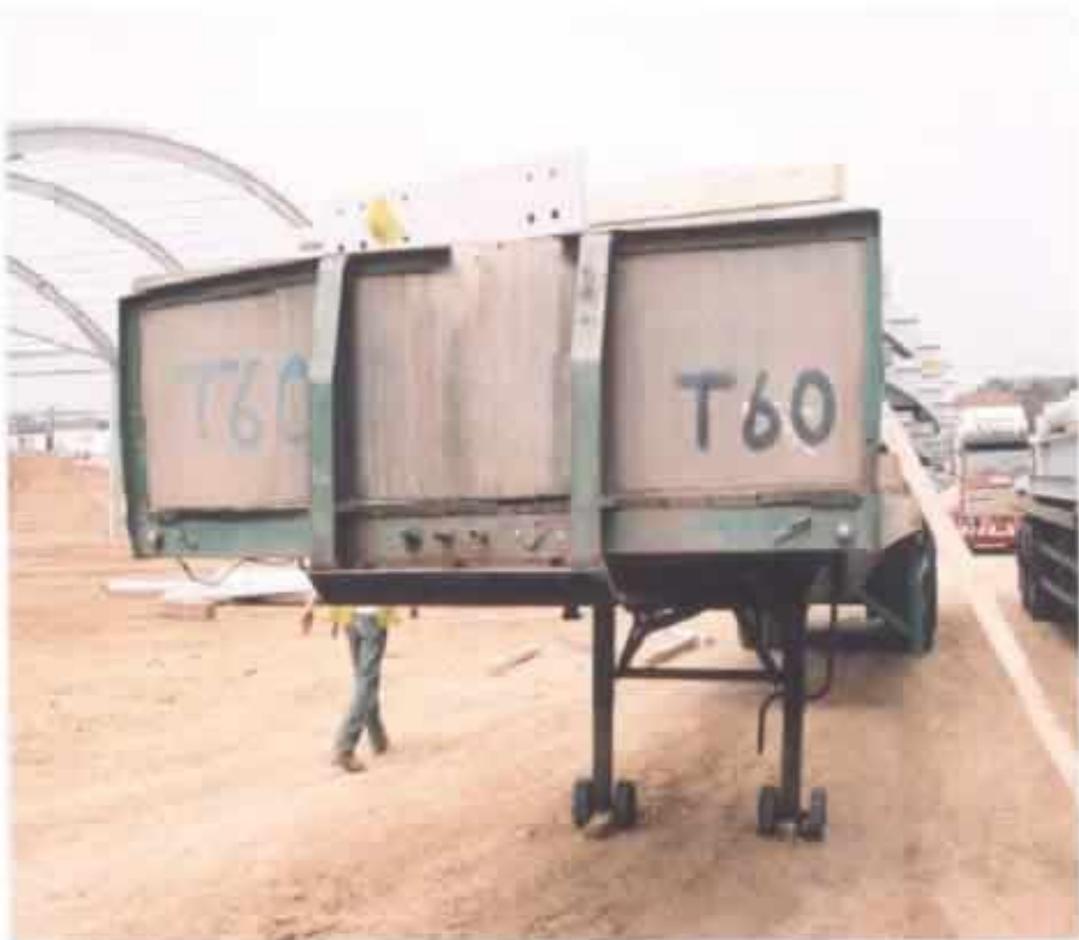
**Figure 10** Photograph of message on steel beam

A photograph of the messages on the steel components is shown in Figure 10.

It was found during the site surveys that the messages did not stick properly to the painted steel components. Messages with 'stronger' adhesive were ordered from the printers and were found to perform well. However, if removal of the messages prior to installation is required, it is recommended to simply attach the messages to components by strings (or wires) through the boltholes.

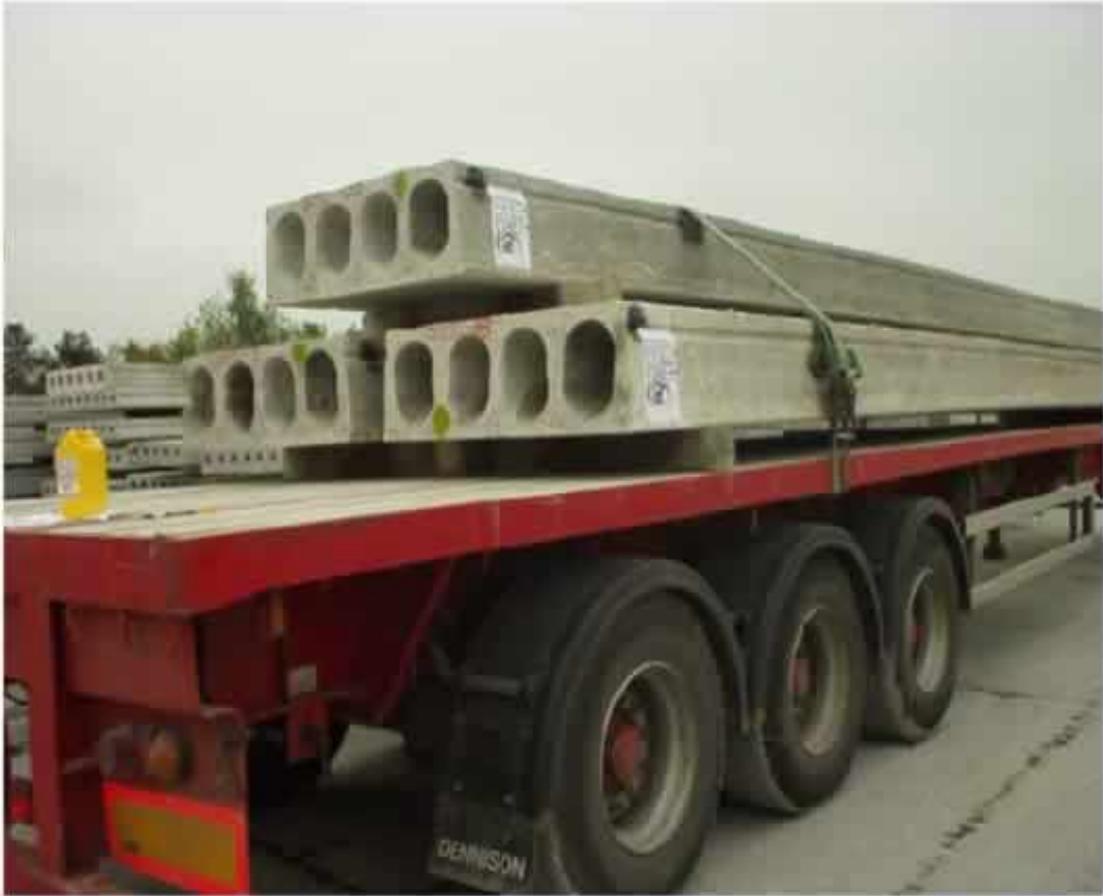
**Figure 11** Photograph of message on precast units

It was found that the messages did not stick well to the units. The manufacturers subsequently used their own special adhesive to stick the messages to the units. A photograph of the messages on the precast units is shown in Figure 11.
