# **Axial fatigue tests on wire rope slings used for offshore containers**

Prepared by the **Health and Safety Laboratory**  
for the Health and Safety Executive 2006

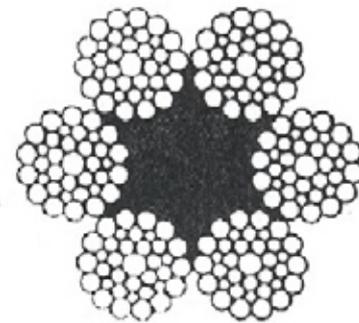
Figure 3 Construction of 6 x36 FC rope

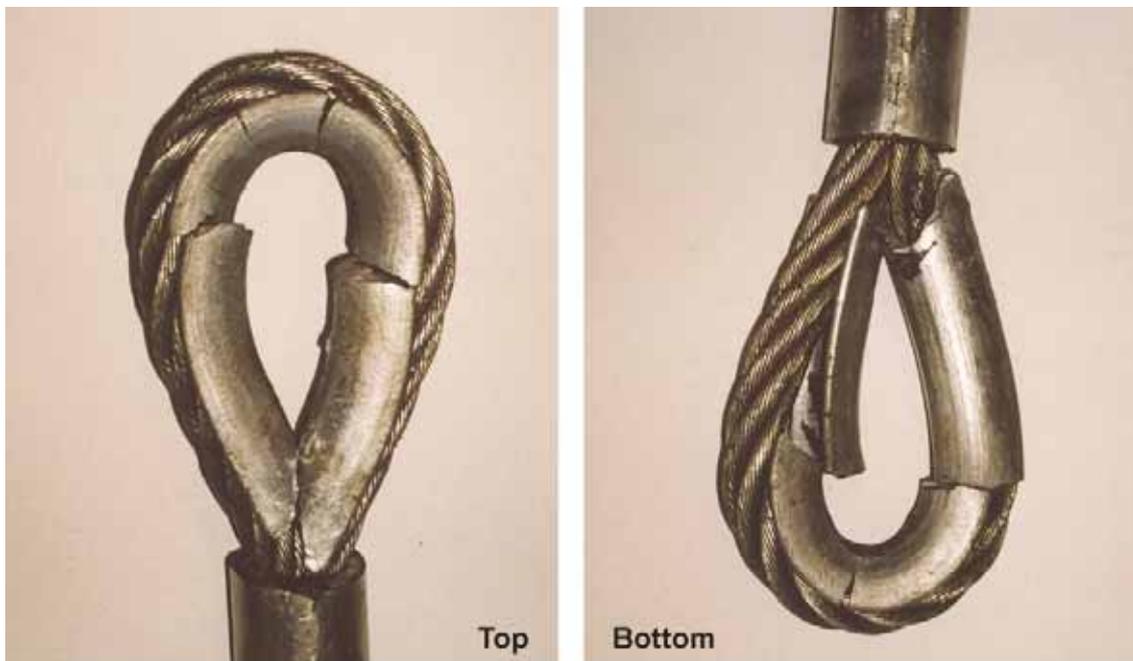
Figure 5 Collapsed thimbles on sample 2 after 20,000 cycles

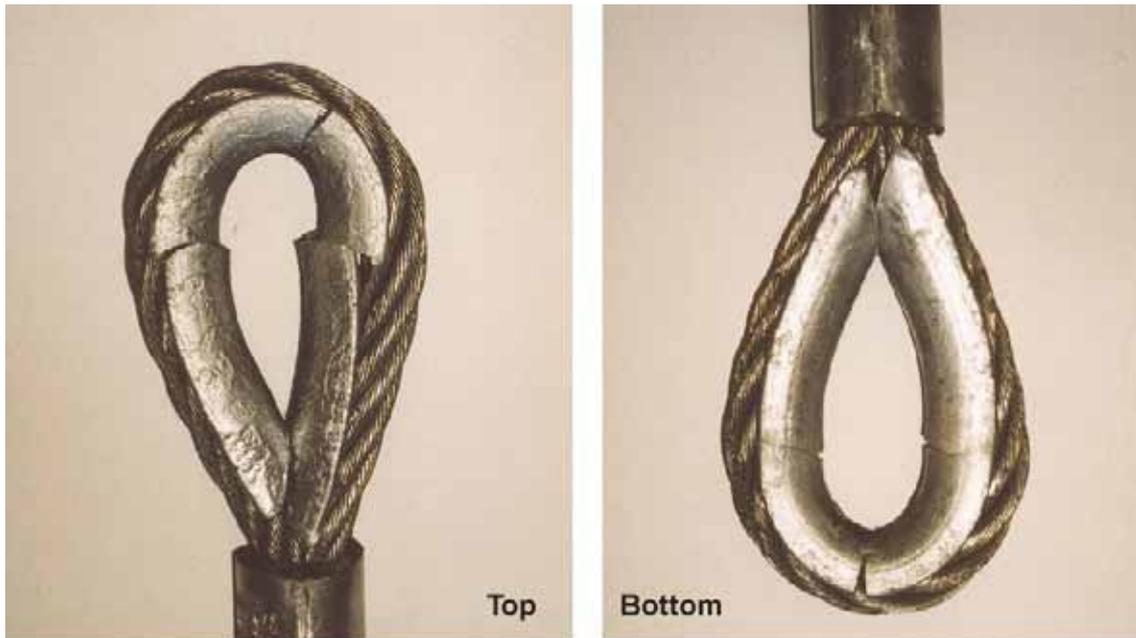
Figure 6 Collapsed thimbles on sample 3 after 15,000 cycles

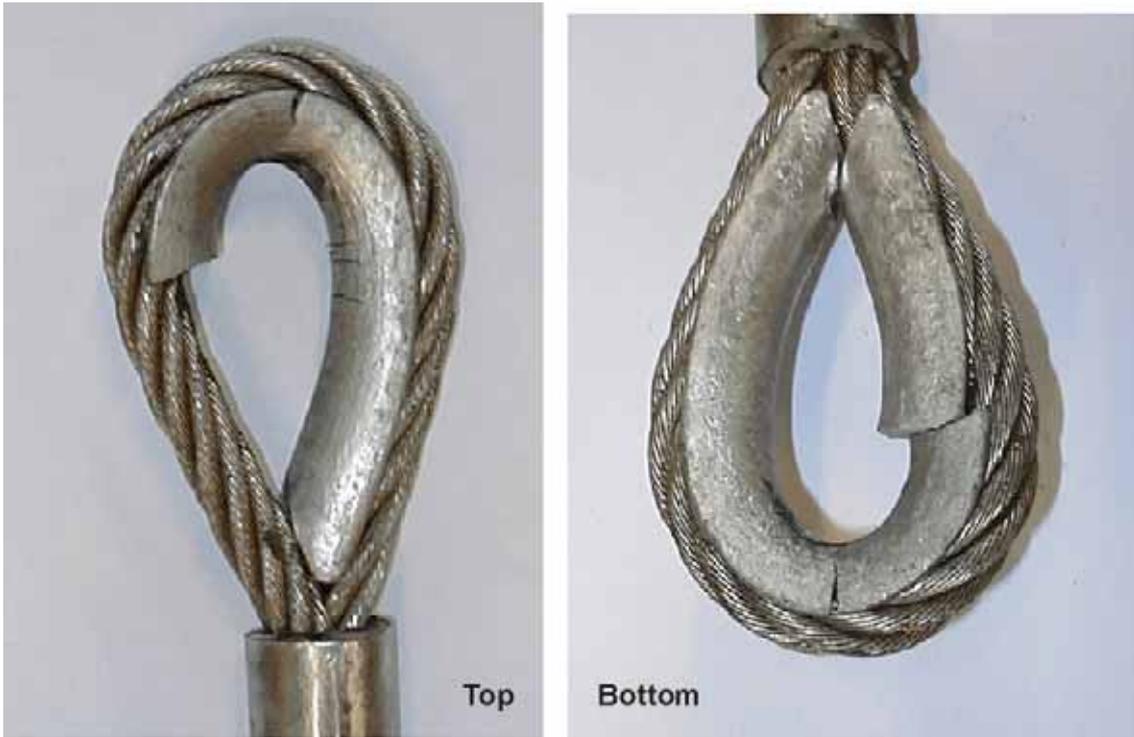
Figure 7 Collapsed thimbles on sample 4 after 5,185 cycles

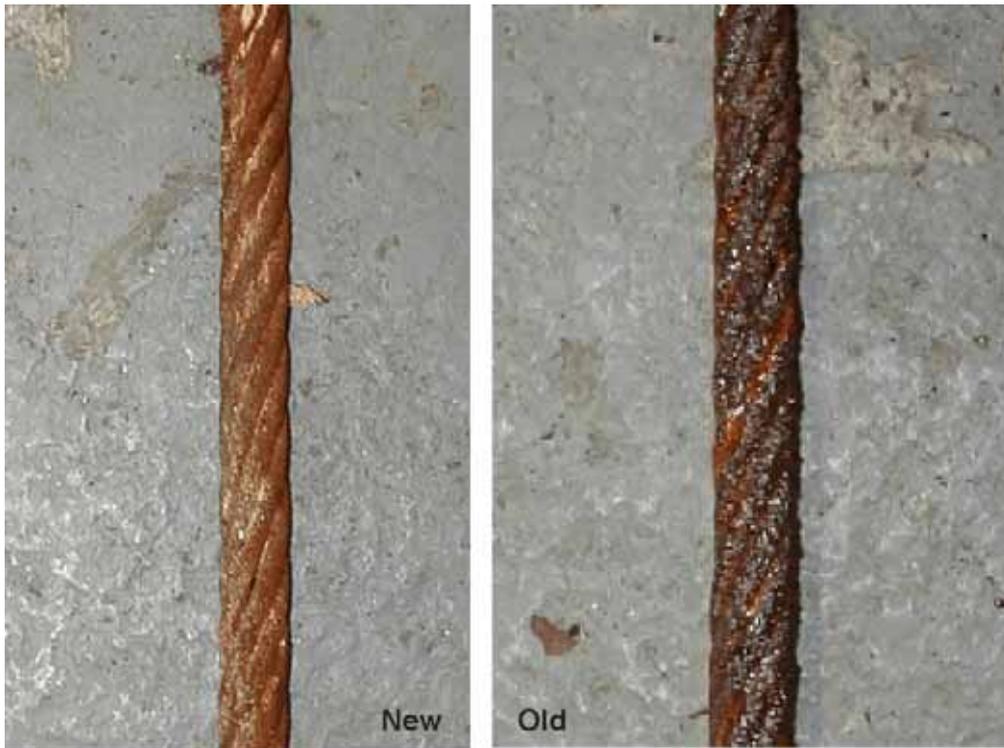
**Figure 8** Rope samples after accelerated corrosion for 5 weeks

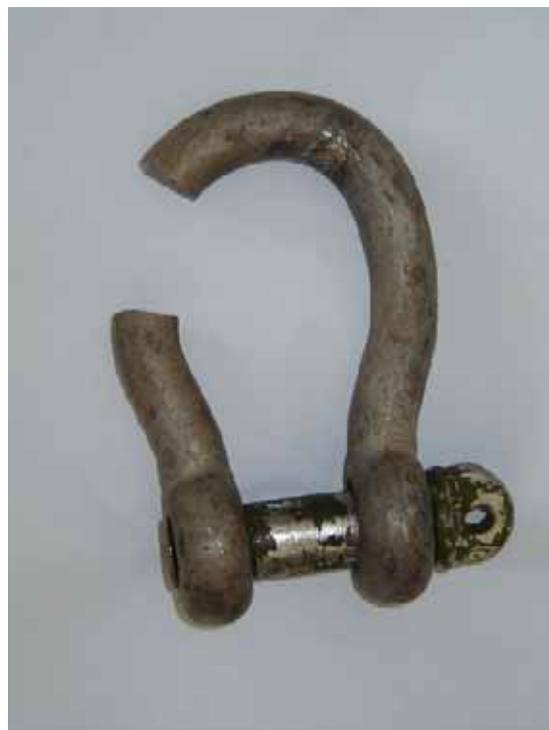
**Figure 9** Failure in the upper attachment shackle after 58,100 cycles
