**REPORT INTO THE GAS EXPLOSION INCIDENT
AT 16 BUCKSTONE GROVE, EDINBURGH
ON 30 NOVEMBER 2005**

APRIL 2006

Gas & Pipelines Unit (Scotland)
Specialised Industries Division
Hazardous Installations Directorate
Lord Cullen House
Aberdeen

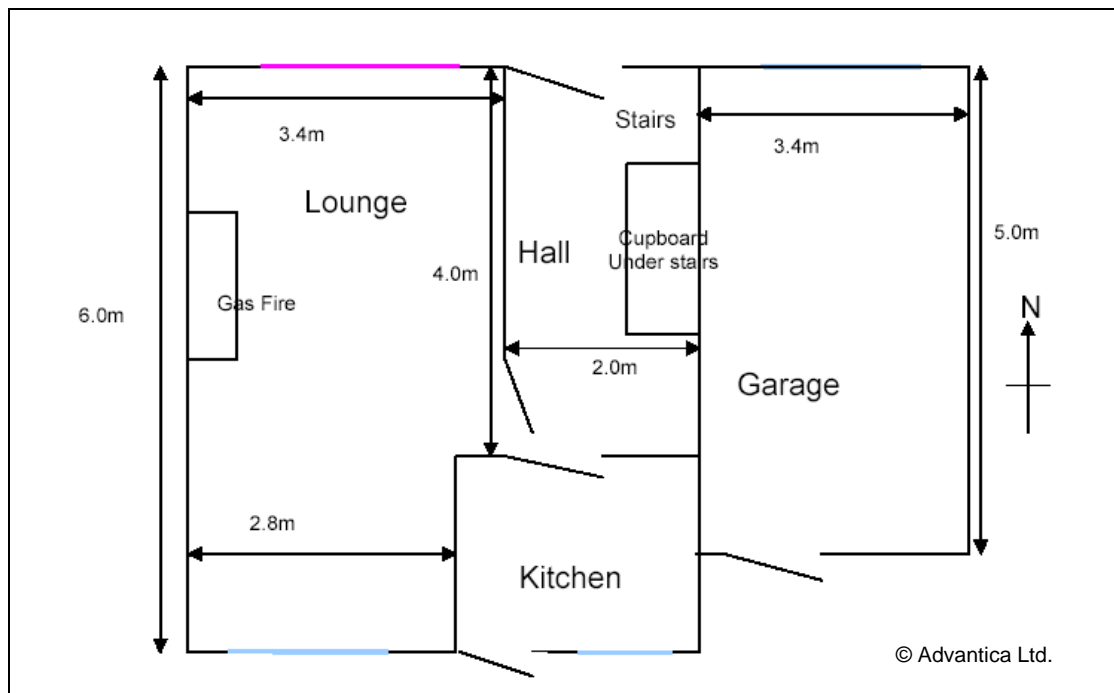
Figure 1 - Ground floor plan of 16 Buckstone Grove

No 16 Buckstone Grove is a semi-detached two-storey dwelling house, of traditional construction, built in the 1960's.

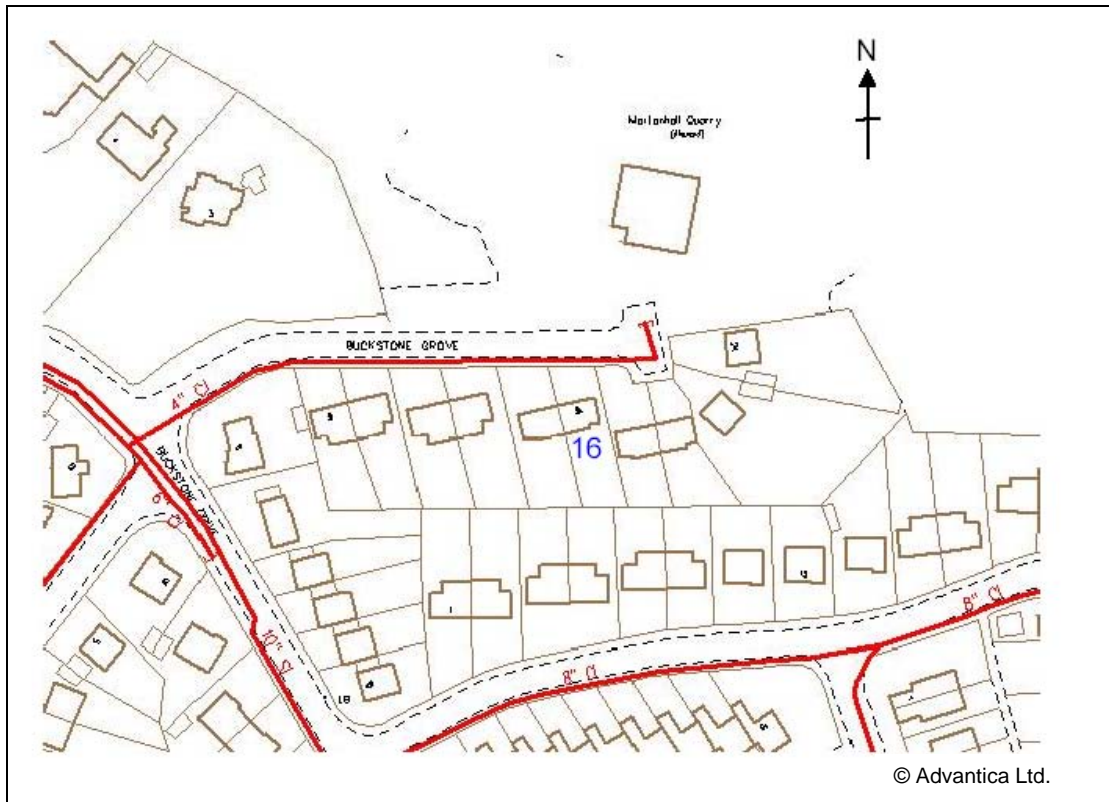
Figure 3 - Gas mains local to Buckstone Grove

the footway. Prior to the incident the system was operating at 25 – 30 mbar, which was the normal operating pressure for this system. Details of the gas mains in the area of Buckstone Grove are shown in Figure 3.
