This safety alert is drawn up to spread the lessons learnt from the major oil release of October 25th, 2005 in an oil storage terminal. The oil storage terminal belongs to a large oil company and is an upper tier Seveso establishment.

This alert is based on the investigation of the company, for which several external experts were consulted, and the investigation of the Belgian authorities. After the accident history recommendations are formulated to prevent similar accidents in the future.

### 3. Construction information and history of the storage tank D2

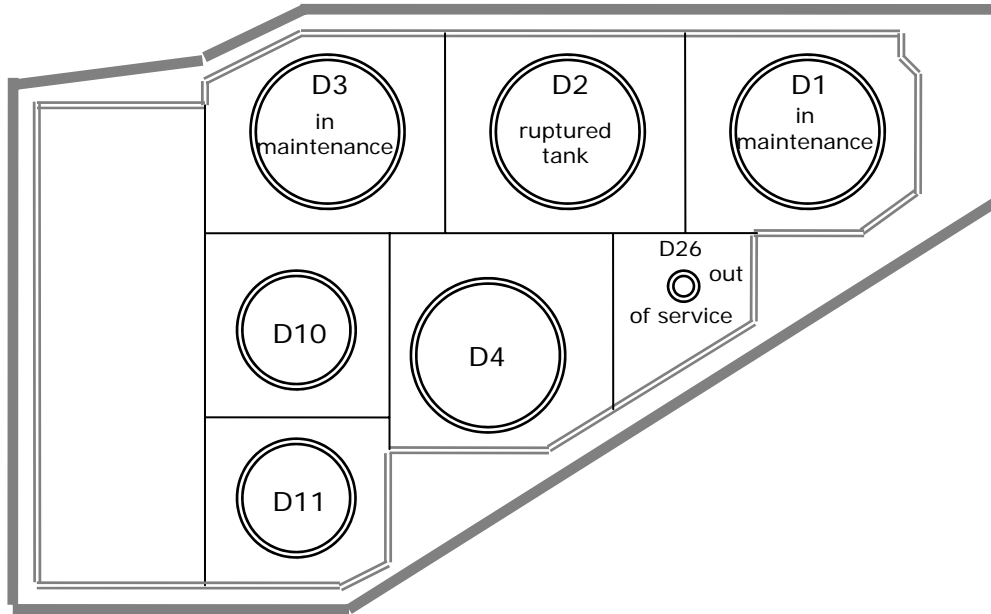
Figure 1: Lay-out of the oil storage terminal

The oil storage terminal contains 7 storage tanks in one large bund made with earth dikes. Between the tanks there are lower inner dikes.

- 4 crude oil storage tanks with a content of 40 000 m<sup>3</sup> each: D1, D2, D3 and D4;
- 2 storage tanks for the multifunctional storage of crude oil or rainwater contaminated with crude oil, slop oil, with a content of 24 000 m<sup>3</sup> each: D10 and D11;
- 1 small tank D26, with a content of 730 m<sup>3</sup> which is out of service.

- crude oil tank D2 was more than 75% full
- crude oil tank D4 was partially full
- tanks D1 and D3 were empty and in maintenance
- storage tank tank D10 was full with slop oil
- storage tank D11 was empty
