Investigation of the Explosion at Linfield Street Dundee 22nd of October 2000

**Issued by the
Hazardous Installations Directorate (HID)
Specialised Industries Division**

**A report of the investigation by the Health and Safety Executive of the explosion
and fire at 21 – 25 Linfield Street Dundee on the 22nd of October 2000.**

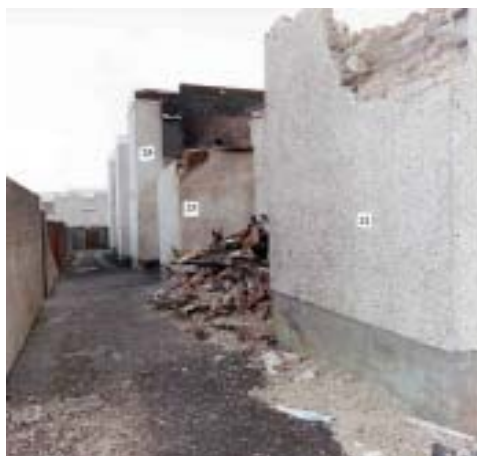
Figure 2 Path at front of 21 – 29 Linfield Street

9. The houses in this block each had a front and back door. The back door opened from the kitchen area into the garden to the rear of the house (South) and the front door opened from the hallway on to the footpath at the front of the block (North) via some steps. The footpath at the front of the houses was a sealed bitumen footpath approx. 2.3 metres wide with a two metre high wall on the opposite side of the footpath (Fig 2).
