# **Investigation of the Explosion at Linfield Street Dundee 22nd of October 2000**

**Issued by the  
Hazardous Installations Directorate (HID)  
Specialised Industries Division**

**A report of the investigation by the Health and Safety Executive of the explosion  
and fire at 21 – 25 Linfield Street Dundee on the 22<sup>nd</sup> of October 2000.**

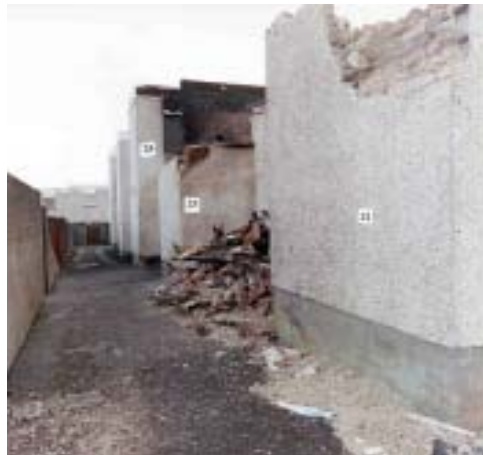
Figure 2 Path at front of 21 – 29 Linfield Street

9. The houses in this block each had a front and back door. The back door opened from the kitchen area into the garden to the rear of the house (South) and the front door opened from the hallway on to the footpath at the front of the block (North) via some steps. The footpath at the front of the houses was a sealed bitumen footpath approx. 2.3 metres wide with a two metre high wall on the opposite side of the footpath (Fig 2).

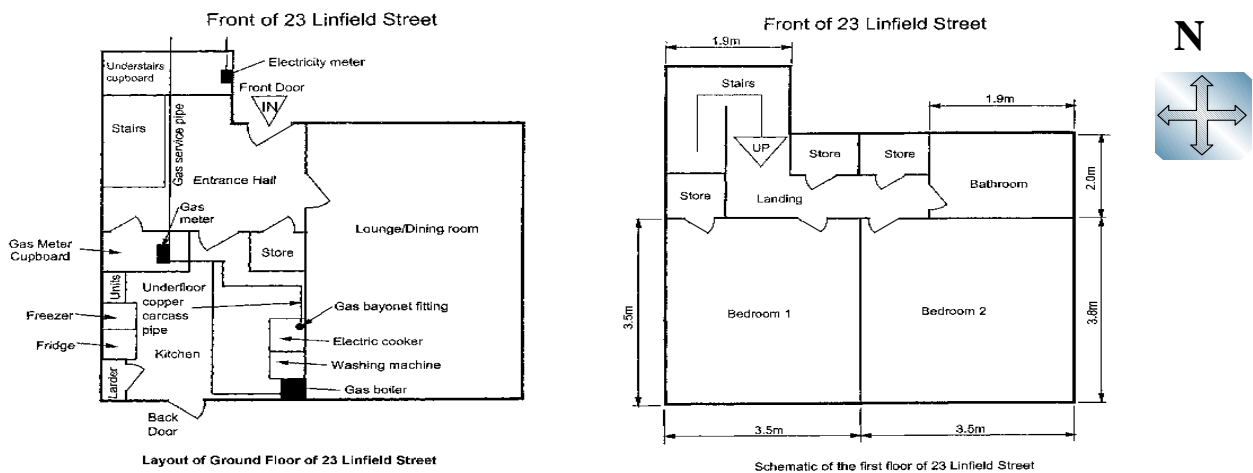
Figure 3 Layout of Ground Floor and First Floor at No 23 Linfield St.

10. The internal layout of the houses is shown in Figure 3.

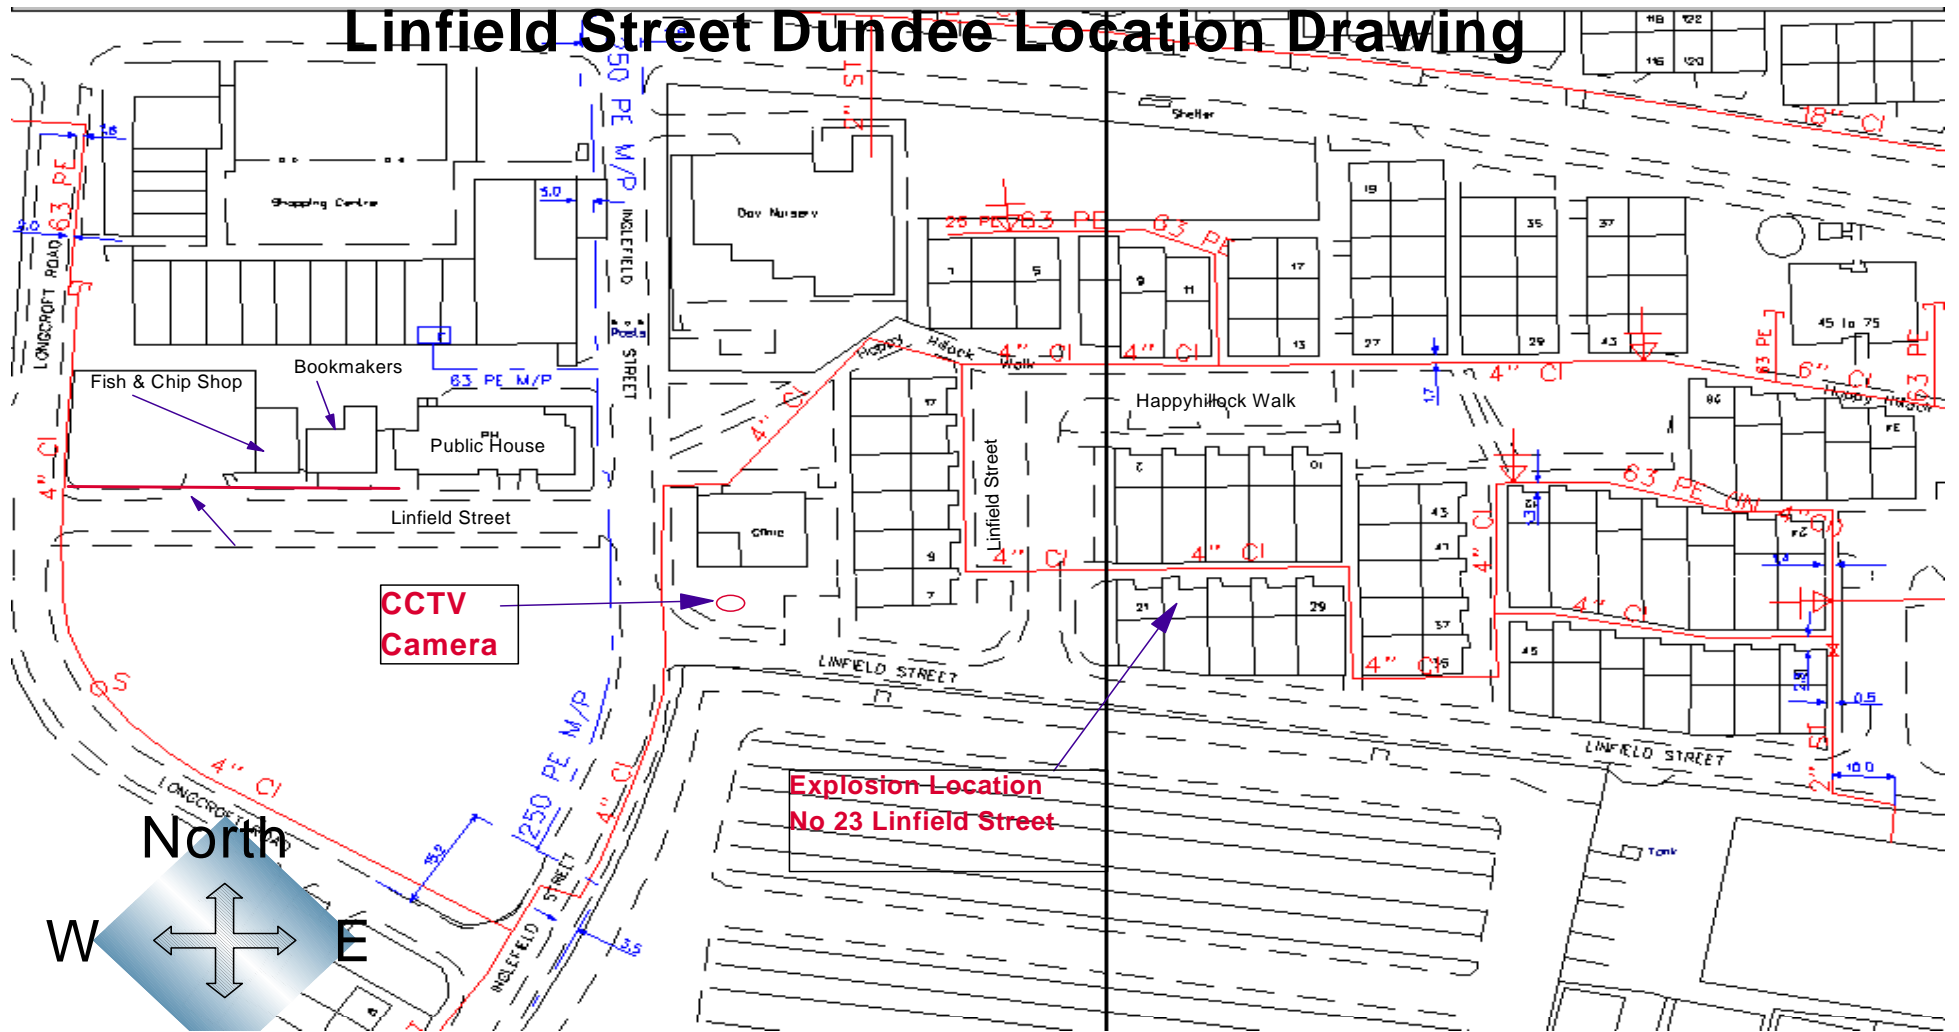
**Figure 4:** Layout of area around Linfield Street Dundee showing existing gas mains.

11. In approx. 1967 gas supplies were laid in the Happyhillock South estate and a 4" mechanically jointed cast iron main was installed in the footpath at the front of Nos. 21 to 29 Linfield Street (Fig 4). The gas main (approximately 121mm Outside Diameter and 107mm Internal Diameter with a wall thickness of 7mm) was positioned approximately 0.8 metres from the front of the stairwell of No. 23. The main was originally designed to convey town gas and was laid to 'fall' (drain) to ensure any liquids were collected at collection points such as siphons. The main operated in the low-pressure range (up to 75mbar) and was operating at around 31 mbar (12.5" Water Gauge) at the time of the incident.
