Investigation of failure of crane rope from DSV DSND PELICAN

Prepared by the
Department of Engineering
The University of Reading
for the Health and Safety Executive

OFFSHORE TECHNOLOGY REPORT
2002/031

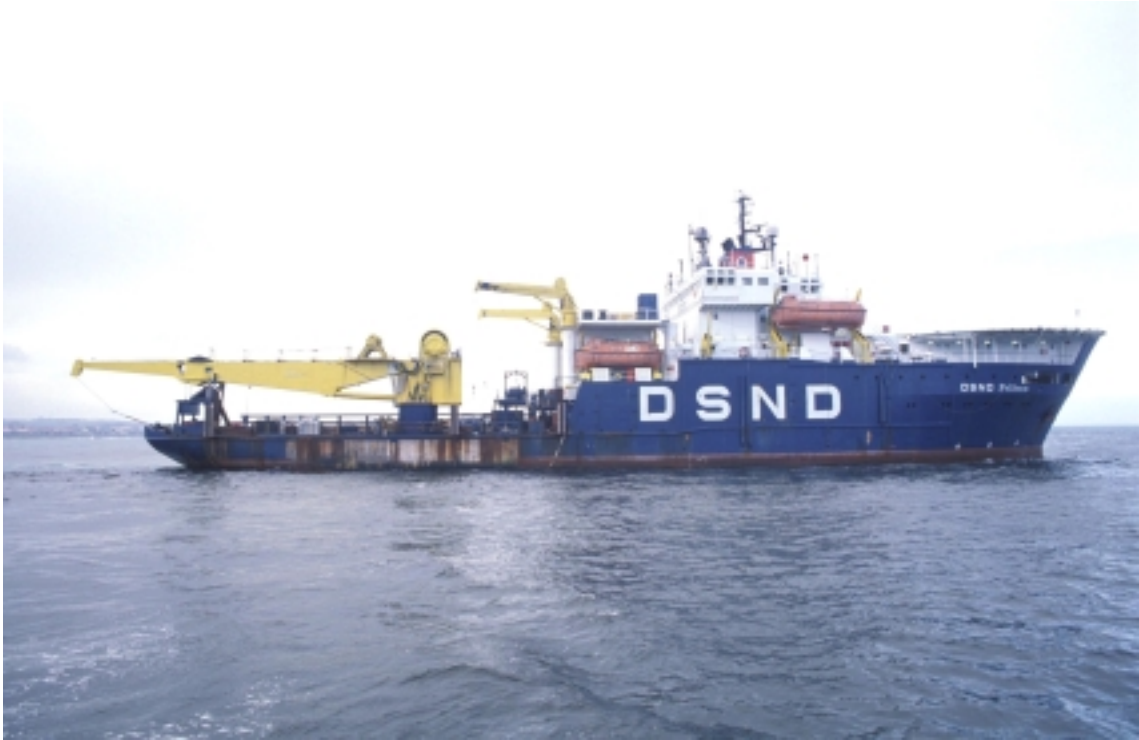
Figure 2

- The rope failed 1 to 1.5m below the sheave (as stated in Appendix 4 to the main report, and from photographs given in Appendix 2).
- The crane ball was 5m above the base of the module (the actual figure would depend on the module dimensions and sling configuration (which are not known); it is assumed that the rigging included a 3m single strop between the module and the hook, as it is understood is common practice).

All of the above taken together, indicate that the break was likely to have been at a distance of some 27m from the headache ball (Figure 2). However, it should be noted that with so many uncertainties and approximations in the data, this distance is far from accurate and has a tolerance of several metres either way. Figure 3 shows the PELICAN at sea. It is interesting to note how the crane hook is tied back to the stern bollards to prevent unnecessary thrashing about. Figure 4 shows where the calculated point of failure on the rope (i.e. 27 m from the headache ball) would have been during storage of the crane.

Schematic drawing of the location of the rope failure during deployment (stern view)
