Report of the LPG Independent Expert Working Group

Executive Summary

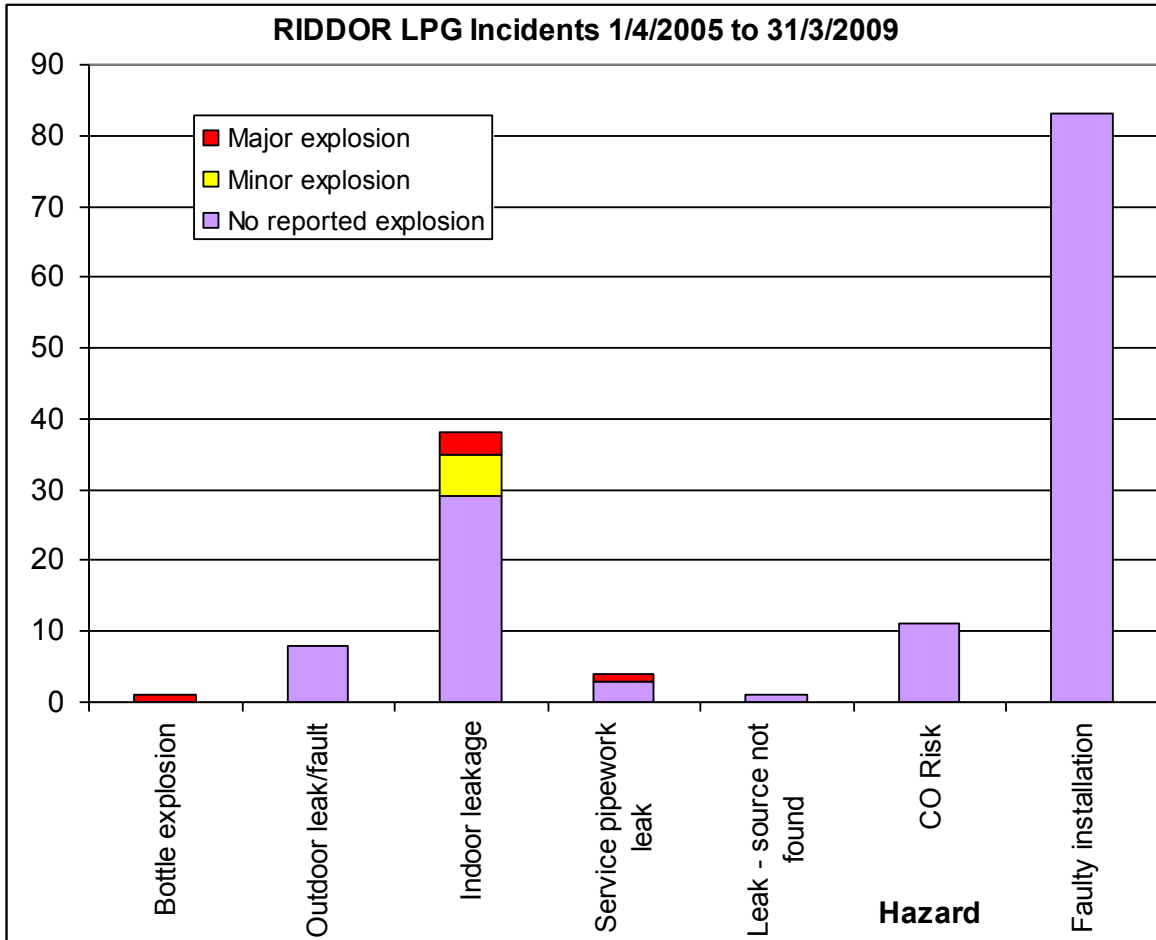
Figure 1: RIDDOR LPG Incidents

The “minor explosions” shown in Figure 1 involved small leaks igniting, often repeatedly, in or around a particular appliance. The “major explosions” caused significant structural damage to the properties involved, though fortunately none was fatal. The figure includes the one explosion we know of in domestic premises due to a corrosion leak in service pipework outside the building (Lanarkshire 2006 – see 2.3 above). The point we particularly note here, though, is the relatively large numbers of incidents involving LPG leaks inside the properties (nearly 10 per year). In addition, there are even larger numbers of “faulty installations” (typically a natural gas appliance being connected without modification to an LPG supply), many of which involve both a leakage/explosion and a carbon monoxide hazard. The absolute rates of incidents implied in the chart are almost certainly substantial underestimates, as there is no reason in many of these cases why a RIDDOR report should have been filed. But observing the relative numbers of incidents, a reasonable conclusion from this analysis might be that external service pipework accounts for perhaps 1-10% of the overall risk of LPG developing at flammable concentrations inside buildings.

As part of the TTAC study, HSE provided TTAC Ltd with raw data from RIDDOR on over 15,000 reported gas incidents from April 2005 to March 2009. These were re-analysed to select incidents involving LPG (based on text searches for “LPG”, “propane” and “butane” in the incident descriptions). These 202 LPG incidents have been further re-analysed to produce Figure 1 below showing the location and severity of the various issues involved.

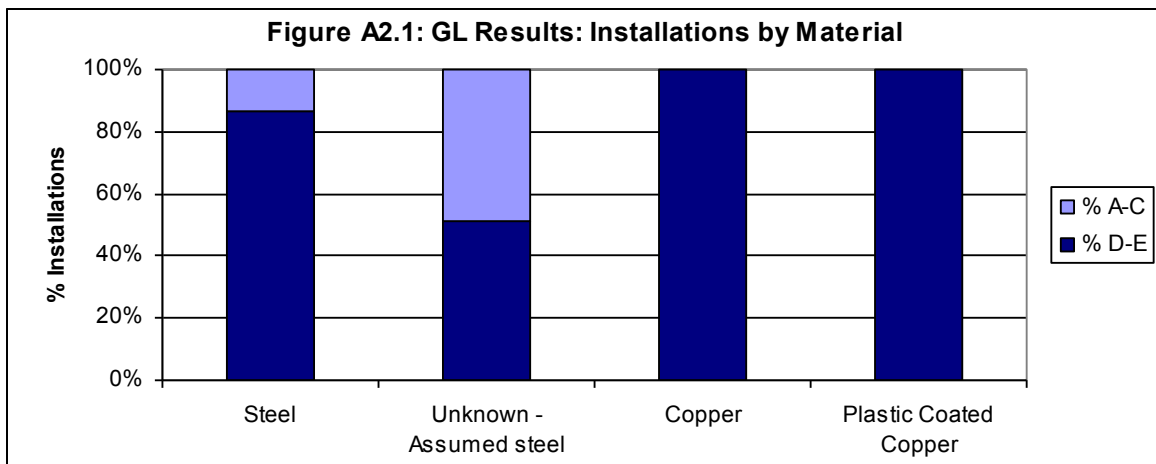
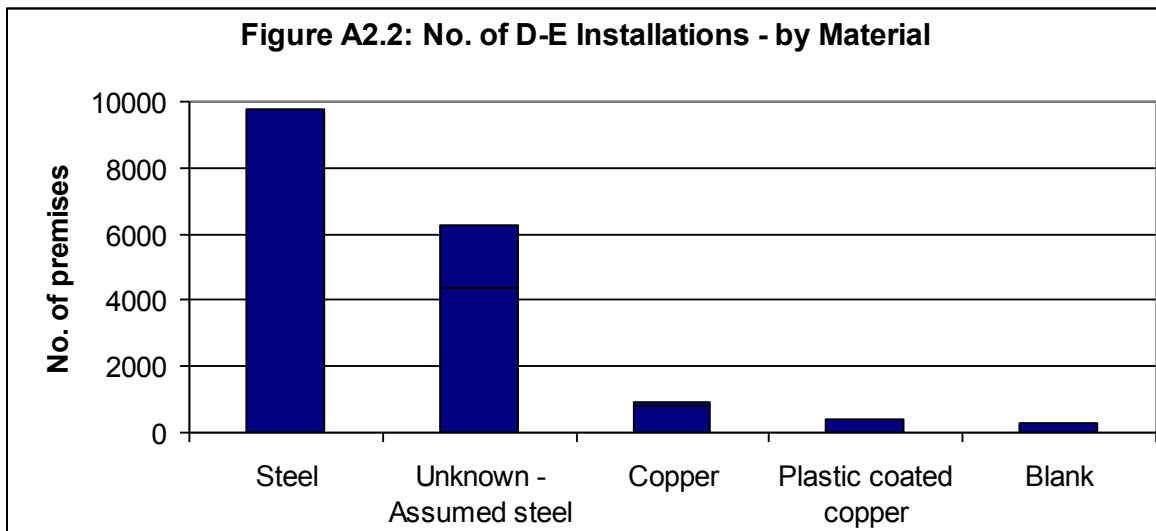
A3.1 Pipework Material

- All copper pipework is rated lower priority
- A much lower proportion of “unknown” than of steel pipework is of lower priority – this is because many “unknown material” will also be “unknown age” (both then assumed to have pessimistic values, i.e. carbon steel age 35 years).

This appendix provides a number of charts illustrating the difference made by various attributes of gas installations and premises to the prioritisation from A to E which emerged via the GL analysis. The first chart for each attribute shows how premises with each attribute split between higher (A-C) and lower (D-E) priority based on the GL/HSE analysis. The second chart shows the absolute number of D-E premises with each attribute (including blanks and unknowns). The attributes considered in turn are pipework material, age, operating pressure, presence of a cellar or basement, and ground cover outside the building.

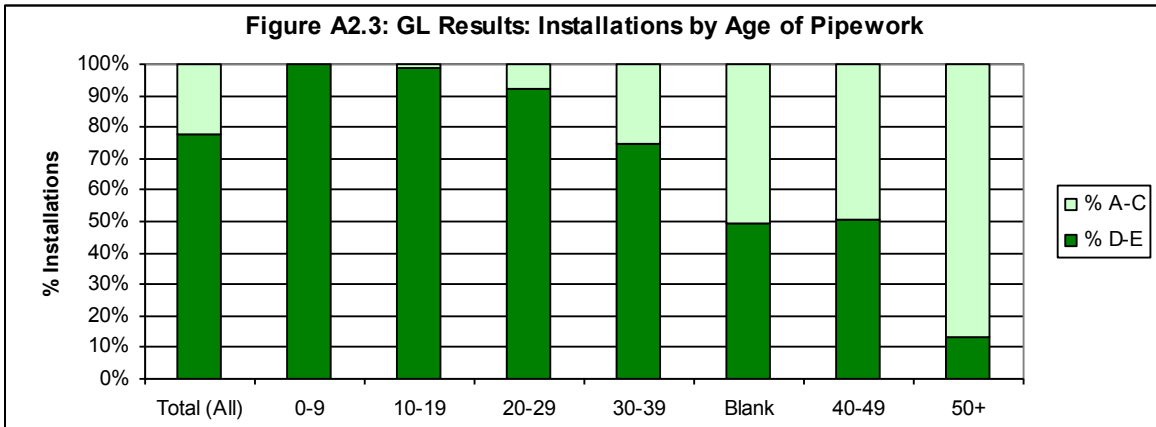
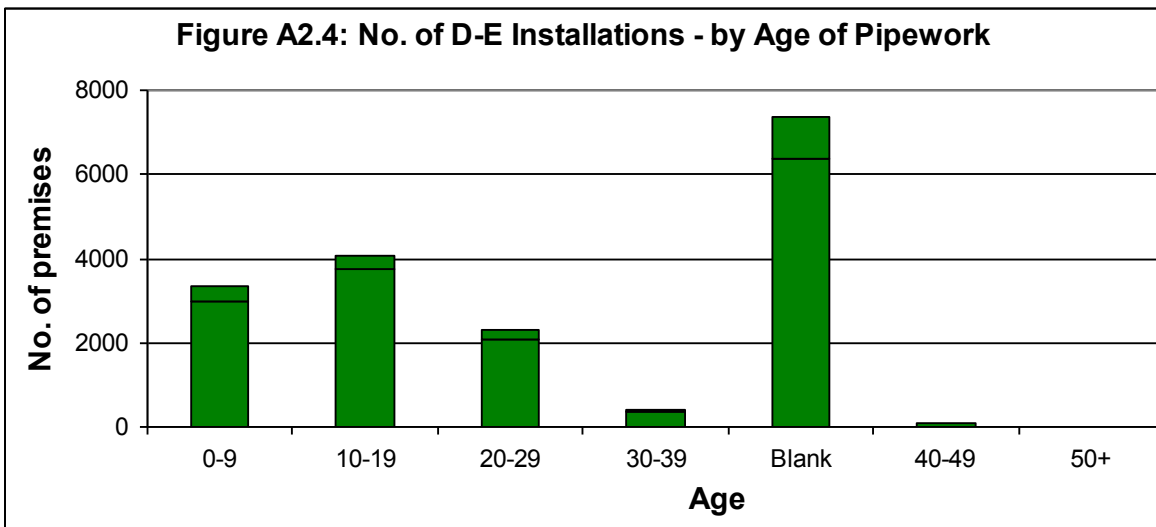
A3.2 Pipework Age

- All premises with pipework under 10 years old fell into the lower D-E categories
- From 10-19 years old about 99% of premises were lower priority D-E
- There are large numbers of premises for which the pipework age is not known; these were assumed to be 35 years old and are accordingly shown in-between the 30-39 and 40-49 categories.

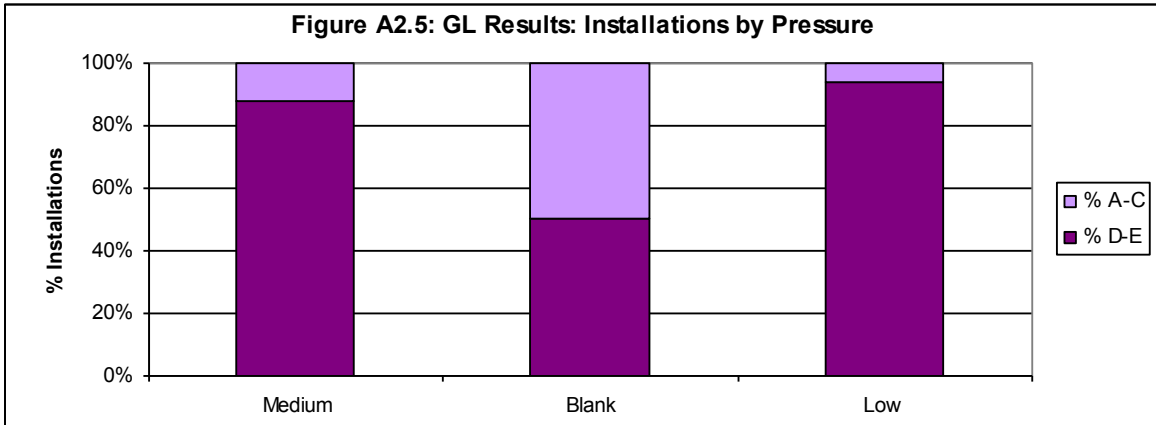
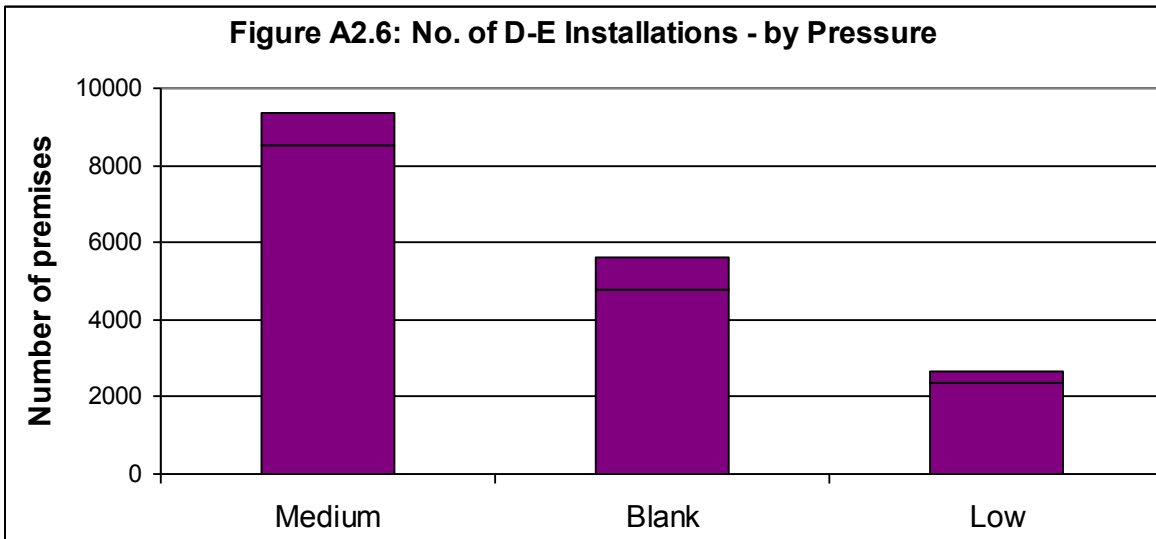
A3.3 Service Pressure

- A higher proportion of Low Pressure installations rated D-E than of Medium Pressure.
- A large proportion (about half) of unknown pressure installations were rated A-C. As for Pipework Age this is because premises with unknown pressure (for which a pessimistic assumption of “MP” was made) are more likely than other premises to have other unknown attributes such as age and material (for which pessimistic assumptions are also made).
- A high proportion of commercial premises have MP service pipework.

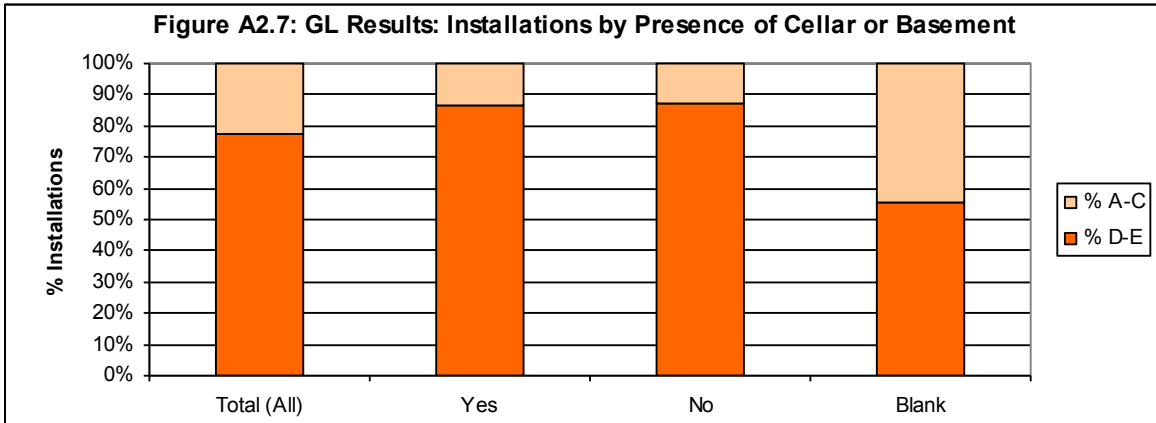
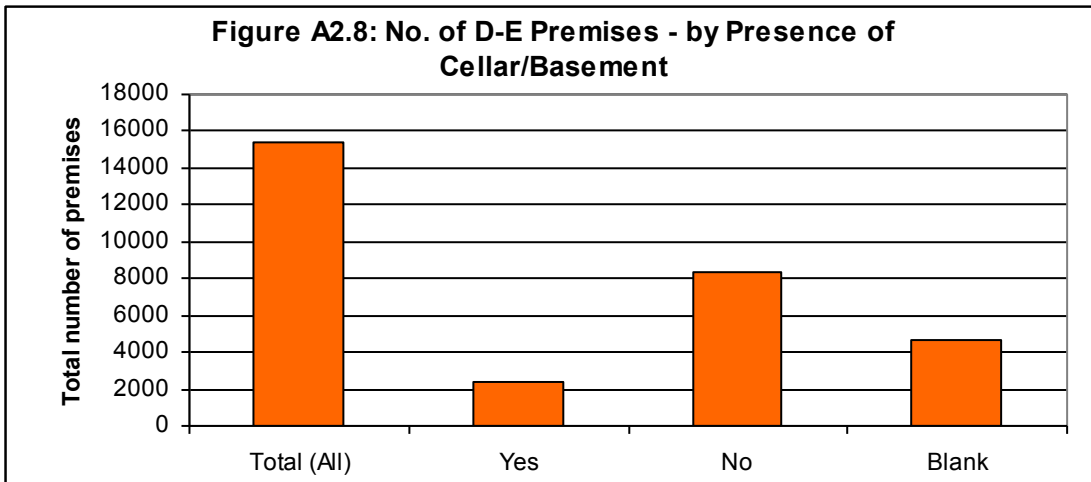
A3.4 Presence of Cellar/Basement

- Presence or otherwise of a cellar or basement does not appear to have made much difference to the proportion of premises classified as D-E
- As with other parameters, a higher proportion of blanks have resulted as higher priority (i.e. lower proportion of D-E) because of the pessimistic assumptions made where attributes were not known.
- A relatively small proportion of premises (just over 10%) have cellars or basements.

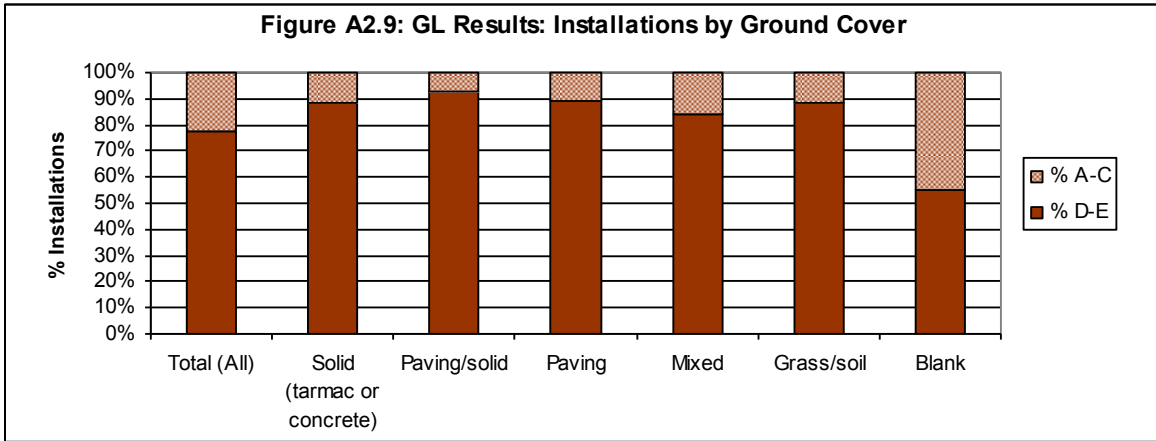
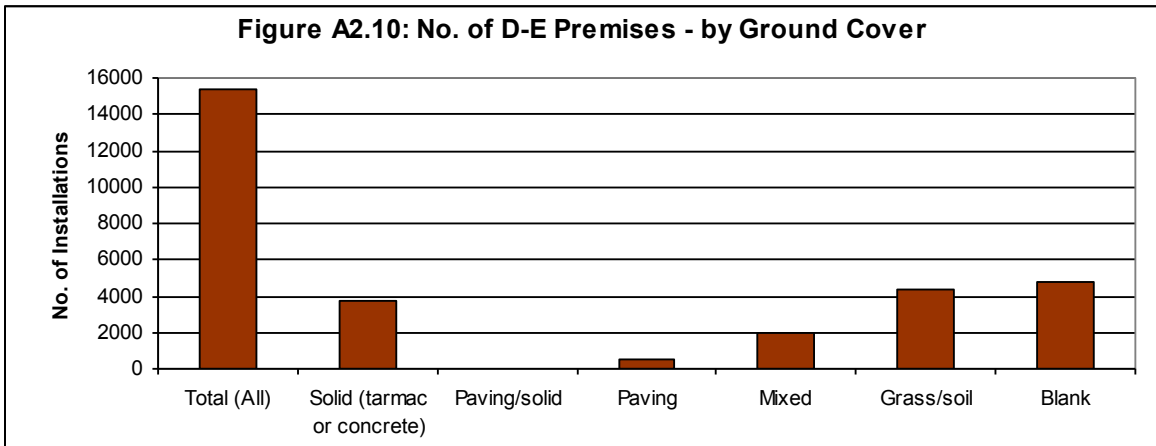
A3.5 Ground Cover outside Building

- In comparison with other factors, ground cover does not appear to have a consistent substantial impact on the A-E prioritisation – the two most substantial numbers of responses (Solid tarmac or concrete on the one hand; grass/soil on the other) emerged with similar proportions of premises in the lower (D-E) category.
- As for other attributes, the “outlier” in terms of prioritisation was the blank entry, because of the combined pessimistic assumptions used for premises with multiple blank entries.
