Joint Industry Programme on carbon monoxide issues

A review of carbon monoxide incident information for 1998/9 produced from the full investigation of incidents which had resulted from the use of piped natural gas and LPG within Great Britain

Prepared by
Advantica Technologies Limited
(formerly BG Technology)
for the Health and Safety Executive

CONTRACT RESEARCH REPORT
376/2001

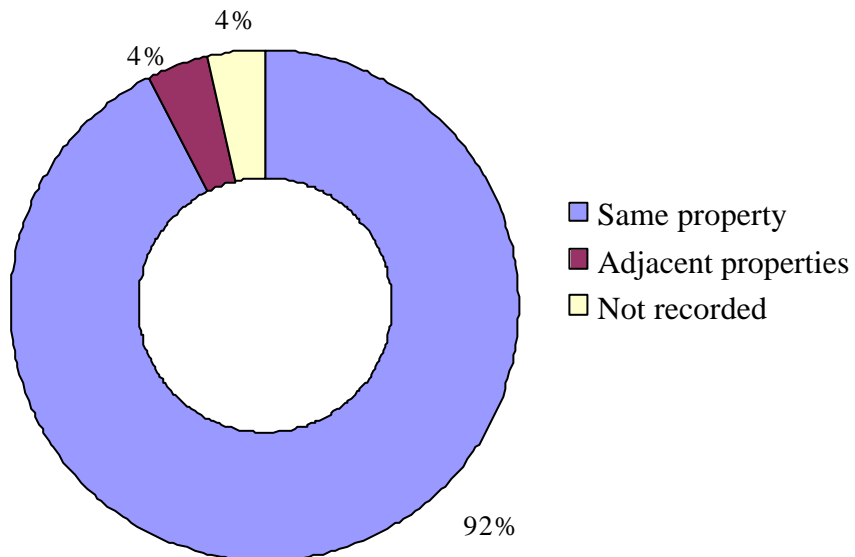
Figure 12 - Casualty/Appliance location

There were 2 appliances located in a room below ground level. At 99 (93%) incidents the casualties were in the same property as the incident appliance. Four incidents had casualties in adjacent properties and 4 were not coded. This is shown on Figure 12.
